| <br><br><b>Technical Service Bulletin</b> | <b>GROUP</b><br><br><b>CAMPAIGN</b> | <b>NUMBER</b><br><br><b>23-01-012G-1</b> |
| | <b>DATE</b><br><br><b>MARCH, 2023</b> | <b>MODEL(S)</b><br><br><b>GV70 (JK1)</b> |
| <b>SUBJECT:</b> ADVANCED DRIVER ASSISTANCE SYSTEM (ADAS) - REMOTE SMART PARKING ASSIST SOFTWARE UPDATE (SERVICE CAMPAIGN T30G) | | |

**Description:** This bulletin provides information related to the ADAS Parking system software upgrade for certain 2023MY GV70(JK1) vehicles.

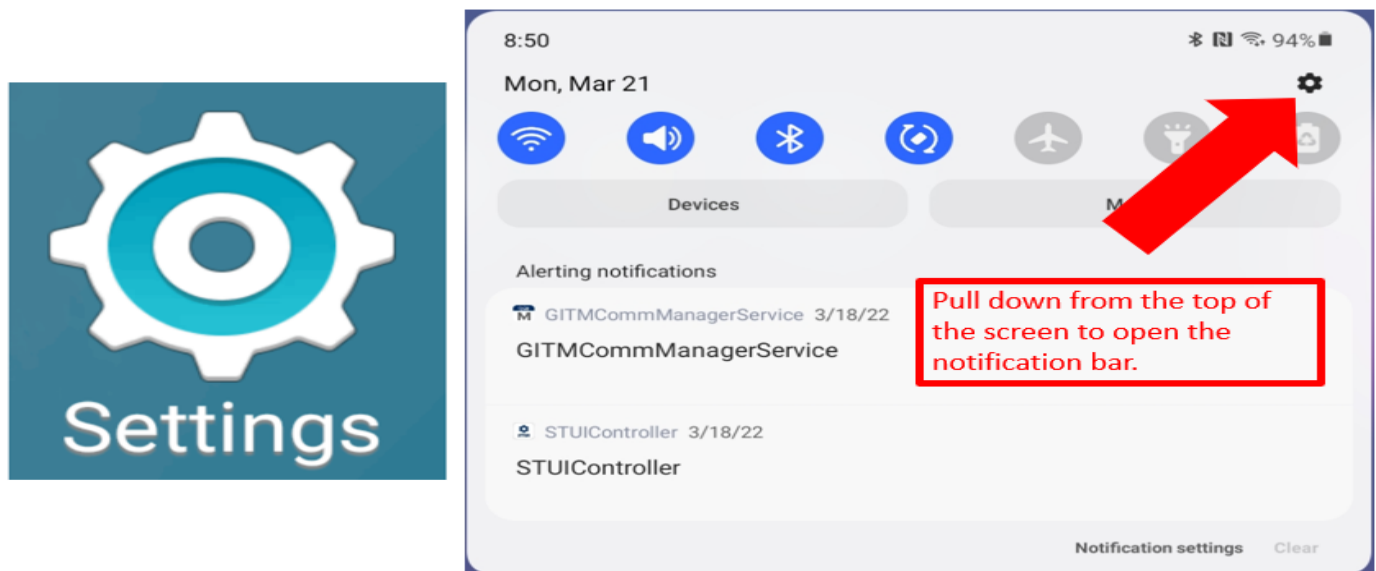
Step 1: Open tablet “Settings” from the apps screen or the drop-down notification bar.

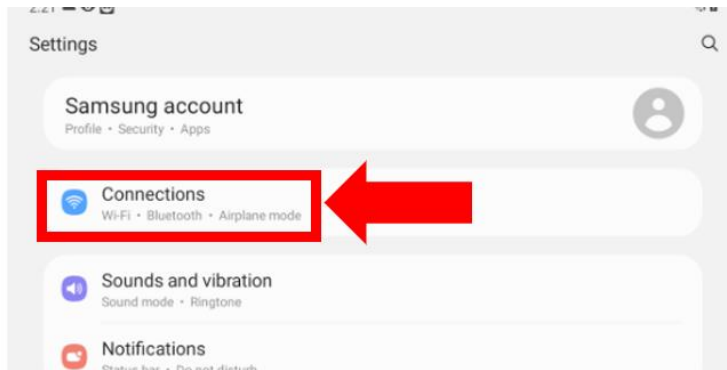
Step 2: Select "Connections" from the Settings menu.

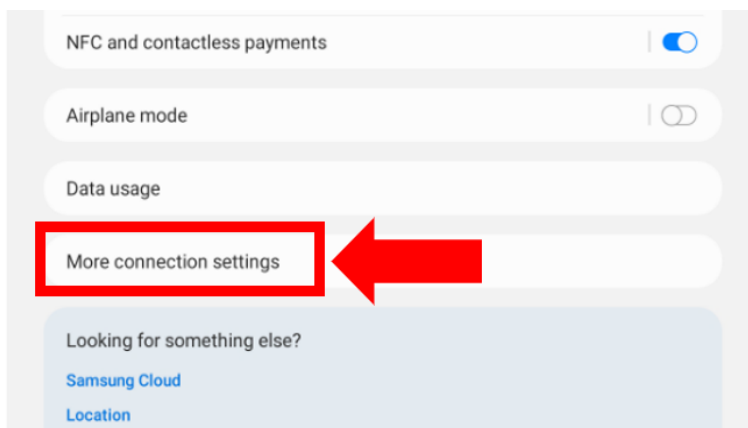
Step 3: Select "More connection settings" from Connections menu.

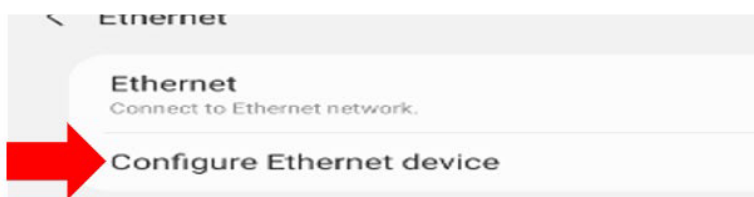
Step 5: Select "Configure Ethernet Device".

Step 6: Select "Static IP".

A screenshot of a network configuration dialog box. At the top, it says "Select Ethernet device" with "eth0" selected in a dropdown menu. Below that, "Connection type" has two radio buttons: "DHCP" (unselected) and "Static IP" (selected). Under "Static IP", there is a "Proxy" dropdown menu with "None" selected. At the bottom, there are two buttons: "Discard" and "Save".

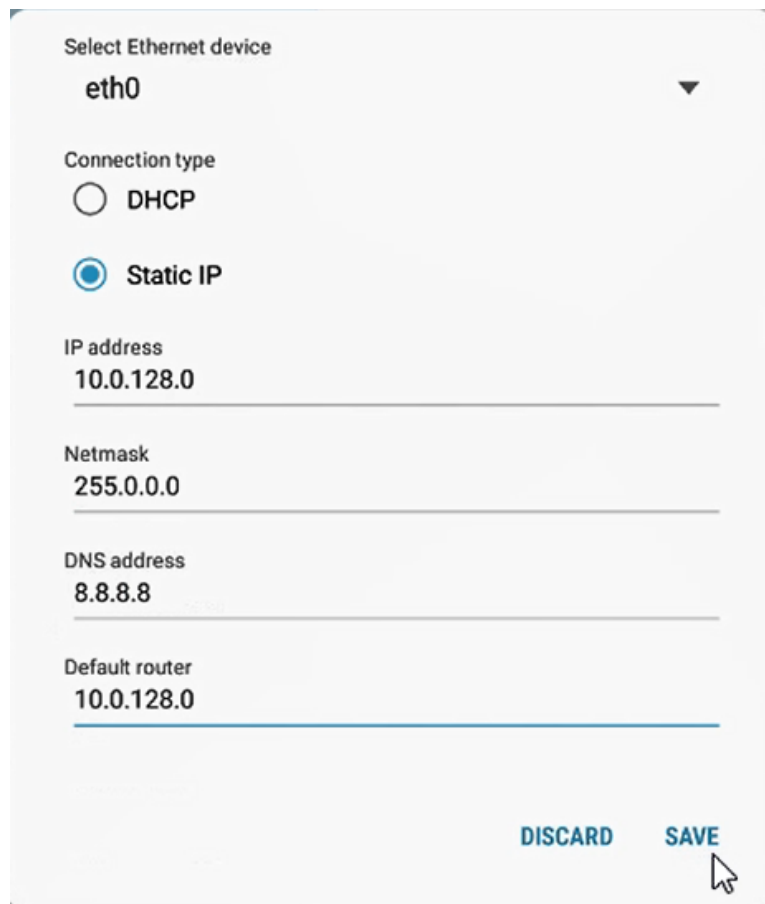
Step 7: Enter the following digits exactly as shown for IP address, Netmask, DNS address, and Default gateway. Save and close.

| <b>IP address – 10.0.128.0</b> | <b>Netmask – 255.0.0.0</b> |
| <b>DNS address – 8.8.8.8</b> | <b>Default gateway – 10.0.128.0</b> |

A screenshot of the same network configuration dialog box, but now with the following values entered in the text fields: "IP address" is 10.0.128.0, "Netmask" is 255.0.0.0, "DNS address" is 8.8.8.8, and "Default router" is 10.0.128.0. The "Static IP" radio button remains selected. At the bottom right, there are "DISCARD" and "SAVE" buttons, with a mouse cursor pointing at the "SAVE" button.

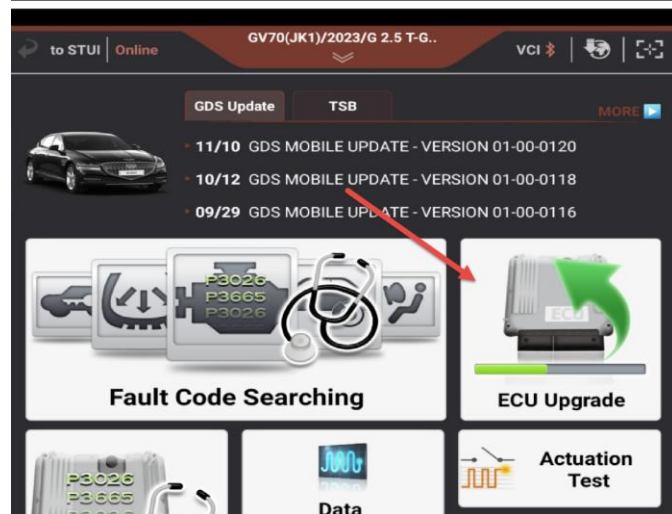
1. Select ECU Upgrade on the initial screen after entering the vehicle information.

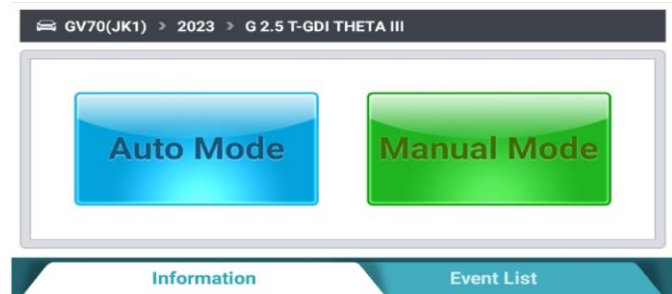
2. Select Auto Mode and then tab the system.

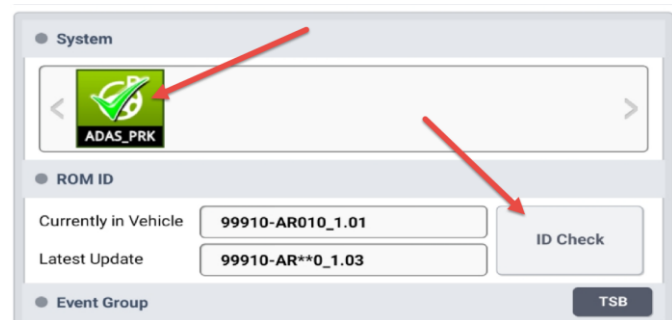
3. Select "ADAS\_PRK" System and Press "ID Check". The GDS-Mobile will read the current ROM ID in vehicle and check the newest upgrade event.

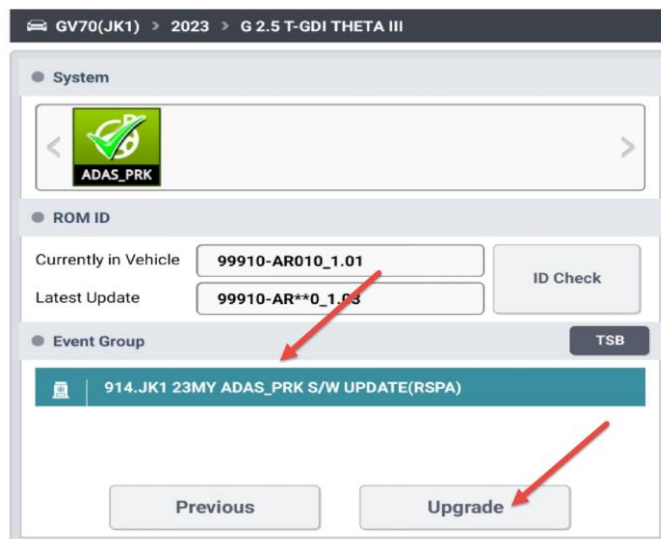
- Select the upgrade event.

"914.JK1 23MY ADAS\_PRK S/W UPDATE(RSPA)"

Press "Upgrade".

Upgrade will begin and the progress of the upgrade will appear until 100% is reached on the bar graph.

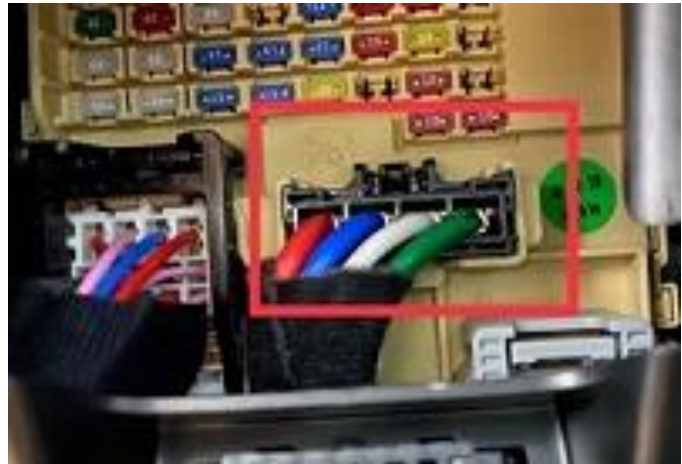
- After upgrade, remove power connector of indoor fuse box and reconnect it after 5 seconds.

Alternatively, remove the battery negative terminal and reconnect it 5 seconds later.

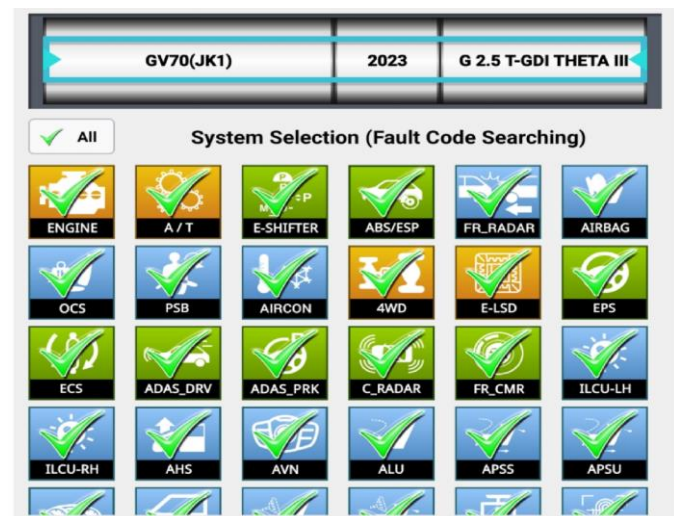
- Check if any incidental Diagnostic Trouble Codes (DTC) have been created by the upgrade and clear the DTC(s) present.

Start the engine to confirm proper operation of the vehicle.

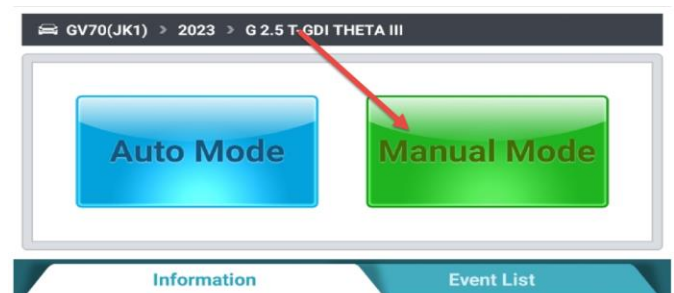
- Within the upgrade screen, select Manual Mode, then select upgrade event.

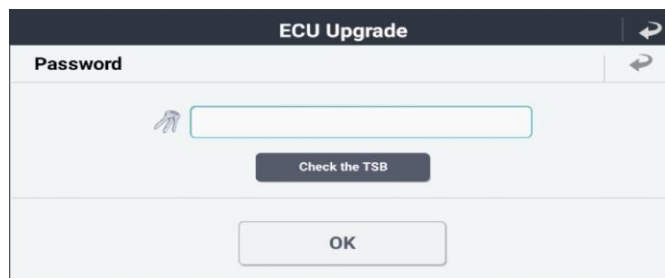
- Enter the password from the below table then press OK.

| MENU | PASSWORD |
|---|---|
| JK1 23MY RSPA 99910-AR010/110 | 1010 |

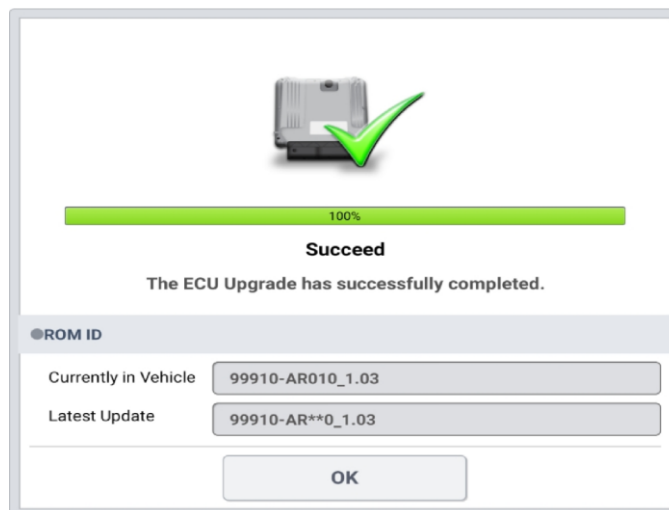
- Press OK on the final screen, which indicates upgrade is complete.

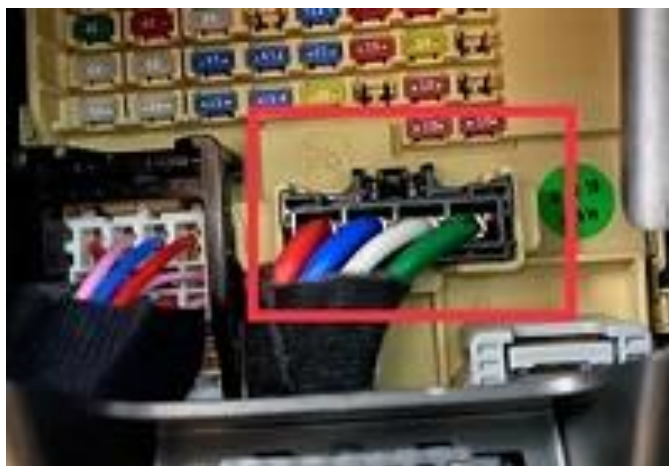
6. After upgrade, remove power connector of indoor fuse box and reconnect it after 5 seconds.

Alternatively, remove the battery negative terminal and reconnect it 5 seconds later. tart

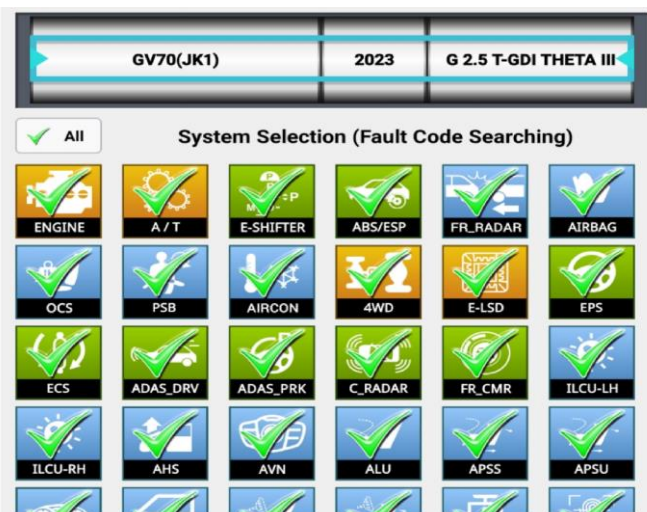
7. Check if any incidental Diagnostic Trouble Codes (DTC) have been created by the upgrade and clear the DTC(s) present.

Start the engine to confirm proper operation of the vehicle.
