<b>HYUNDAI</b> <b>Technical Service Bulletin</b>	GROUP <b>CAMPAIGN</b>	NUMBER <b>23-01-006H</b>
	DATE <b>MARCH 2023</b>	MODEL(S) <b>ELANTRA (CN7/CN7a)</b>
<b>SUBJECT:</b> IVT DAMPER CLUTCH LOGIC UPDATE (SERVICE CAMPAIGN 967)

**Description:** This bulletin provides the service procedure to update the Transmission Control Unit (TCU) software for certain Elantra (CN7/CN7a) vehicles equipped with the 2.0L MPI and Intelligent Variable Transmission (IVT). This update to the damper clutch logic is to address a potential engine stall condition immediately following Forward Collision Avoidance (FCA) activation under specific operating conditions at low engine RPM and low vehicle speeds. In the event a low-speed stall does occur, the engine can immediately be restarted.

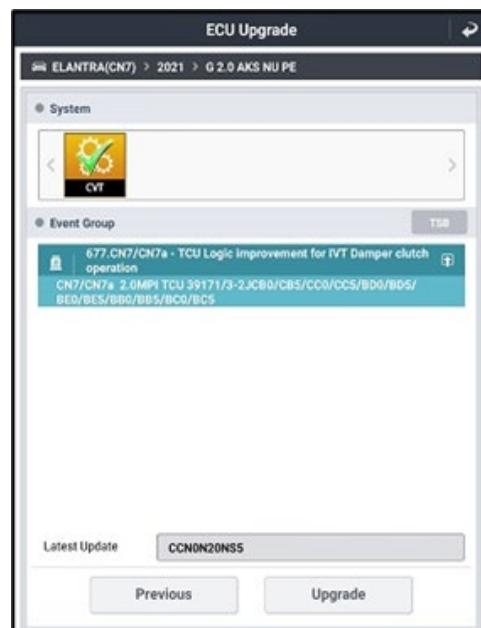
1. From the GDS-M home screen, select **ECU Upgrade**.
2. From the ECU Upgrade screen, select **Manual Mode**, then select the **Update Event 677**.

<p><b>Update Event</b></p> <p><b>677.CN7/CN7a-TCU LOGIC IMPROVEMENT FOR IVT OPERATION</b></p>
---

3. A password prompt will appear. Enter the password and select **Upgrade**.

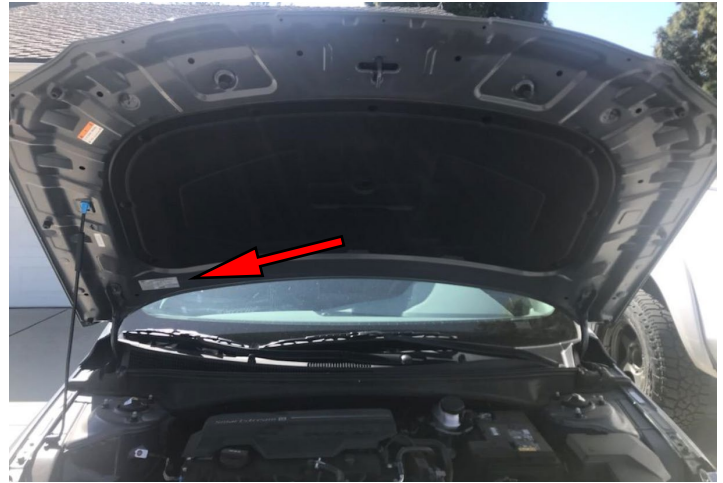
Fill in the information on the 00305-SC967 Campaign Sticker and apply onto the hood in the area below the Emission Label as shown.

Using STUI, photograph the campaign sticker along with the last 6 digits of the VIN and the date of the repair on a piece of paper.
