| <b>HYUNDAI</b><br><b>Technical Service Bulletin</b> | GROUP<br><b>CAMPAIGN</b> | NUMBER<br><b>23-01-028H</b> |
| | DATE<br><b>MARCH, 2023</b> | MODEL(S)<br><b>TUCSON (NX4)</b> |
| <b>SUBJECT:</b> D-AUDIO SOFTWARE UPDATE: VOLUME UNAVAILABLE<br>(SERVICE CAMPAIGN T9D) | | |

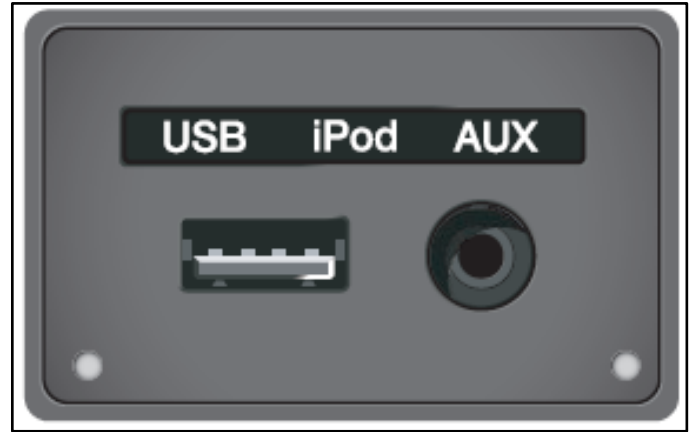
- 6. The USB drive has an MP3 file that will play automatically when USB is plugged into the slot.

This is to distinguish when the update does not work due to file corruption or a faulty USB.

If the MP3 file plays and the update fails, the file is corrupt.

If the MP3 file does not play and the update fails, the USB is faulty.

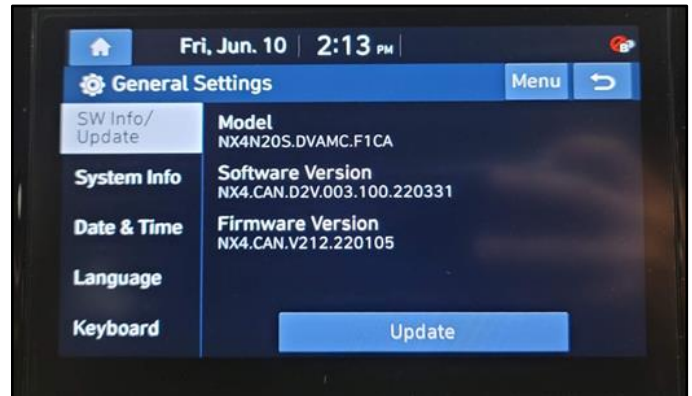
The picture to the right is the updated version for a Canadian vehicle; the updated version will say USA instead of CAN for a USA vehicle.

***NX4.USA.D2V.003.100.220331***
