GLOBAL SAFETY FIELD INVESTIGATIONS
DCS6520
URGENT - DISTRIBUTE IMMEDIATELY

Subject: REVISION: N222375790-03 - Customer Satisfaction Program
Park Assist Retrofit
Population Update

Models: 2022 – 2023 Cadillac CT4
2022 – 2023 Cadillac CT5
2022 Cadillac Escalade/Escalade ESV
2022 – 2023 Chevrolet Corvette

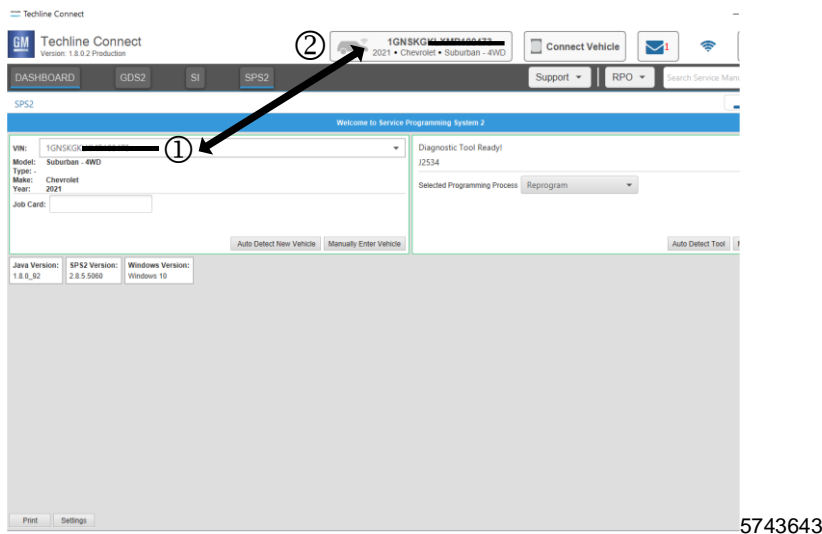
Caution: Be sure the VIN selected in the drop down menu (1) is the same as the vehicle connected (2) before beginning programming.

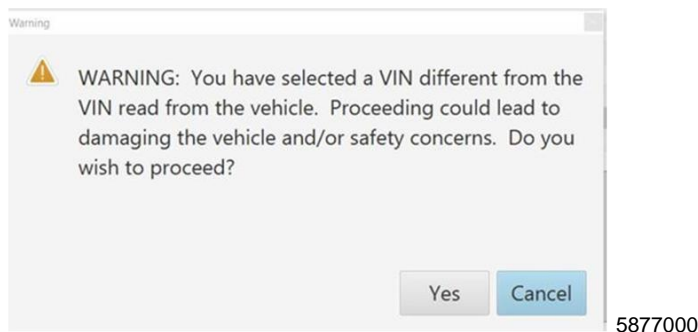
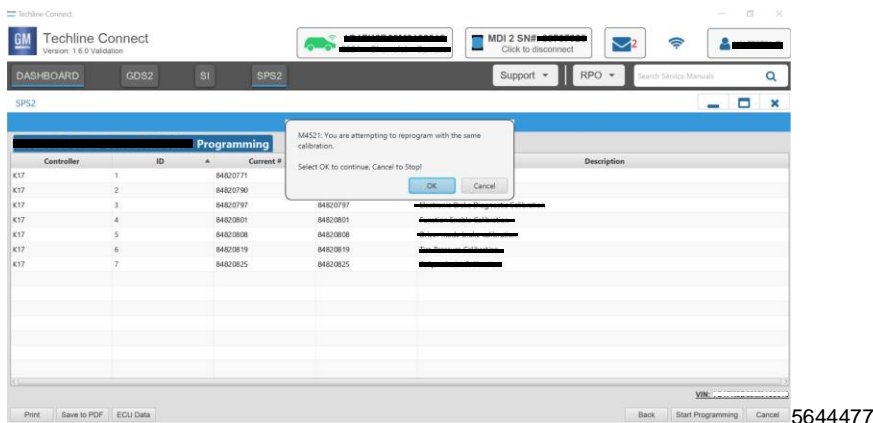
Important: If the vehicle VIN DOES NOT match, the message below will be shown.

Important: Techline Connect screens shown above.

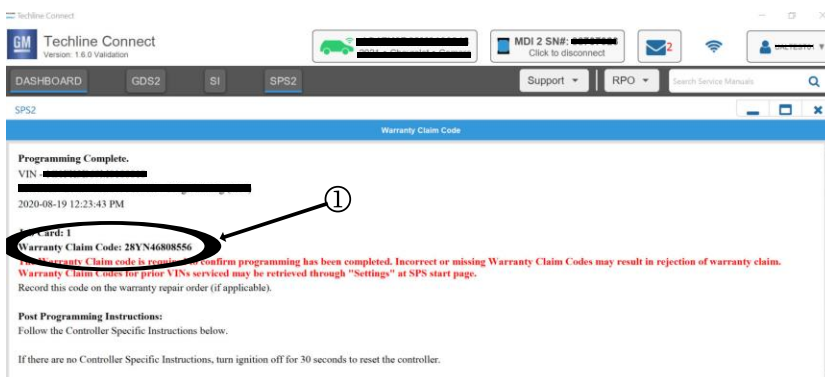
5644478

4. Perform “setup” on the Serial Data Gateway Module. Select “Setup” on the SPS Supported Controllers screen and follow the on-screen instructions. Refer to *K56 Serial Data Gateway Module: Programming and Setup* in SI.

Note: The screenshot above is an example of module programming and may not be indicative of the specific module that is being programmed. Module selection and VIN information have been blacked out.

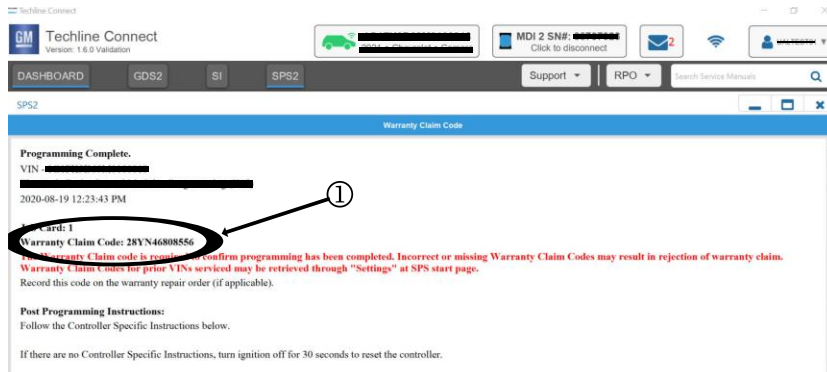
5644478

5. Perform “setup” on the Serial Data Gateway Module. Select “Setup” on the SPS Supported Controllers screen and follow the on-screen instructions. Refer to *K56 Serial Data Gateway Module: Programming and Setup* in SI.

Note: The screenshot above is an example of module programming and may not be indicative of the specific module that is being programmed. Module selection and VIN information have been blacked out.

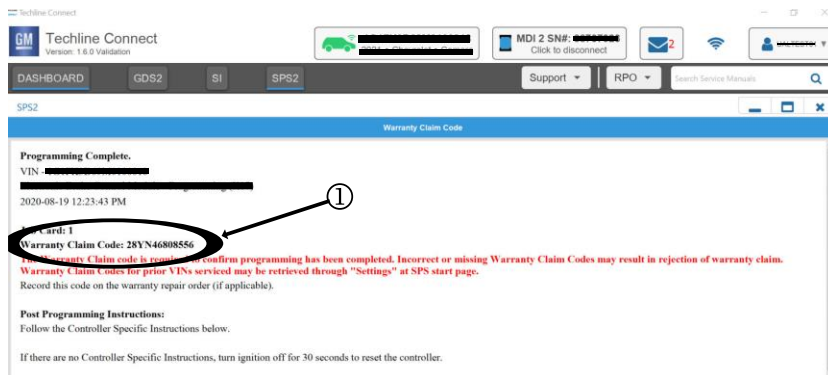
5644478

5. Perform “setup” on the Serial Data Gateway Module. Select “Setup” on the SPS Supported Controllers screen and follow the on-screen instructions. Refer to *K56 Serial Data Gateway Module: Programming and Setup* in SI.

Note: The screenshot above is an example of module programming and may not be indicative of the specific module that is being programmed. Module selection and VIN information have been blacked out.

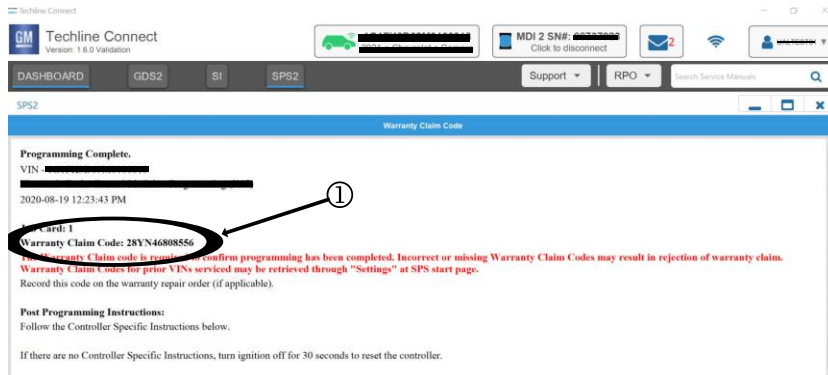
5644478

6. Perform “setup” on the Serial Data Gateway Module. Select “Setup” on the SPS Supported Controllers screen and follow the on-screen instructions. Refer to *K56 Serial Data Gateway Module: Programming and Setup* in SI.

Note: The screenshot above is an example of module programming and may not be indicative of the specific module that is being programmed. Module selection and VIN information have been blacked out.

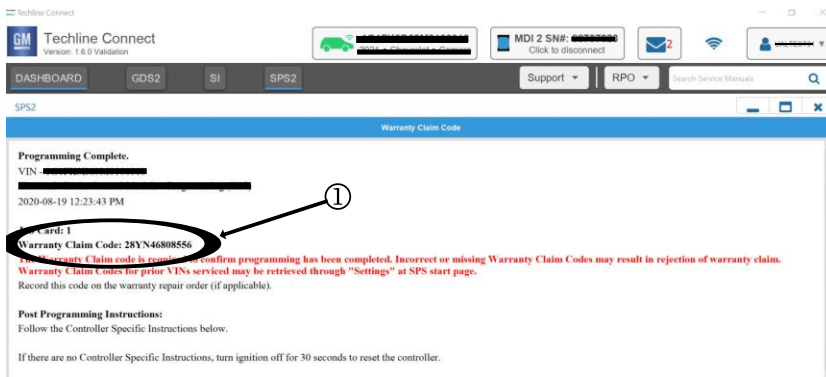
5644478

5. Perform “setup” on the Serial Data Gateway Module. Select “Setup” on the SPS Supported Controllers screen and follow the on-screen instructions. Refer to *K56 Serial Data Gateway Module: Programming and Setup* in SI.

Note: The screenshot above is an example of module programming and may not be indicative of the specific module that is being programmed. Module selection and VIN information have been blacked out.
