Technical Service Bulletin

SUBJECT:		No: TSB-22-55-002REV	
A/C UNINTENTIONALLY TURNS OFF - REVISED		DATE: March 2023	
		MODEL: 2022-23 Outlander	
CIRCULATE TO:	<input type="checkbox"/> GENERAL MANAGER	<input checked="" type="checkbox"/> PARTS MANAGER	<input checked="" type="checkbox"/> TECHNICIAN
<input checked="" type="checkbox"/> SERVICE ADVISOR	<input checked="" type="checkbox"/> SERVICE MANAGER	<input checked="" type="checkbox"/> WARRANTY PROCESSOR	<input type="checkbox"/> SALES MANAGER

This Campaign Bulletin provides instructions to reprogram the HVAC ECU with updated software.

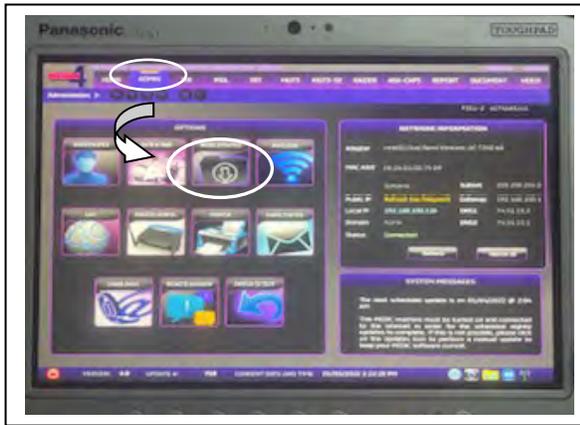
3. Select the MEDIC 3.5/4 Admin tab and click on "Updates".

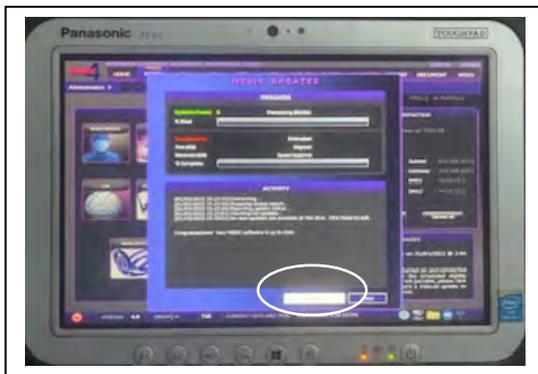
4. If the MEDIC update screen advises updates are available, click the "Begin" button. After all updates are complete, **GO TO THE REPROGRAMMING PROCEDURE.**

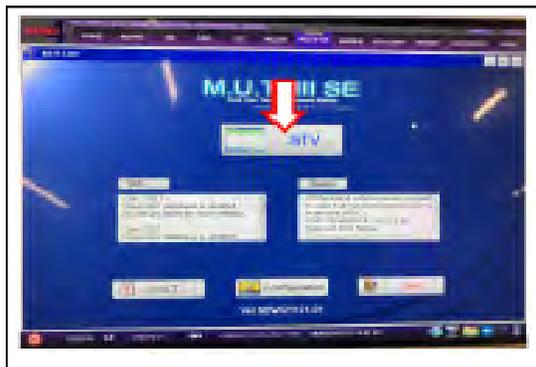
- a. Press the MUT-III SE STV icon.

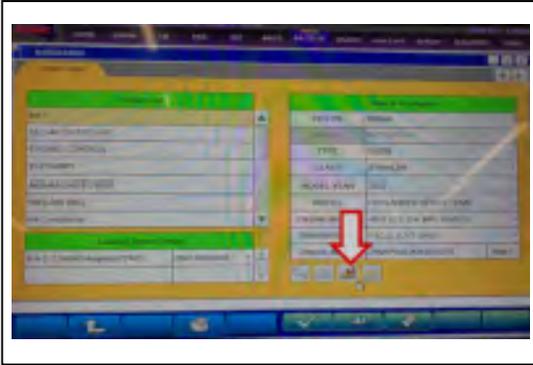
b. Press the ECU Reprogramming button.

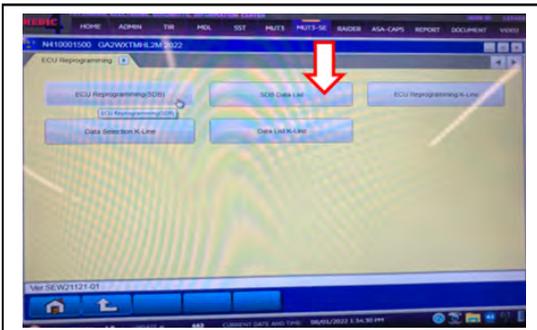
c. Press SDB Data List, select the reprogramming data system and press the OK button.

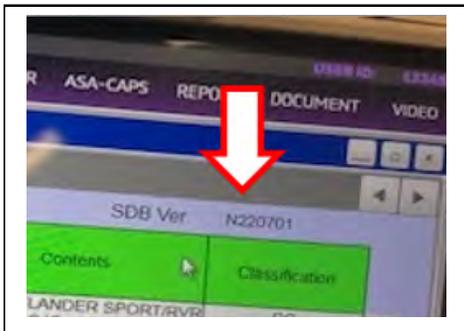
d. Confirm that the database number displayed in the upper right above the chart is **N220701** or higher.

- i. If the database number displayed on your MUT-III SE is **N220701** or greater, continue to the next section.
- ii. If the reprogramming database number displayed on your MUT-III SE is lower than **N220701**, then the MUT-III SE database needs to be updated.
- iii. Once the database number is confirmed, hit the Home button to go back to the System Select screen.

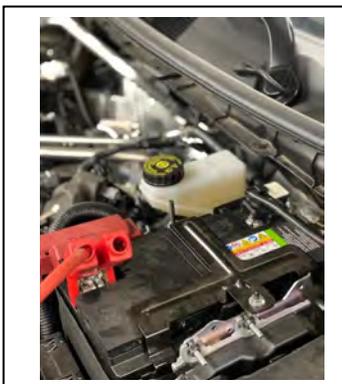
NOTE: Due to limited space it may be easiest to connect battery charger cable onto ground point.

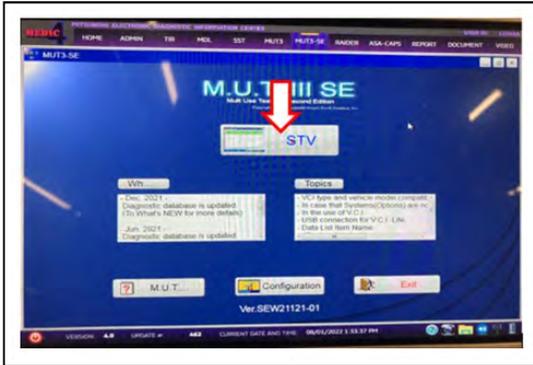
a. Press MUT-III SE STV icon.

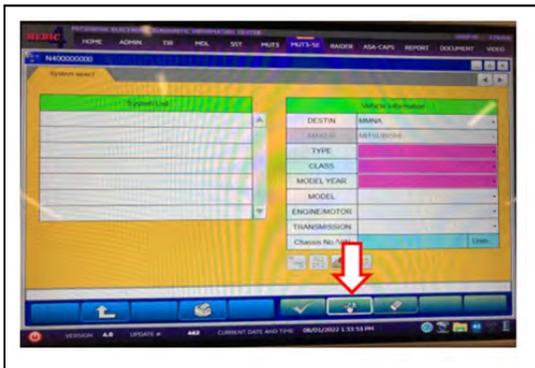
b. Press the model information display button (car icon) and verify all vehicle info is correct.

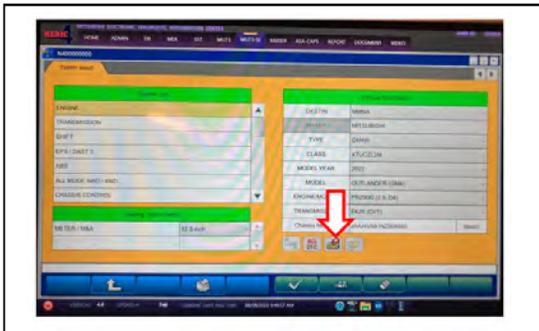
c. Press the reprogramming icon button.

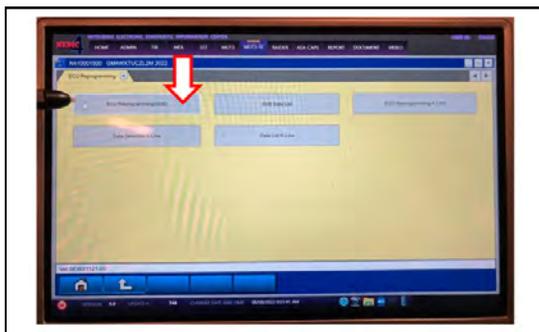
d. Press the "ECU reprogramming" (SDB) button.

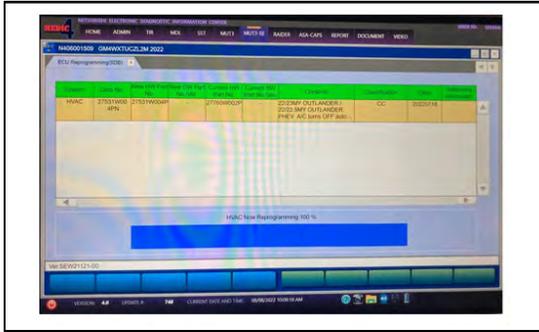
- h. Once the reprogramming is initiated, the screen will show the reprogramming progress.

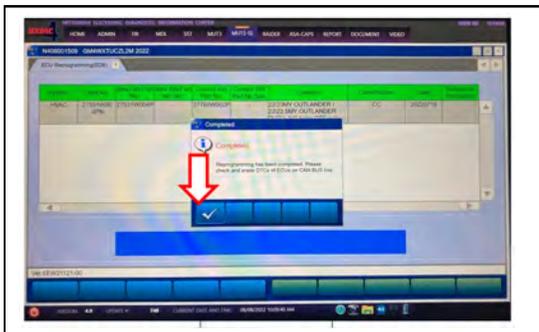
- i. When reprogramming is completed; turn the ignition switch to the OFF position and press the OK button to confirm the results of reprogramming.

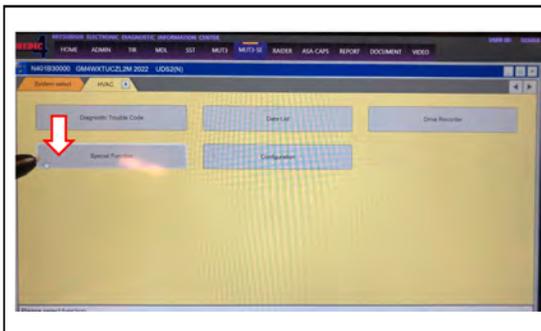
- j. Verify the software by turning the ignition switch to the ON position and select the "Special Function" button under the HVAC tab.

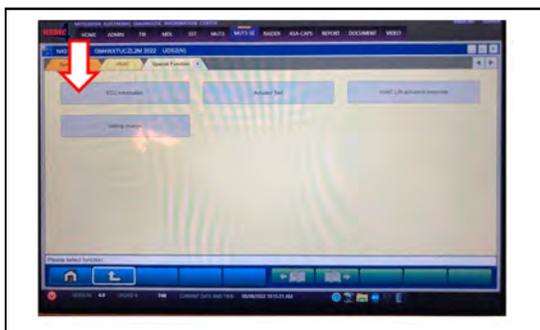
- k. Select "ECU Information" under the Special Function tab.

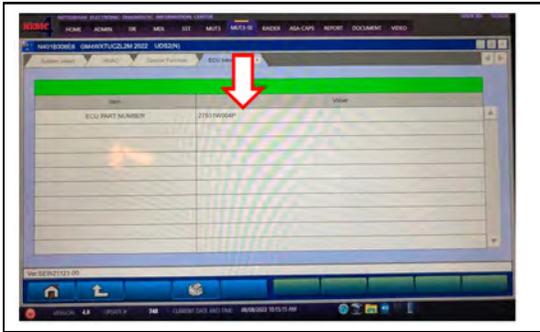
- i. Verify that the software version has been updated to 27531W003P or 27531W004P depending on the vehicles specification.

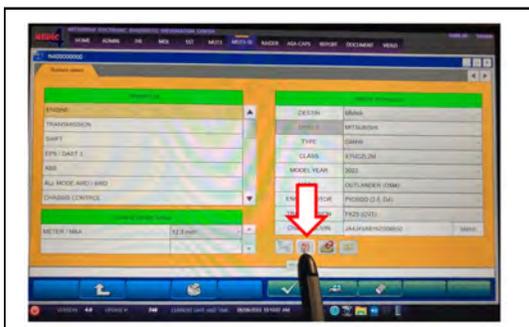
- m. Press "ALL DTC" button to initiate the "Erase and Read all DTCs". Press OK when complete.

IMPORTANT: The "Erase and Read all DTCs" must be performed since HVAC related DTCs may be generated and stored.

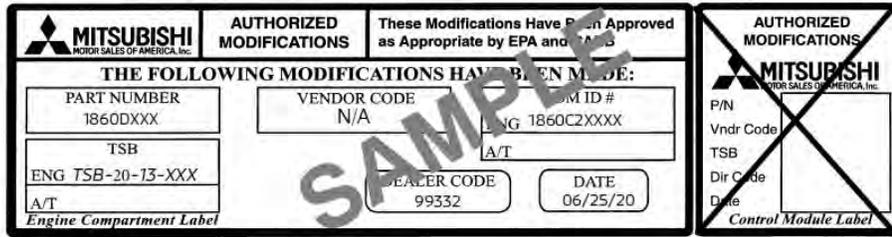
- 6 Using a ball-point pen, enter the appropriate ECU part number, Software Part Number (ROM ID#), this Technical Service Bulletin number, your dealer code, and the current date on the Engine Compartment/Control Module Label (p/n MSSF024G00). The Vendor Code is not applicable. The label is available from your facing PDC.
