Technical Service Bulletin

SUBJECT:		NO: TSB-23-23-002	
TRANSMISSION CONTROL MODULE (TCM) SOFTWARE UPDATE FOR DTC: P0780/P0706		DATE: March 2023	
		MODEL: 2022-23 Outlander	
CIRCULATE TO:	<input type="checkbox"/> GENERAL MANAGER	<input checked="" type="checkbox"/> PARTS MANAGER	<input checked="" type="checkbox"/> TECHNICIAN
<input checked="" type="checkbox"/> SERVICE ADVISOR	<input checked="" type="checkbox"/> SERVICE MANAGER	<input checked="" type="checkbox"/> WARRANTY PROCESSOR	<input type="checkbox"/> SALES MANAGER

This bulletin provides instructions to update the software for the TCM (Transmission Control Module)/SCU (Shift by Wire Control Unit) when the TCM detects DTC: P0780/P0706.

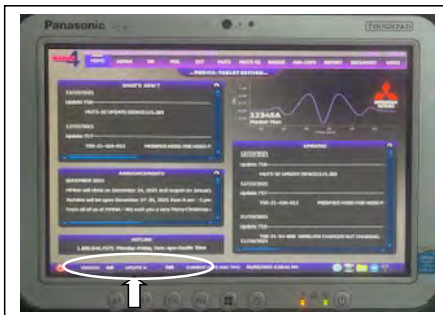
2. Verify the MEDIC 3.5/4 is at version 3.5 and at update **786** or higher. If your **MEDIC 3.5/4 update is at least 786**, continue with the Reprogramming Procedure. If your **MEDIC 3.5/4 update is below 786**, update your MEDIC as follows:

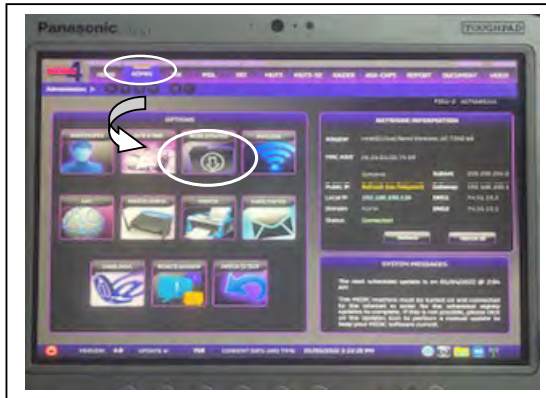
3. Select the MEDIC 3.5/4 Admin tab and click on "Updates".

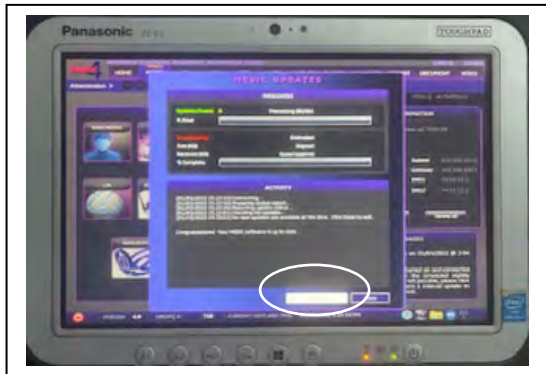
4. If the MEDIC update screen advises updates are available, click the "Begin" button. After all updates are complete, **GO TO THE REPROGRAMMING PROCEDURE**.

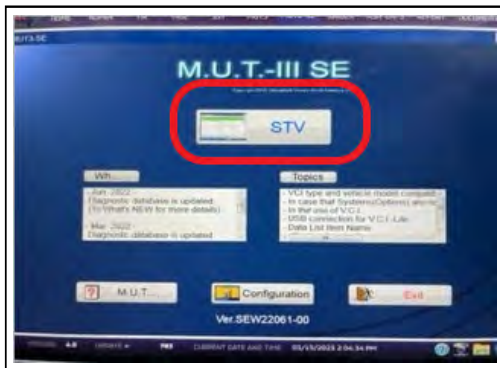
- a. Press the MUT-III SE STV icon.

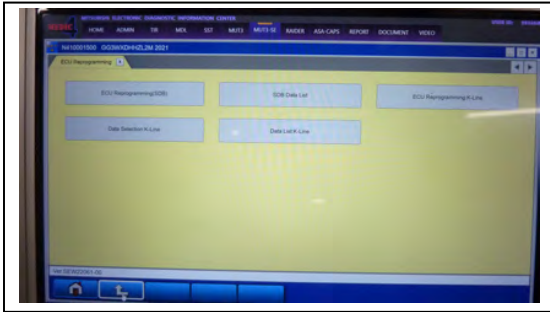
b. Press "ECU Reprogramming (SDB)" button.

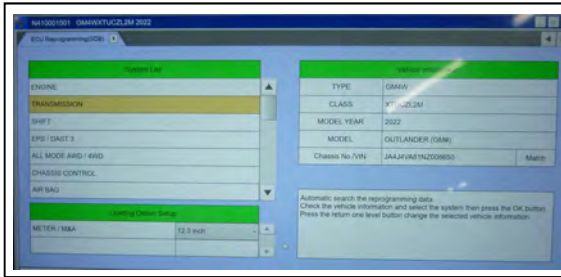
c. Verify the vehicle information and select the system "Transmission" followed by the OK button.

d. Confirm that the database number displayed at the top is **N230201NR** or higher.

- i. If the database number displayed on your MUT-III SE is **N230201NR** or greater, continue to the next section.
- ii. If the reprogramming database number displayed on your MUT-III SE is lower than **N230201NR**, then the MUT-III SE database needs to be updated.
- iii. Once the database number is confirmed, hit the Home button to go back to the System Select screen.

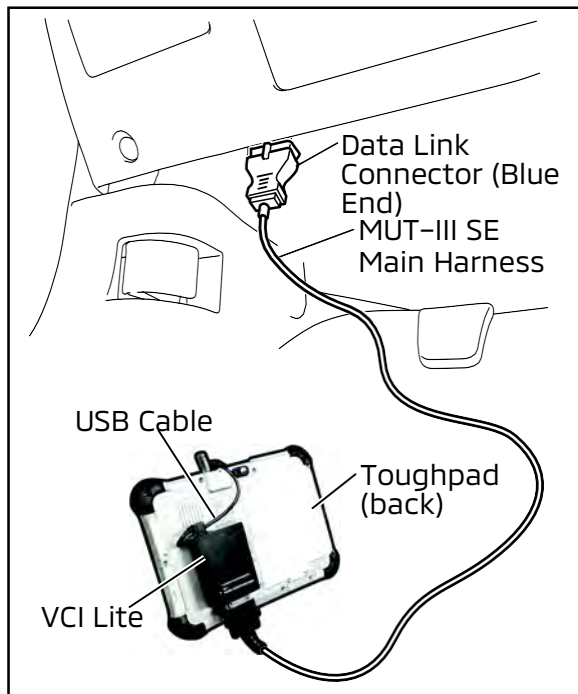
1. Connect the equipment as follows:

NOTE: VCI Lite and MEDIC 4.0 Toughpad shown for illustration purposes only.

- Turn the MEDIC PC/tablet on. If the battery indicator in the lower right hand corner of the screen does not show a full charge, it is recommended that either the battery be charged prior to beginning or be used with the A/C power adaptor connected.
- Connect the USB cable to the VCI/VCI Lite. When the laptop/tablet displays the MUT-III SE main screen, connect the USB cable to the device.
- Connect the MUT-III SE main harness with the blue DLC connection to the VCI/VCI Lite. Connect the blue connection of the MUT-III SE main harness to the vehicle's data link connector.
- For VCI only (p/n MB991824): Turn the VCI power switch ON. Verify that the indicator lamp in the upper right corner of the screen is green.

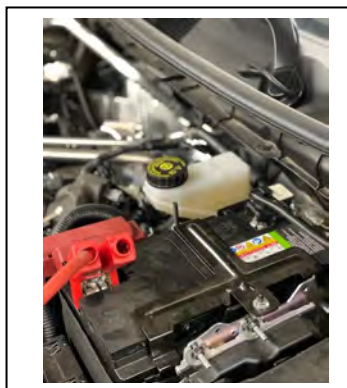
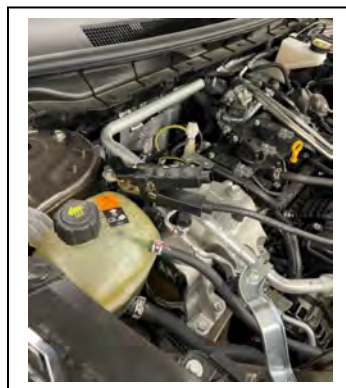
NOTE: Due to limited space it may be easiest to connect battery charger cable onto ground point.

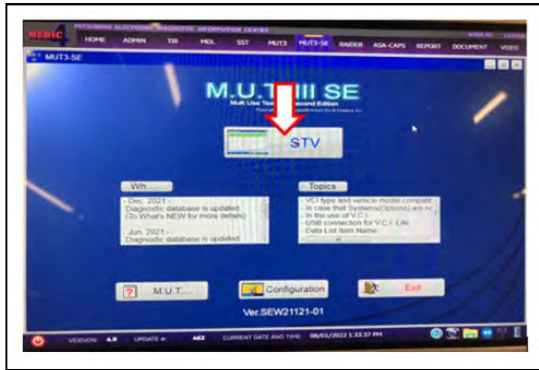
a. Press MUT-III SE STV icon.

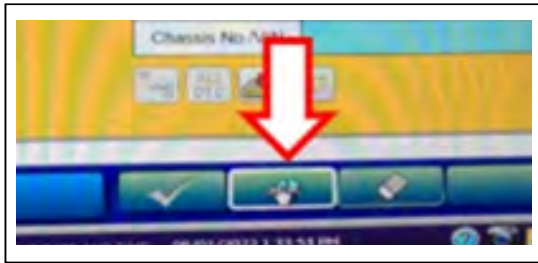
b. Press the model information display button (car icon) and verify all vehicle info is correct.

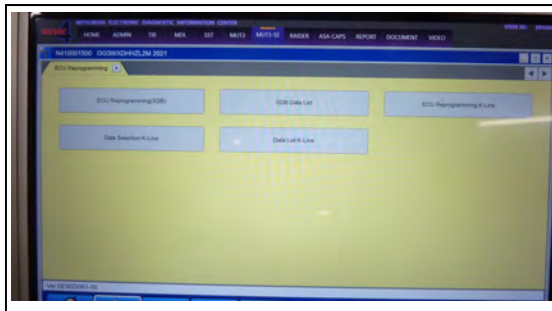
c. Press "ECU Reprogramming (SDB)" button.

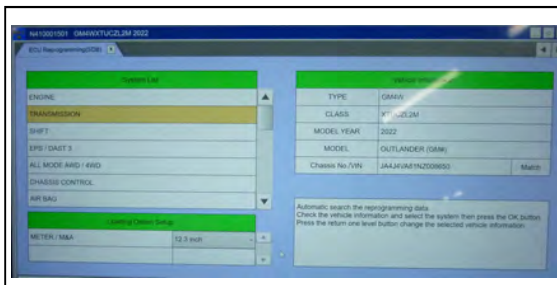
d. Verify the vehicle information and select the system "Transmission" followed by the OK button.

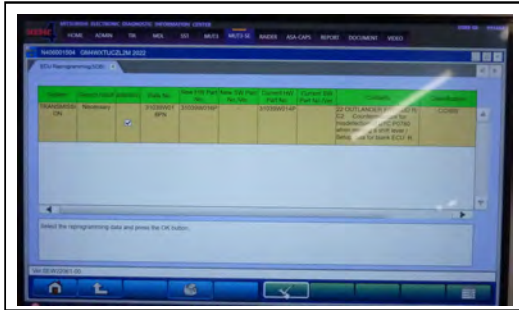
- e. The Automatic ECU Reprogramming (SDB) database screen will display. Press the OK button.

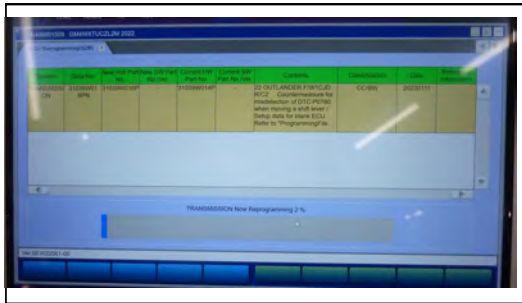
- f. Type AS2 account information (if applicable) and press the OK button to start the reprogramming.

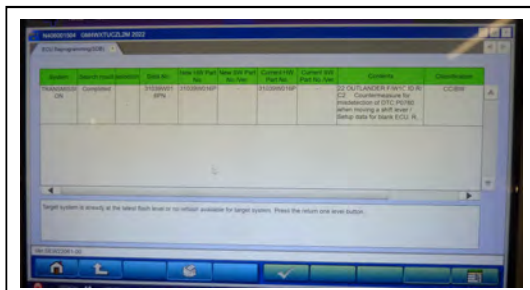
- g. Once the reprogramming is initiated the screen will display the reprogramming progress. Verify that the software version has been updated per the ECU Reprogramming chart.

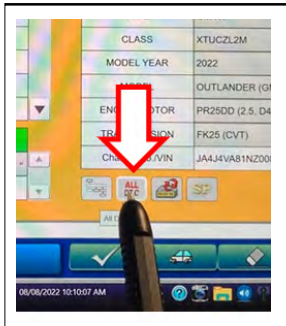
h. Press the " ALL DTC" button to initiate " Erase and Read all DTCs". Press OK when complete.

IMPORTANT: The " Erase and Read all DTCs" must be performed since DTCs may be generated and stored.

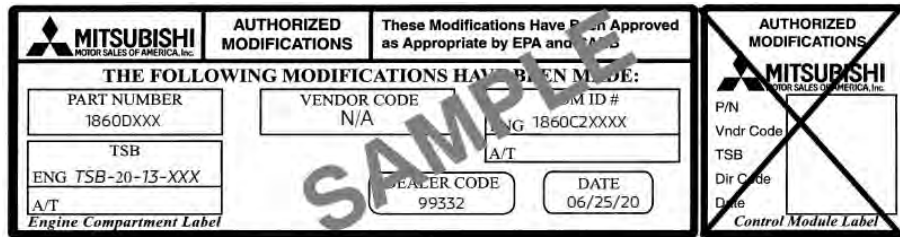
3. Using a ball-point pen, enter the appropriate ECU part number, Software Part Number (ROM ID#), this Technical Service Bulletin number, your dealer code, and the current date on the Engine Compartment/Control Module Label (p/n MSSF024G00). The Vendor Code is not applicable. The label is available from your facing PDC.
