Technical Service Bulletin

SUBJECT: BLIND SPOT WARNING (BSW) SERVICE REQUIRED WARNING ON MULTI INFORMATION DISPLAY (MID)		NO: TSB-23-54-001	
		DATE: March 2023	
		MODEL: See below	
CIRCULATE TO:	<input type="checkbox"/> GENERAL MANAGER	<input checked="" type="checkbox"/> PARTS MANAGER	<input checked="" type="checkbox"/> TECHNICIAN
<input checked="" type="checkbox"/> SERVICE ADVISOR	<input checked="" type="checkbox"/> SERVICE MANAGER	<input checked="" type="checkbox"/> WARRANTY PROCESSOR	<input type="checkbox"/> SALES MANAGER

This bulletin provides instructions to reprogram the Gateway ECU software for the Blind Spot Warning (BSW).

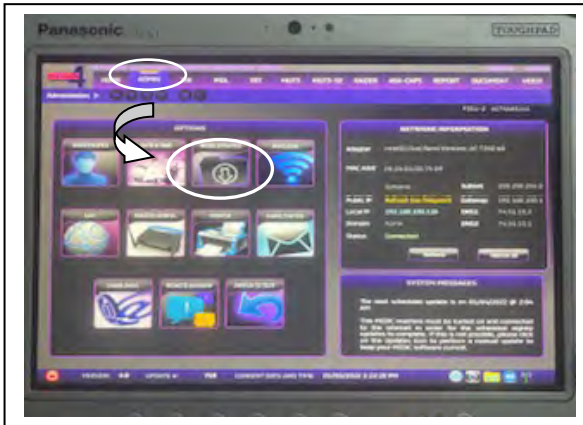
3. Select the MEDIC 3.5/4 Admin tab and click on "Updates".

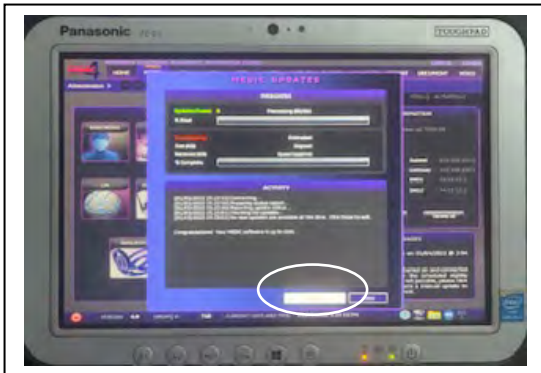
4. If the MEDIC update screen advises updates are available, click the "Begin" button. After all updates are complete, **GO TO THE REPROGRAMMING PROCEDURE**.

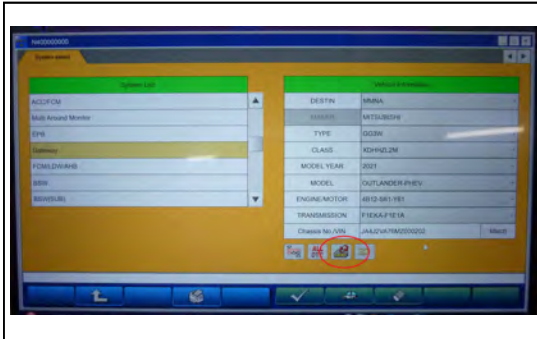
- b. Press the Reprogramming button once the vehicle information is entered.

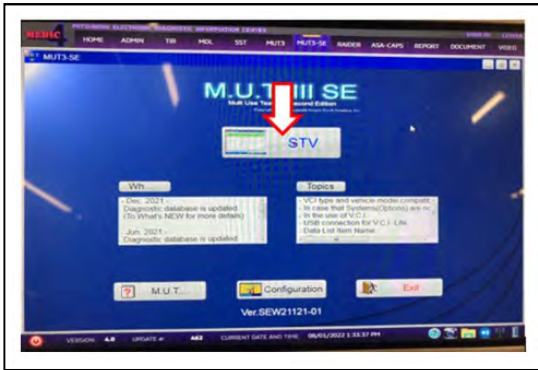
a. Press MUT-III SE STV icon.

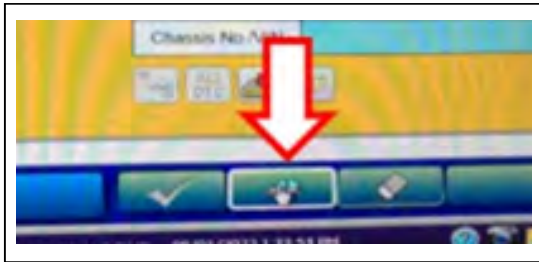
b. Press the model information display button (car icon) and verify all vehicle info is correct.

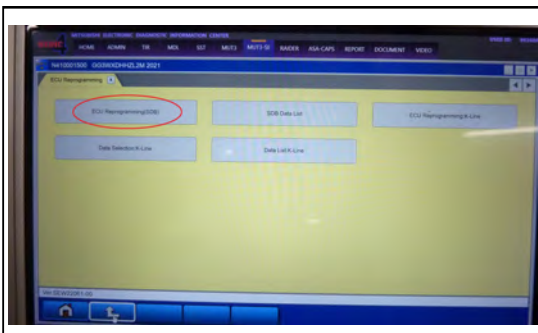
d. Press the "ECU Reprogramming" (SDB) button.

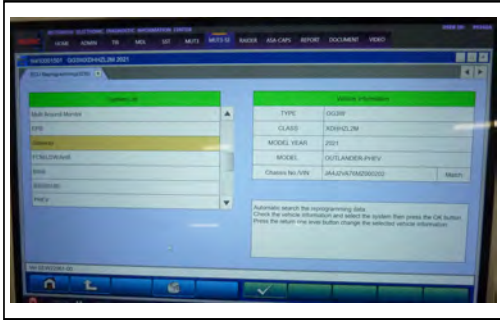
- e. Select "Gateway" from the System List and press the OK button.

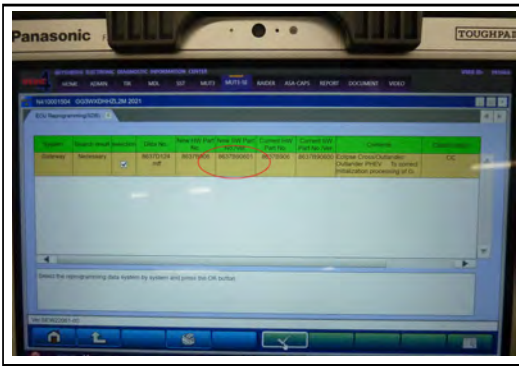
- f. The Automatic ECU Reprogramming (SDB) database screen will display. Press the OK button.
- Verify that the correct new Software (Countermeasure for wireless charger unable to charge) is listed in the table.

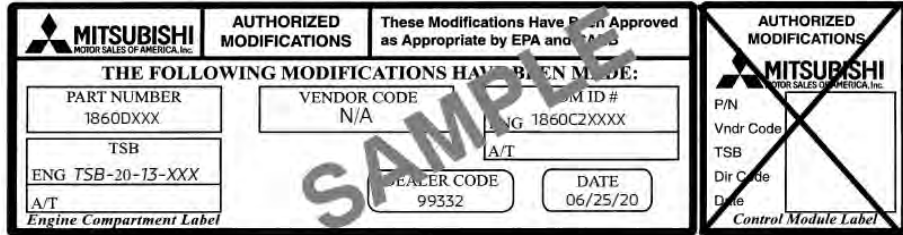
3. Using a ball-point pen, enter the appropriate ECU part number, Software Part Number (ROM ID#), this Technical Service Bulletin number, your dealer code, and the current date on the Engine Compartment/Control Module Label (p/n MSSF024G00). The Vendor Code is not applicable. The label is available from your facing PDC.
