Technical Service Bulletin

SUBJECT:		NO: TSB-23-55-002
COOL AIR EXPELLED WHEN A/C SWITCH IS TURNED OFF WHILE IN ECO DRIVE MODE		DATE: March 2023
		MODEL: 2022-23 Outlander
CIRCULATE TO:	<input type="checkbox"/> GENERAL MANAGER	<input checked="" type="checkbox"/> PARTS MANAGER
<input checked="" type="checkbox"/> SERVICE ADVISOR	<input checked="" type="checkbox"/> SERVICE MANAGER	<input checked="" type="checkbox"/> WARRANTY PROCESSOR
		<input checked="" type="checkbox"/> TECHNICIAN
		<input type="checkbox"/> SALES MANAGER

This bulletin provides instructions to reprogram the HVAC ECU software for the A/C Auto Amplifier.

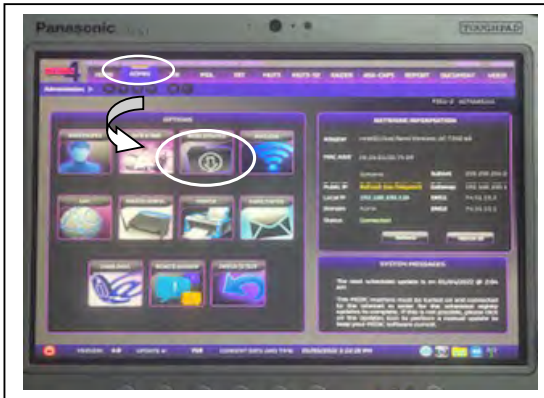
3. Select the MEDIC 3.5/4 Admin tab and click on "Updates".

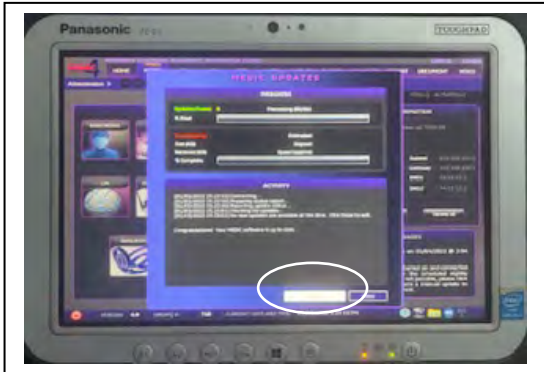
4. If the MEDIC update screen advises updates are available, click the "Begin" button. After all updates are complete, **GO TO THE REPROGRAMMING PROCEDURE**.

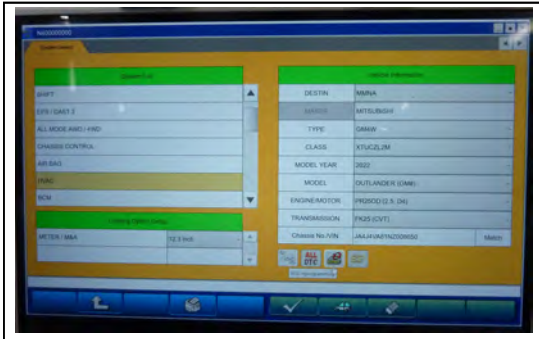
- b. Press the Reprogramming button once the vehicle information is entered.

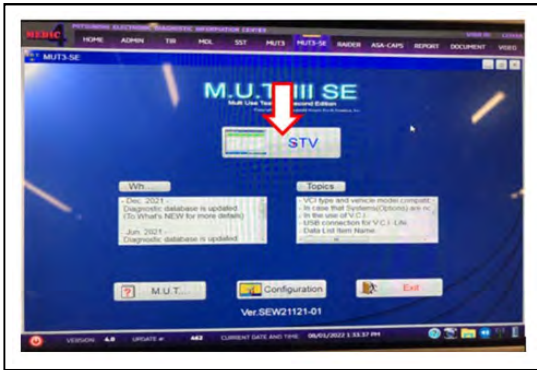
a. Press MUT-III SE STV icon.

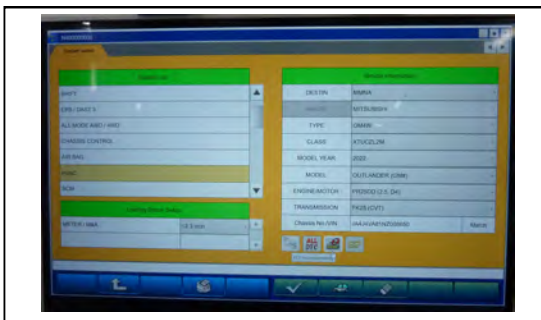
c. Press the Reprogramming button once the vehicle information is entered.

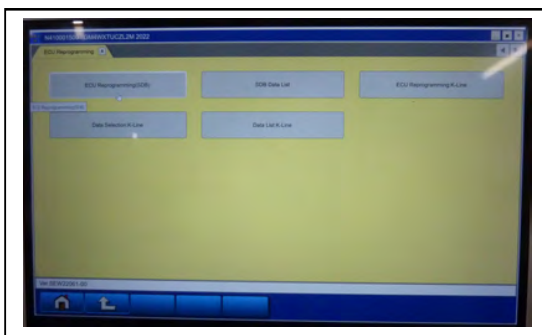
d. Press the "ECU Reprogramming" (SDB) button.
