Technical Service Bulletin

SUBJECT:		No: TSB-23-54-002	
ENGINE START DELAY WHEN USING REMOTE START		DATE: March 2023	
		MODEL: 2022-23 Outlander	
CIRCULATE TO:	<input type="checkbox"/> GENERAL MANAGER	<input checked="" type="checkbox"/> PARTS MANAGER	<input checked="" type="checkbox"/> TECHNICIAN
<input checked="" type="checkbox"/> SERVICE ADVISOR	<input checked="" type="checkbox"/> SERVICE MANAGER	<input checked="" type="checkbox"/> WARRANTY PROCESSOR	<input type="checkbox"/> SALES MANAGER

This bulletin provides instructions to update the BCM configuration for Remote Engine Start.

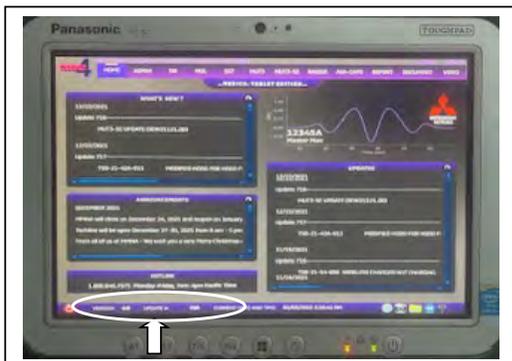
2. Verify the MEDIC 3.5/4 is at version 3.5 and at update **786** or higher.
If your **MEDIC 3.5/4 update is at least 786**, continue with the Procedure. If your **MEDIC 3.5/4 update is below 786**, update your MEDIC as follows:

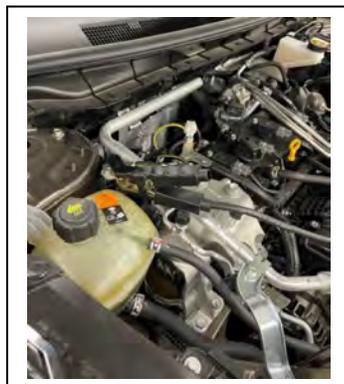
NOTE: Due to limited space it may be easiest to connect battery charger cable onto ground point.

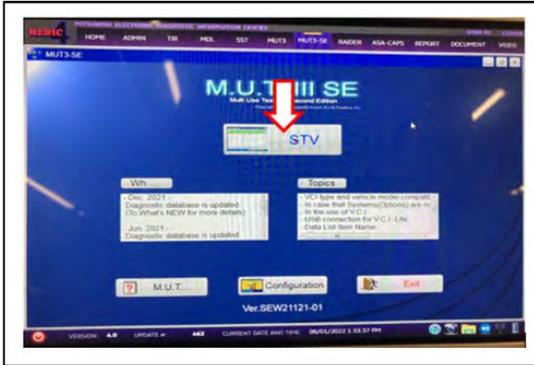
a. Press MUT-III SE STV icon.

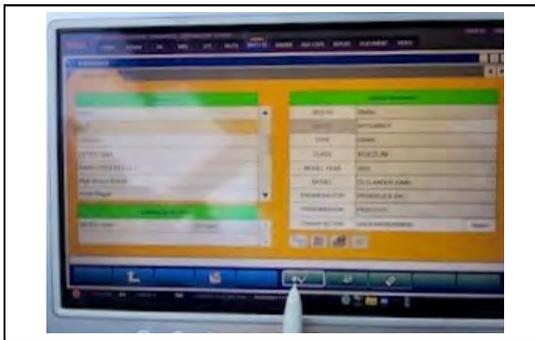
b. Select BCM from System list once vehicle information is verified.

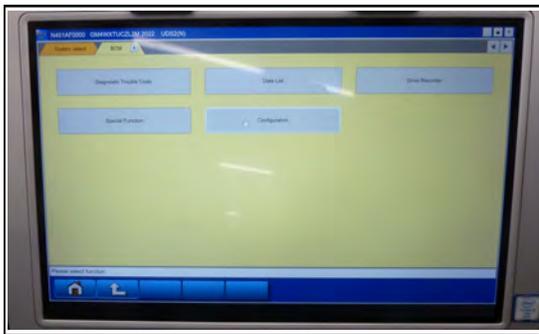
c. Press "Configuration" button.

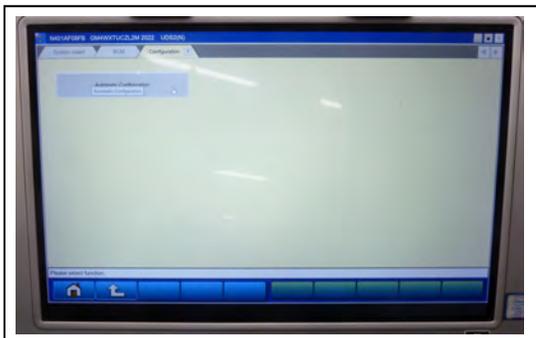
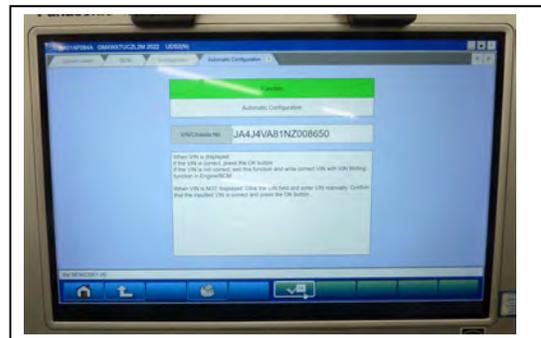
d. Press the "Automatic Configuration" followed by the "OK" button.

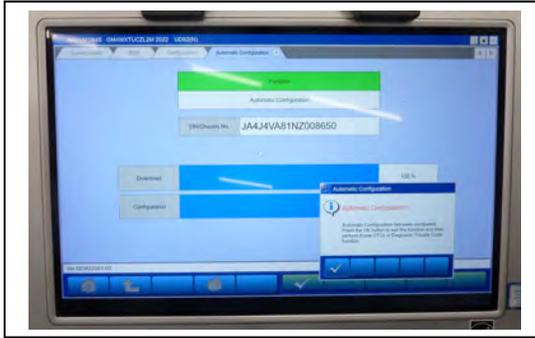
e. The download progress bar will display followed by a automatic configuration notification upon completion.
