INFINITI®

CAMPAIGN BULLETIN IVI Reprogram SXM Presets

Reference: PC964
Date: March 24, 2023

Affected Models/Years:	Affected Population:	Retailer Inventory:	SERVICE COMM Activation date:	Stop Sale In Effect
MY2023 QX60 (L51)	NA	66	March 24, 2023	NO

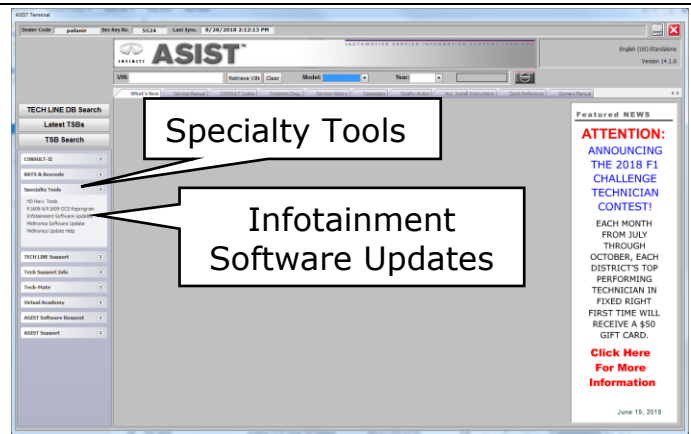
Figure 2

2. Open Infotainment downloader tool (Figure 2).

- Open ASIST
- Select Specialty Tools
- Select Infotainment Software Updates

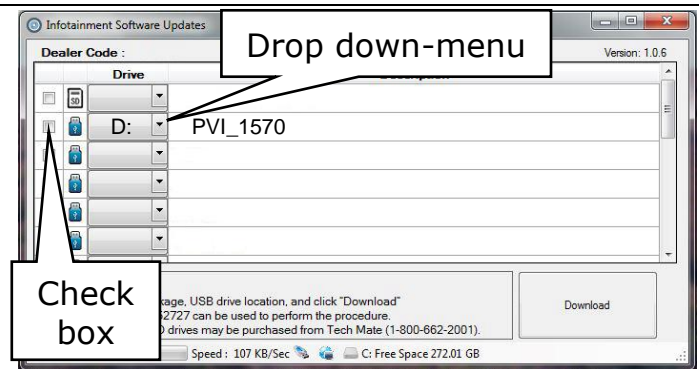
Figure 3

3. Select the check box next to the item titled **PVI_1570** (Figure 3).

- Use the drop-down menu and select the location of the USB drive
- Select Download, and then wait for the download to complete
- The update is estimated to take 4-5 hours to download to the USB drive

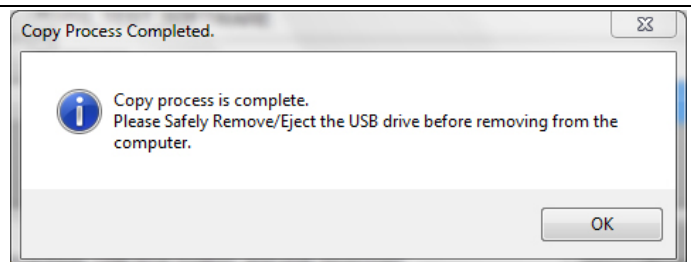
4. When the data download/transfer is completed, the message in Figure 4 will display.

- Select **OK**

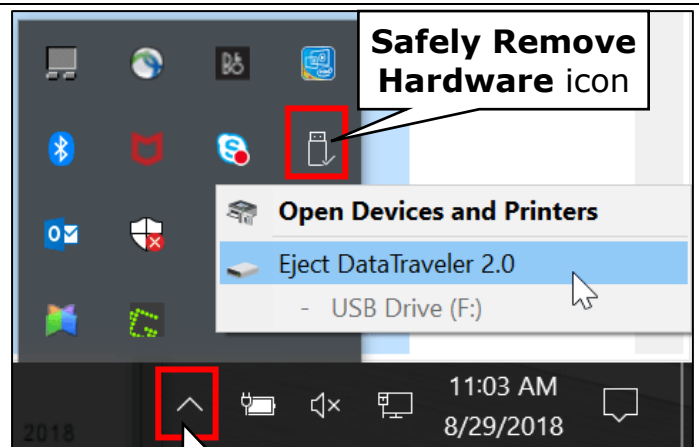
Figure 5

5. Once the transfer is complete, safely remove the USB drive from the ASIST Station (Figure 5).

- From the PC toolbar, select the Safely Remove Hardware icon
- Select the USB drive to be removed
- Wait for message to appear that states, It is safe to remove hardware
- Remove the USB drive from the ASIST station

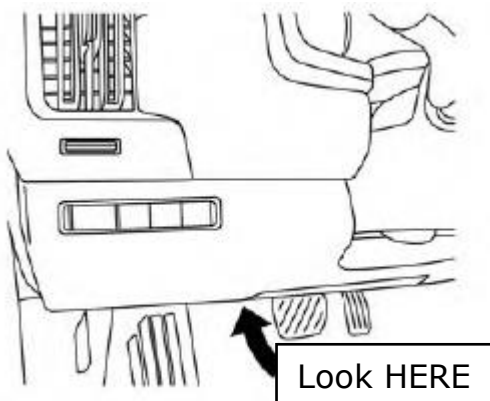
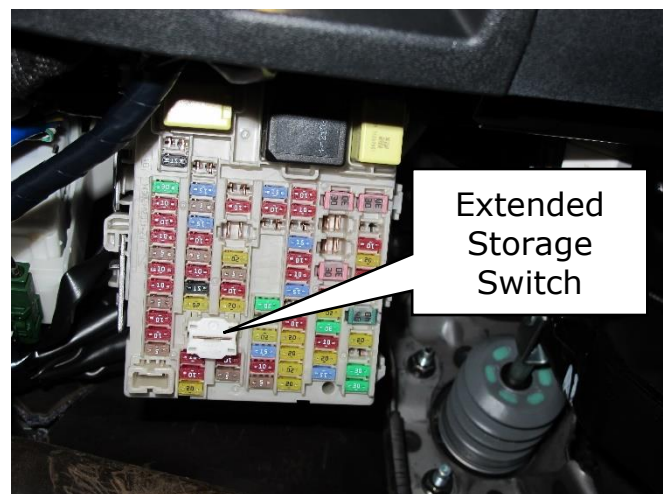
Figure 6

6. If needed, push-in the extended storage switch (Figure 6).

- In fuse panel under Driver's side dash

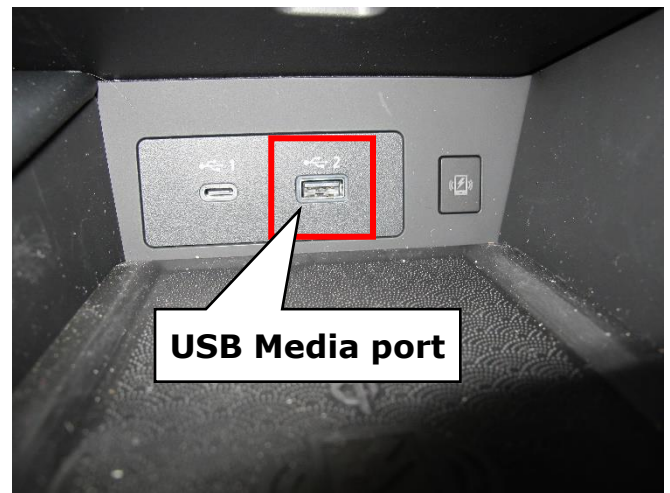
Figure 7

8. Insert the USB drive with infotainment software update into the vehicle's USB media port (Figure 7).

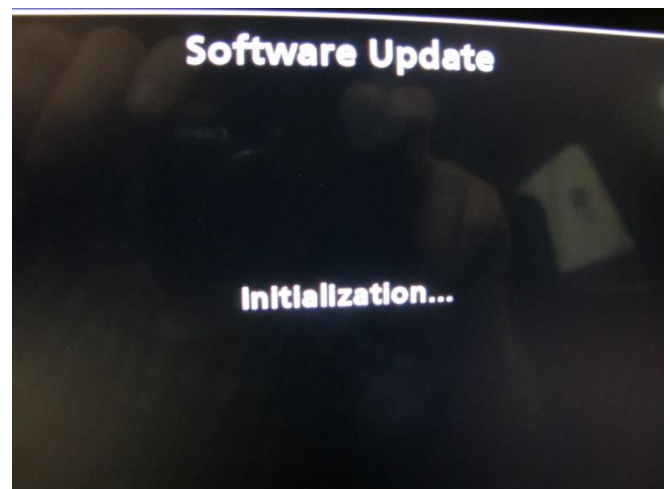
9. Wait approximately 10-30 seconds for the screen in Figure 8 to appear.

- The screen will display "**Software Update Initialization...**"
- The software update will start automatically

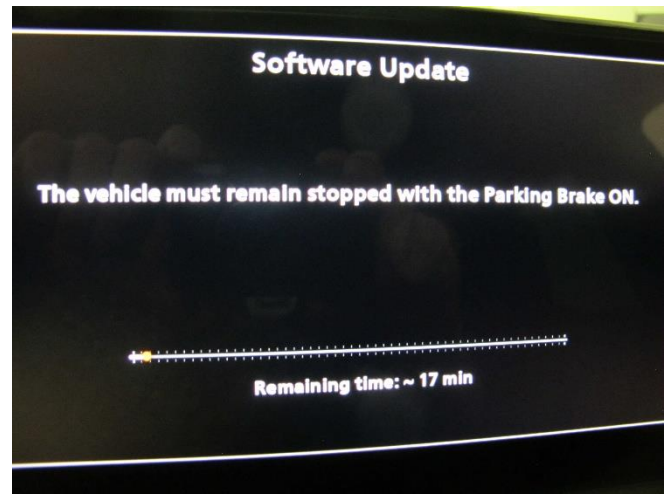
10. The software progress screen in Figure 9 will be displayed during the update.

- Do not remove the USB drive during the update
- The update will take approximately 20 minutes
- The parking brake must remain applied
- Do not drive the vehicle
- Do not turn the engine off during the update

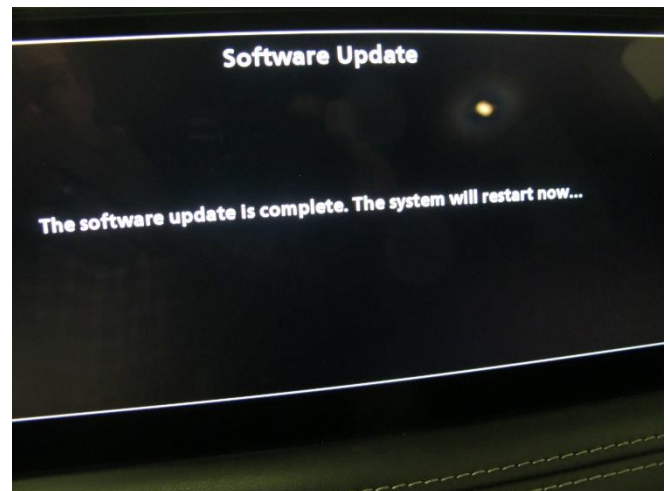
11. Once the software update is complete, the message shown in Figure 10 will display.

- With the engine still running, remove the USB drive from the USB port
- Wait approximately 10-30 seconds for the AV control unit to restart (INFINITI logo will display)
- Verify the home screen appears

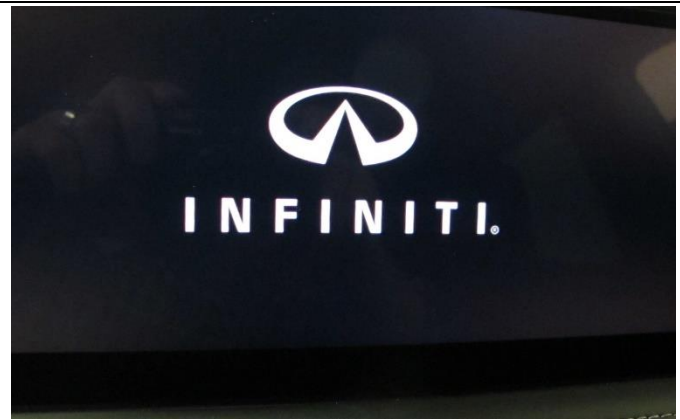
Figure 11

12. Wait approximately 10-30 seconds for the AV control unit to restart (INFINITI logo will display) (Figure 11).

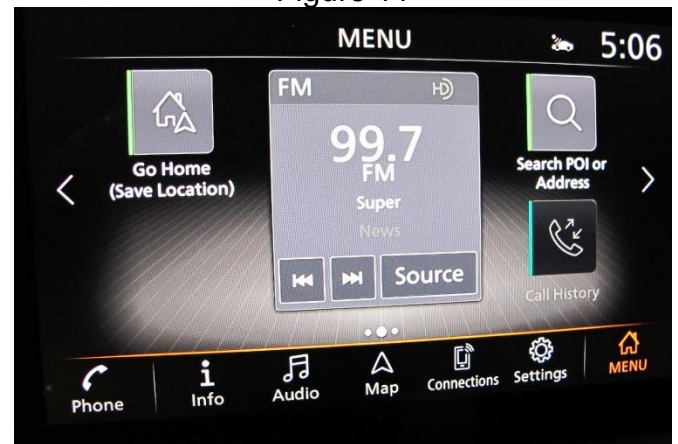
Figure 12

- Verify the home screen appears (Figure 12)
- Turn the ignition off

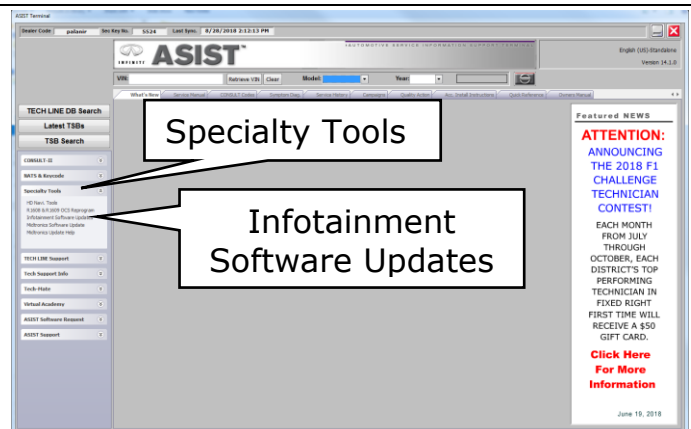
Figure 13

14. Open Infotainment downloader tool (Figure 13).

- Open ASIST
- Select Specialty Tools
- Select Infotainment Software Updates

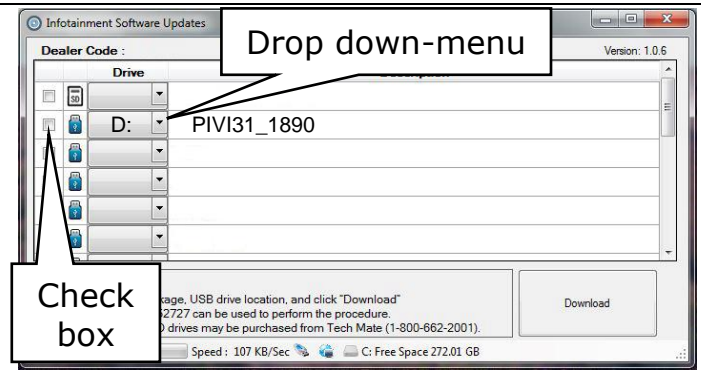
Figure 14

15. Select the check box next to the item titled **PIV131_1890** (Figure 14).

- Use the drop-down menu and select the location of the USB drive
- Select Download, and then wait for the download to complete
- The update is estimated to take 4-5 hours to download to the USB drive

- If software version is correct, procedure is complete, proceed to claims information
- If the software version is **NOT 283C31890B**, start this procedure over and verify the correct software shown in Step 3 and Step 15 is downloaded

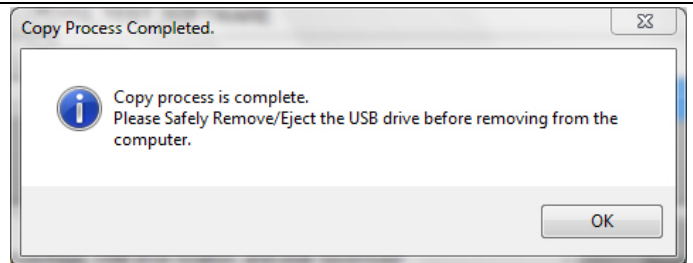
16. When the data download/transfer is completed, the message in Figure 15 will display.

- Select **OK**

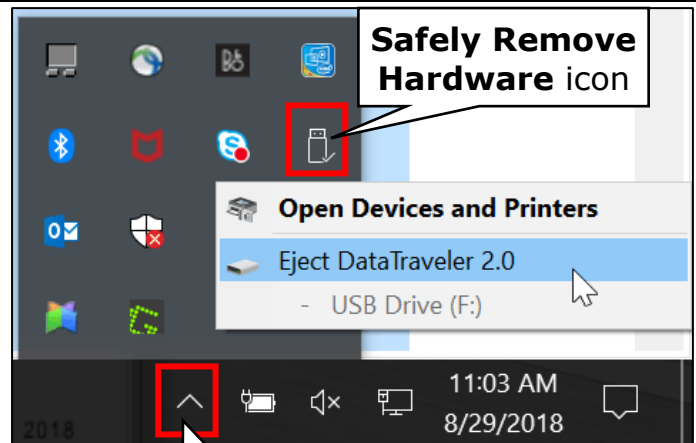
Figure 16

17. Once the transfer is complete, safely remove the USB drive from the ASIST Station (Figure 16).

- From the PC toolbar, select the Safely Remove Hardware icon
- Select the USB drive to be removed
- Wait for message to appear that states, It is safe to remove hardware
- Remove the USB drive from the ASIST station

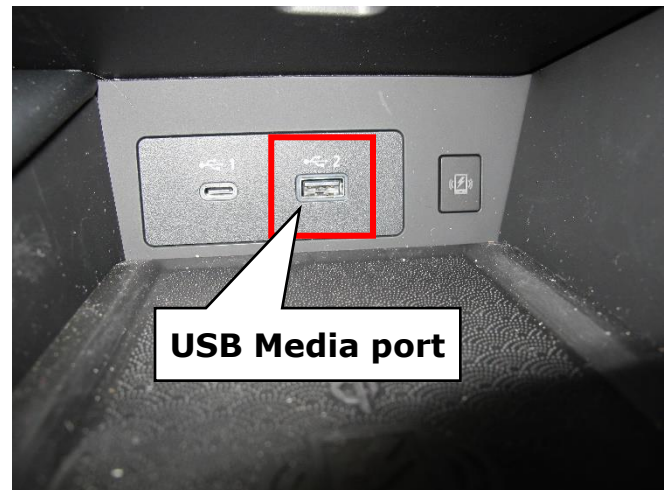
Figure 17

19. Insert the USB drive with infotainment software update into the vehicle's USB media port (Figure 17).

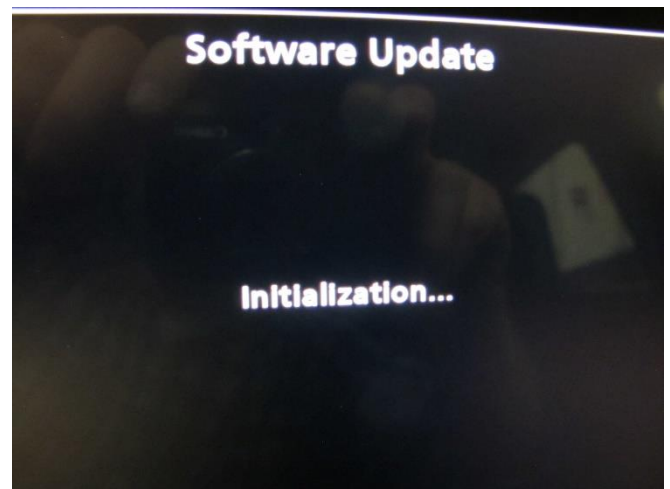
20. Wait approximately 10-30 seconds for the screen in Figure 18 to appear.

- The screen will display "**Software Update Initialization...**"
- The software update will start automatically

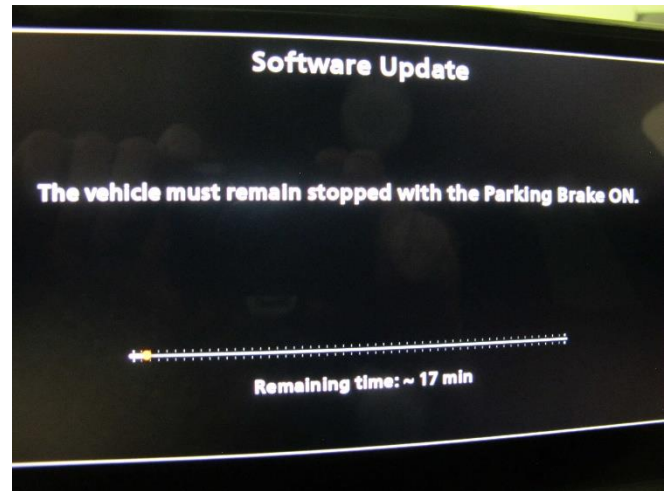
Figure 19

21. The software progress screen (Figure 19) will be displayed during the update.

- Do not remove the USB drive during the update
- The update will take approximately 20 minutes
- The parking brake must remain applied
- Do not drive the vehicle
- Do not turn the engine off during the update

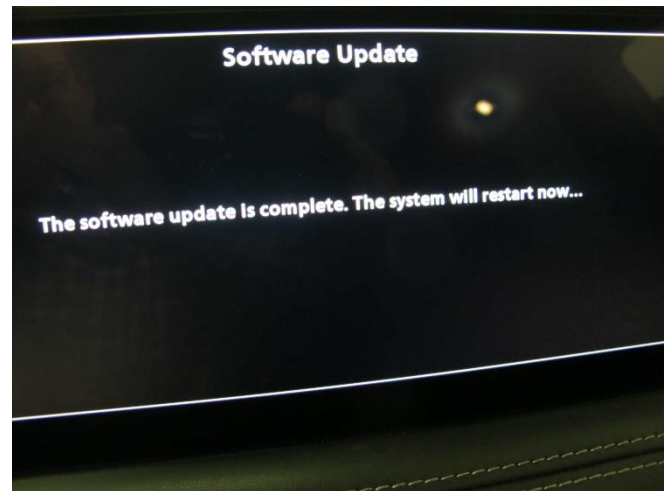
22. Once the software update is complete, the message shown in Figure 20 will display.

- With the engine still running, remove the USB drive from the USB port
- Wait approximately 10-30 seconds for the AV control unit to restart (INFINITI logo will display)
- Verify the home screen appears

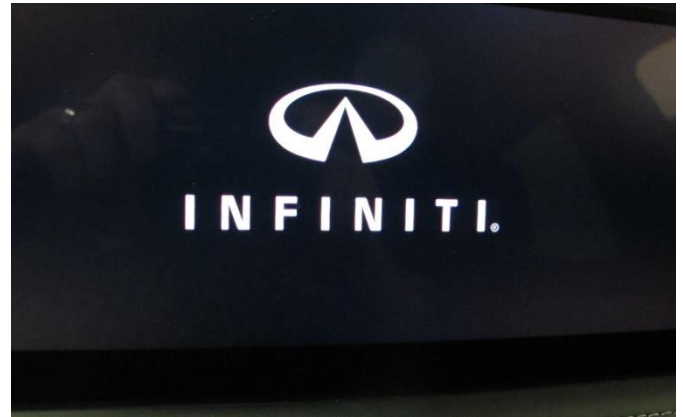
Figure 21

23. Wait approximately 10-30 seconds for the AV control unit to restart (INFINITI logo will display) (Figure 21).

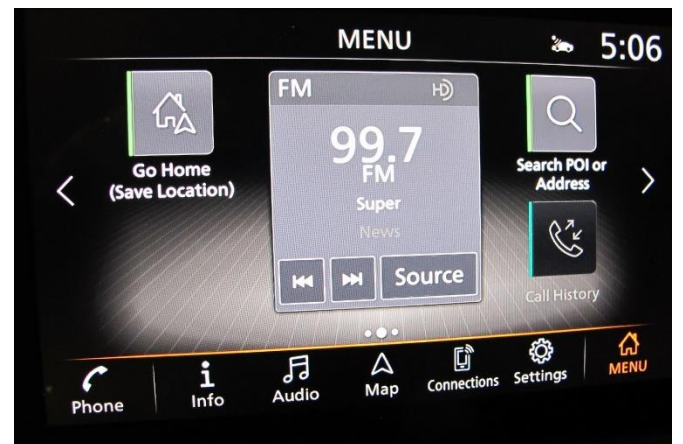
Figure 22

- Verify the home screen appears (Figure 22)
- Turn the ignition off
- Open and close the driver's door
- Restart the engine

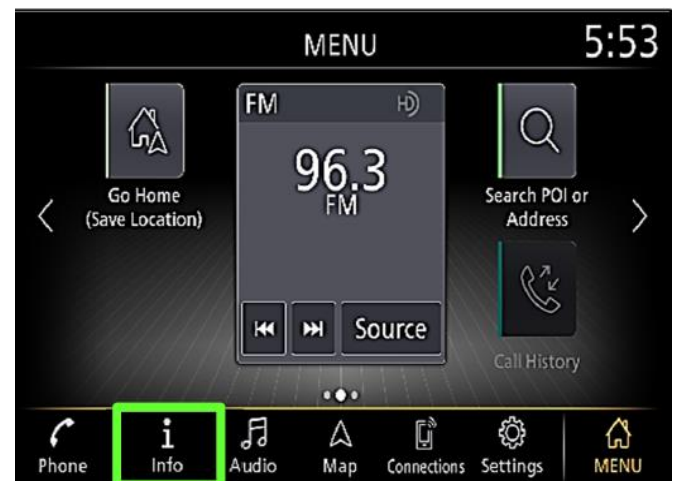
Figure 23

24. From the Home screen, select **Info** from the bottom of the screen (Figure 23).

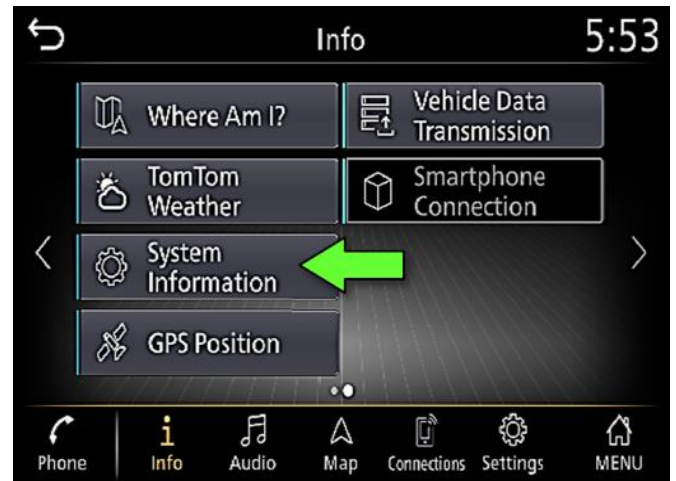
Figure 24

25. Select **System Information** (Figure 24).

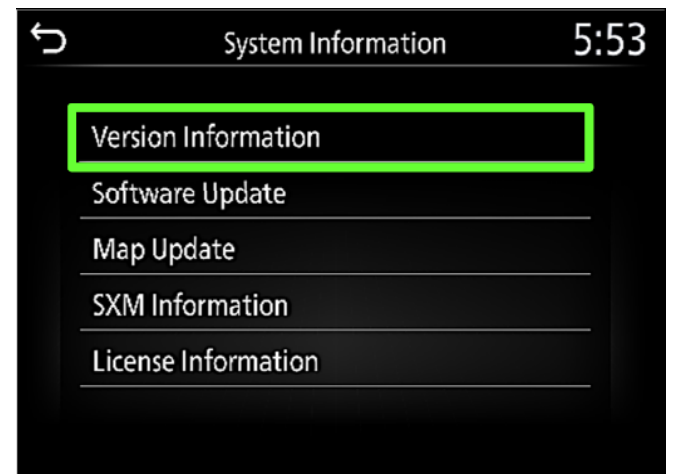
Figure 25

26. Select **Version Information** (Figure 25).

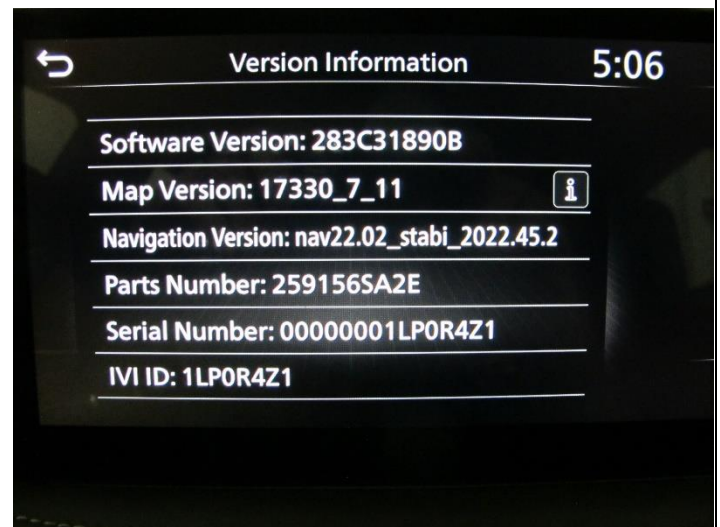
Figure 26

27. Confirm Software Version is **283C31890B** (Figure 26).
