Service Bulletin

Bulletin No.: 23-NA-049

Subject: Volume Selection Does Not Clear from DIC After Adjusting Volume

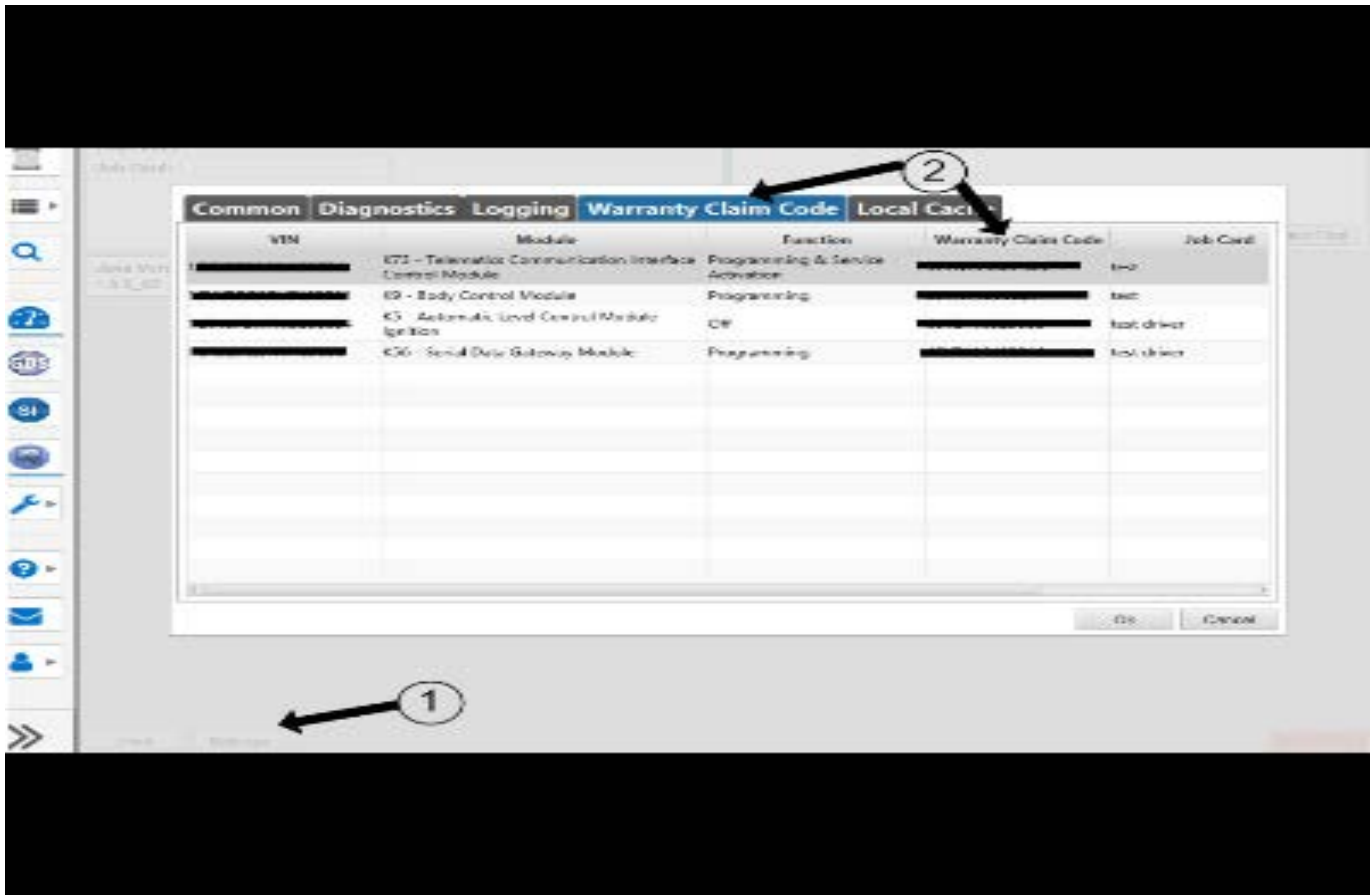
6125774

If the Warranty Claim Code was not recorded on the Job Card, the code can be retrieved in the SPS2 system as follows:

The VIN, Warranty Claim Code and Date/Time will be listed on a roster of recent programming events. If the code is retrievable, dealers should resubmit the transaction making sure to include the code in the SPS Warranty Claim Code field.
