Subject: N232397810 - Service Update
OnStar and Bluetooth Phone Calls Loss of Audio

Models: 2023 Cadillac LYRIQ

Service Update

N232397810 OnStar and Bluetooth Phone Calls Loss of Audio

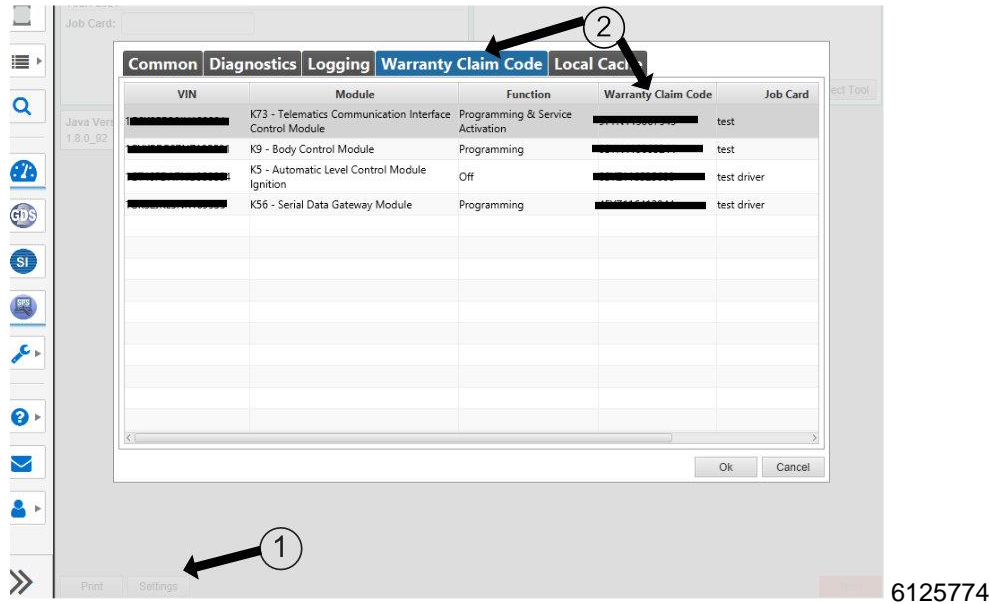
Warranty Claim Code Information Retrieval

1. Open TLC on the computer used to program the vehicle.
2. Select and start SPS2.
3. Select Settings (1).
4. Select the Warranty Claim Code tab (2).

The VIN, Warranty Claim Code and Date/Time will be listed on a roster of recent programming events. If the code is retrievable, dealers should resubmit the transaction making sure to include the code in the SPS Warranty Claim Code field.

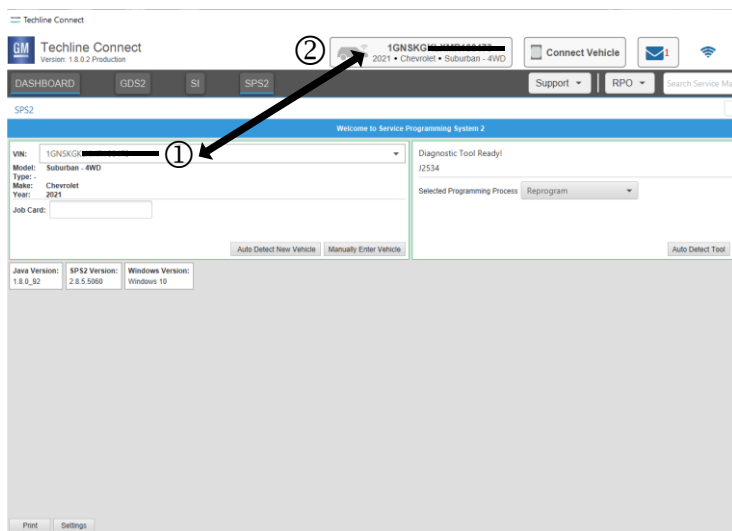
5743643

Caution: Be sure the VIN selected in the drop down menu (1) is the same as the vehicle connected (2) before beginning programming.

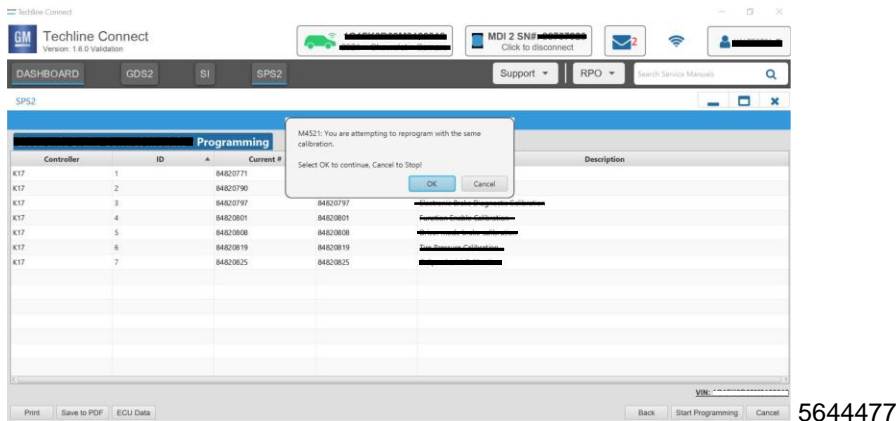
Important: Techline Connect screens shown above.

Important: If the same calibration/software warning is noted on the TLC Summary screen, select OK and follow screen instructions. After a successful programming event, the WCC is located in the Service Programming System dialogue box of the SPS Summary screen. No further action is required. Refer to the Warranty section of the bulletin.

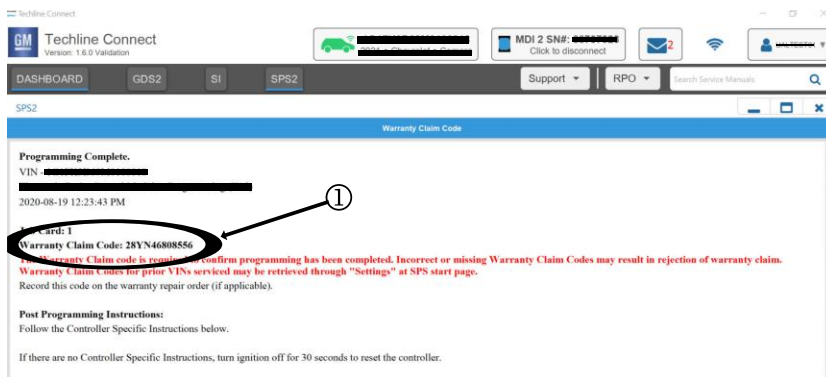
5644478

1. Reprogram the radio. Refer *A11 Radio: Programming and Setup* in SI.
2. Start SPS, select Radio – USB File Transfer and follow the on-screen instructions.
3. Insert the USB drive into the vehicle while in Park.
4. Follow on screen prompts to complete the USB software update.

Note: The screenshot above is an example of module programming and may not be indicative of the specific module that is being programmed. Module selection and VIN information have been blacked out.
