Technical Service Bulletin

SUBJECT: A/C INOPERATIVE WITH DTC B20C8-14 - REVISED		No: TSB-22-55-001REV	
		DATE: February 2022	
		MODEL: 2022 Outlander	
CIRCULATE TO:	<input type="checkbox"/> GENERAL MANAGER	<input checked="" type="checkbox"/> PARTS MANAGER	<input checked="" type="checkbox"/> TECHNICIAN
<input checked="" type="checkbox"/> SERVICE ADVISOR	<input checked="" type="checkbox"/> SERVICE MANAGER	<input checked="" type="checkbox"/> WARRANTY PROCESSOR	<input checked="" type="checkbox"/> SALES MANAGER

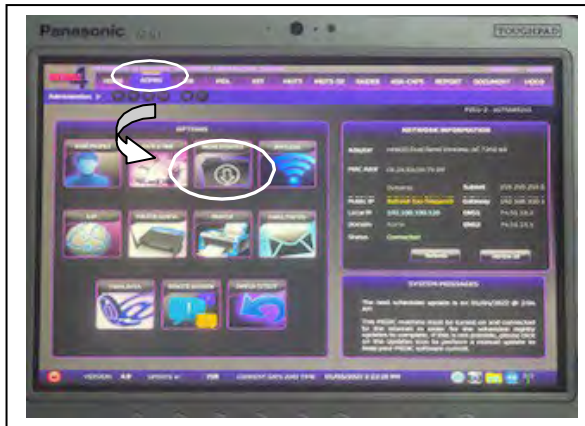
3. Select the MEDIC 3.5/4 Admin tab and click on "Updates".

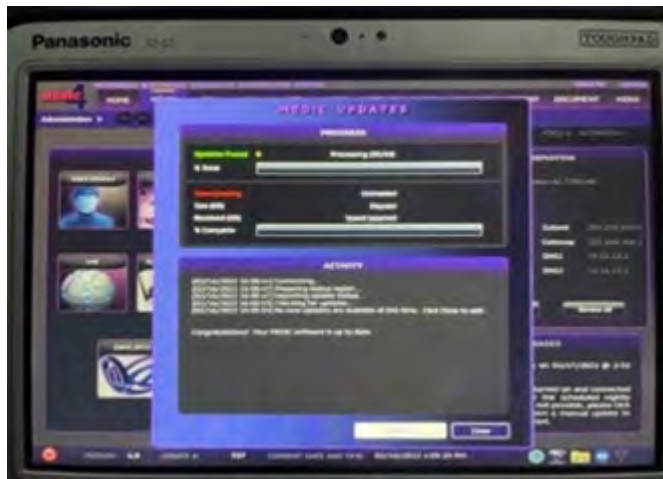
4. If the MEDIC update screen advises updates are available, click the "Begin" button. After all updates are complete, **GO TO THE REPROGRAMMING PROCEDURE.**

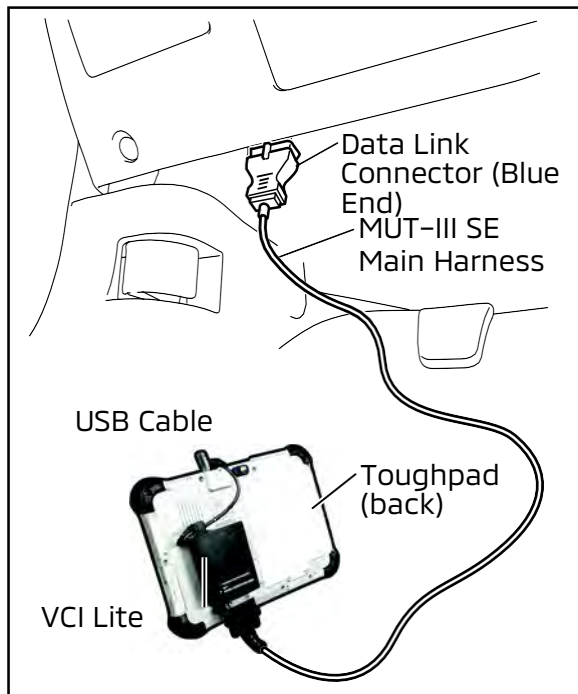
1. Connect the equipment as follows:

NOTE: VCI Lite and MEDIC 4.0 Toughpad shown for illustration purposes only.

- Turn the MEDIC PC/tablet on. If the battery indicator in the lower right hand corner of the screen does not show a full charge, it is recommended that either the battery be charged prior to beginning or be used with the A/C power adaptor connected.
- Connect the USB cable to the VCI/VCI Lite. When the laptop/tablet displays the MUT-III SE main screen, connect the USB cable to the device.
- Connect the MUT-III SE main harness with the blue DLC connection to the VCI/VCI Lite. Connect the blue connection of the MUT-III SE main harness to the vehicle's data link connector.
- For VCI only (p/n MB991824): Turn the VCI power switch ON. Verify that the indicator lamp in the upper right corner of the screen is green.

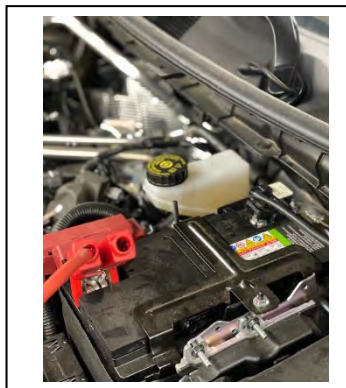
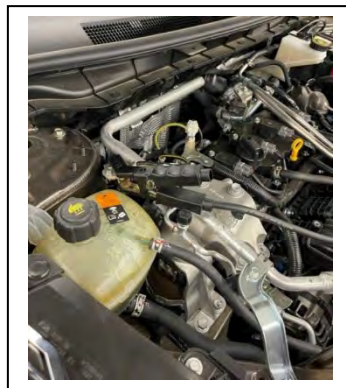
NOTE: Due to limited space it may be easiest to connect cable onto negative ground post and ground strap as shown below.

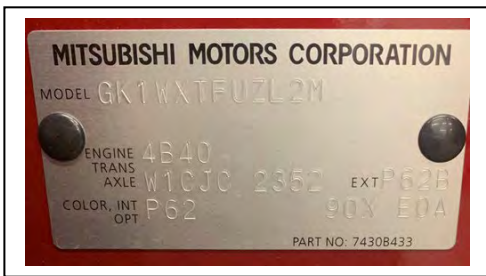
4. The System Select screen opens and populates with some basic information from the vehicle. Look at the label on the passenger side B pillar to identify the appropriate class. (See B pillar label below; class is labeled as "model"). If necessary, select the correct class from the drop-down list.

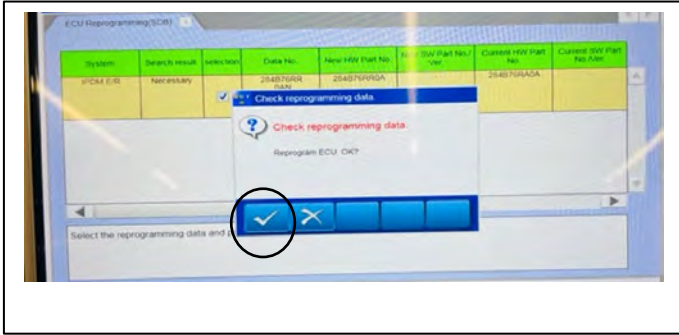
b. Select "IPDM E/R" from Systems List and click the OK button.

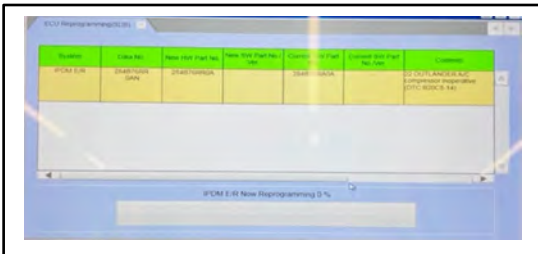
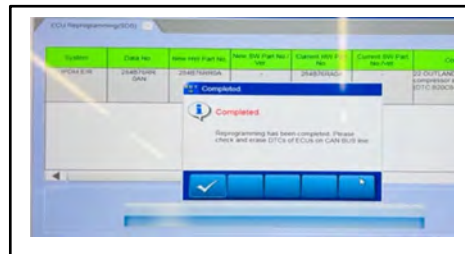
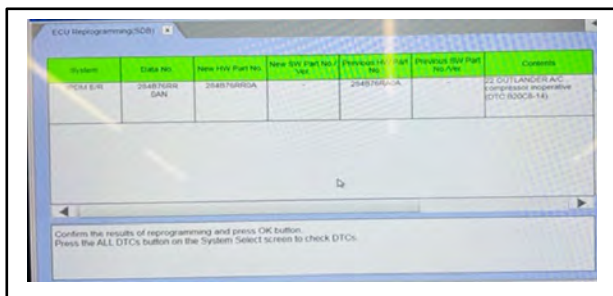
e. Reprogramming will begin and a progress bar will appear followed by a notification upon successful completion.

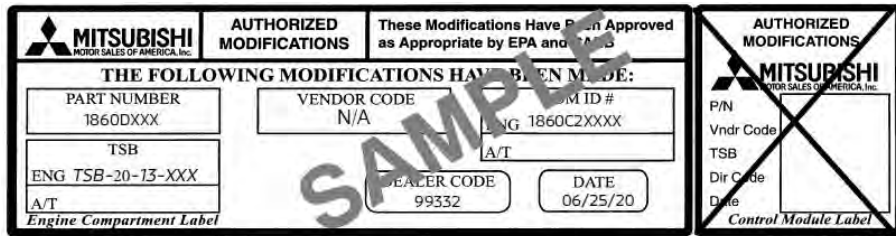
7. Using a ball-point pen, enter the appropriate ECU part number, Software Part Number (ROM ID#), this Technical Service Bulletin number, your dealer code, and the current date on the Engine Compartment/Control Module Label (p/n MSSF024G00). The Vendor Code is not applicable. The label is available from your facing PDC.
