March 2023
SF662 A
Revised Notice

Subject: TomTom Android Black Box Update

Models Affected: Specific Model Year 2020-2022 Freightliner Cascadia Vehicles, manufactured January 16, 2019, through November 2, 2021.

Revision: The fuse referenced in Step 16 has been corrected from F24 to F35.

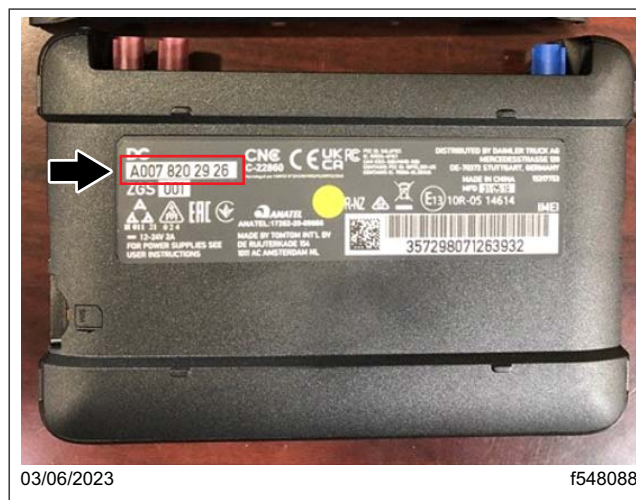
7. Remove the TomTom from the bracket, and check the part number on the label on the bottom side. See [Fig. 9](#).

Is the part number **A 008 820 15 26**?

Fig. 9, TomTom Part Number Identification

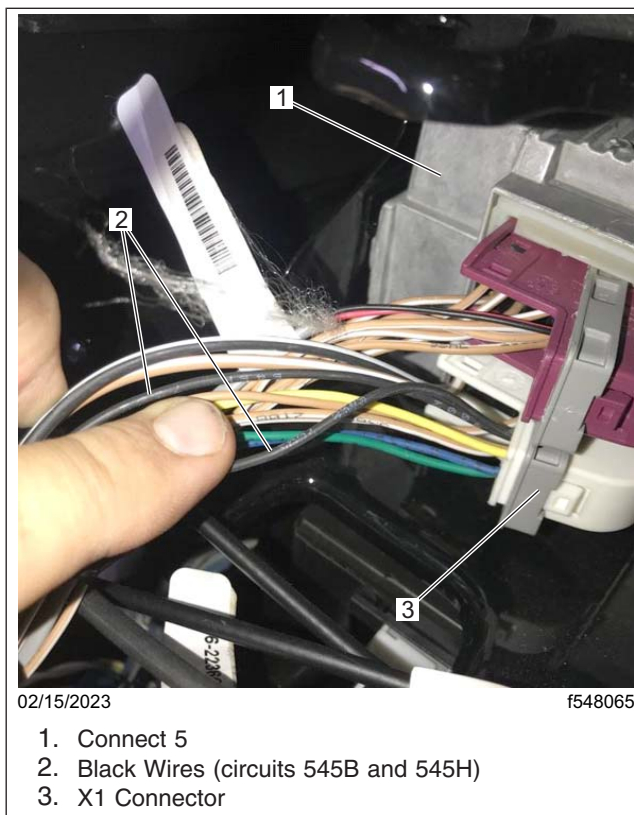
- 13.5 Secure the green 433 circuit to the harness bundle leading to the VPDM with zip ties as needed.
- 13.6 In the harness leading to the Connect 5 X1 connector (white latching connector), locate the circuits 545B and 545H as both have black wires. See [Fig. 20](#).

**Fig. 20, Locating Existing Circuits 545B and 545H
Connecting to Connect 5**

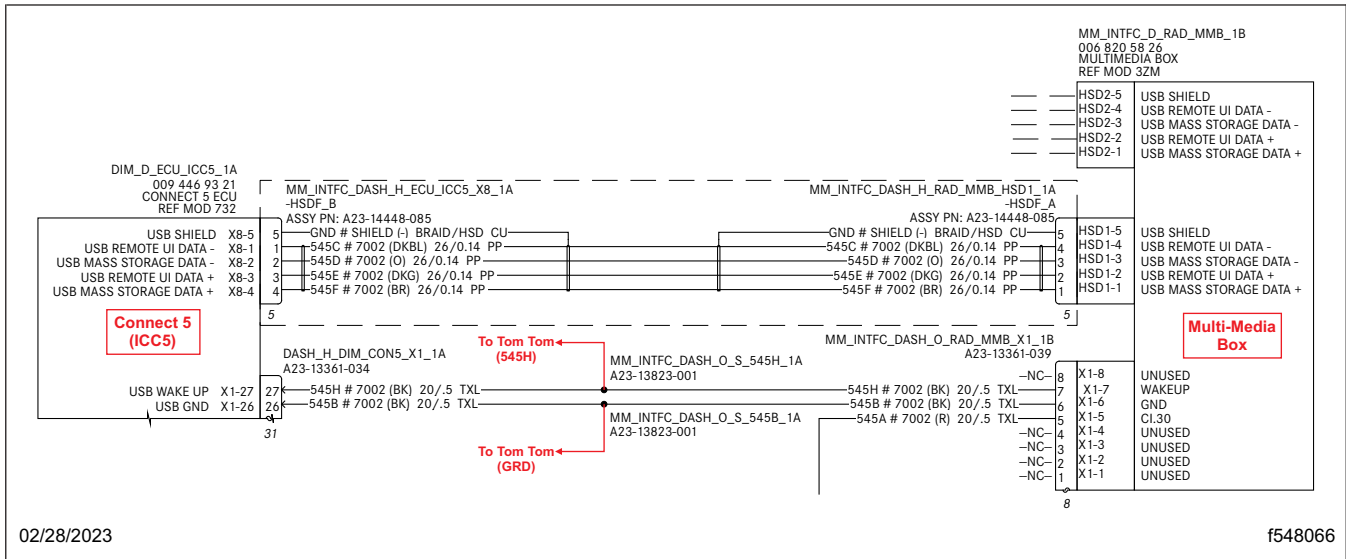
13.7 About 6 inches from the Connect 5 X1 connector, splice the black GRD circuit of the harness being installed to the black 545B circuit leading to the Connect 5 X1 connector. See **Fig. 21**. For splicing procedures, see **Section 54.00.100** of the *New Cascadia Workshop Manual*. See **Fig. 22**.

Fig. 21, Splicing Harness

- 13.8 About 8 inches from the Connect 5 X1 connector, splice the black 545H circuit of the harness being installed to the black 545H circuit leading to the Connect 5 X1 connector. See [Fig. 21](#) and [Fig. 22](#).
- 13.9 Secure the spliced wires to the harness bundle as shown in [Fig. 22](#). Plug the X1 connector back into the Connect 5 ECU.

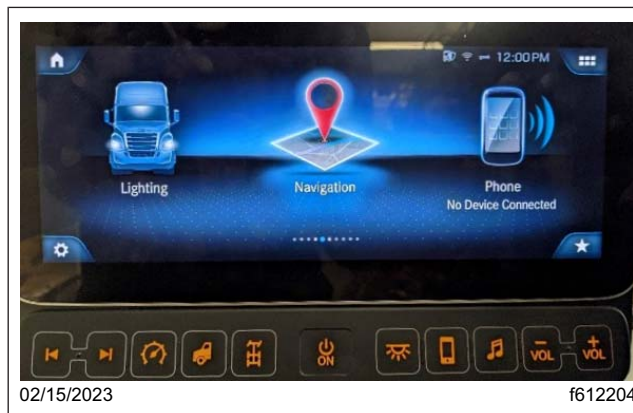
- 22.1 Start the engine. If the TomTom has been successfully installed and activated, the navigation icon shown in [Fig. 28](#) is visible on the head unit display. If the navigation does not work right away, it may be necessary to cycle the key off, allow all modules to power down, and then key back on.

Fig. 28, Navigation Icon

- 22.2 Select the navigation icon shown in **Fig. 28** to start the route navigation. A caution is displayed as shown in **Fig. 29**; select 'OK.'

- 22.3 If the screens shown in **Fig. 28**, **Fig. 29**, and **Fig. 30** are displayed, then the TomTom installation is successful.
23. Clean a spot on the base label (Form WAR259) and attach a campaign completion sticker for SF662 (Form WAR261), indicating this work has been completed.

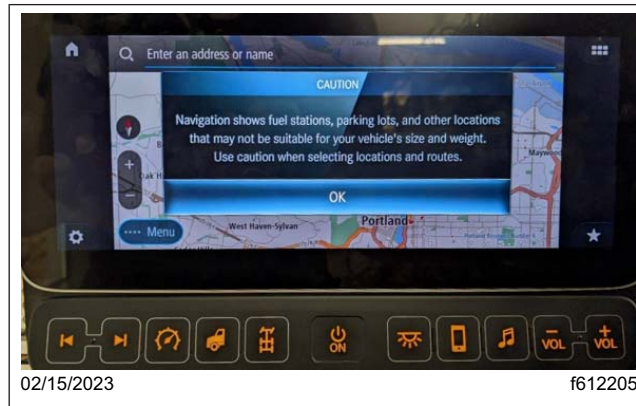
Fig. 29, Navigation Caution
