# Service Bulletin

Bulletin No.: 23-NA-071

**Subject: Engine Control Module Service Update for MIL Illuminated on DIC with DTC's Set**

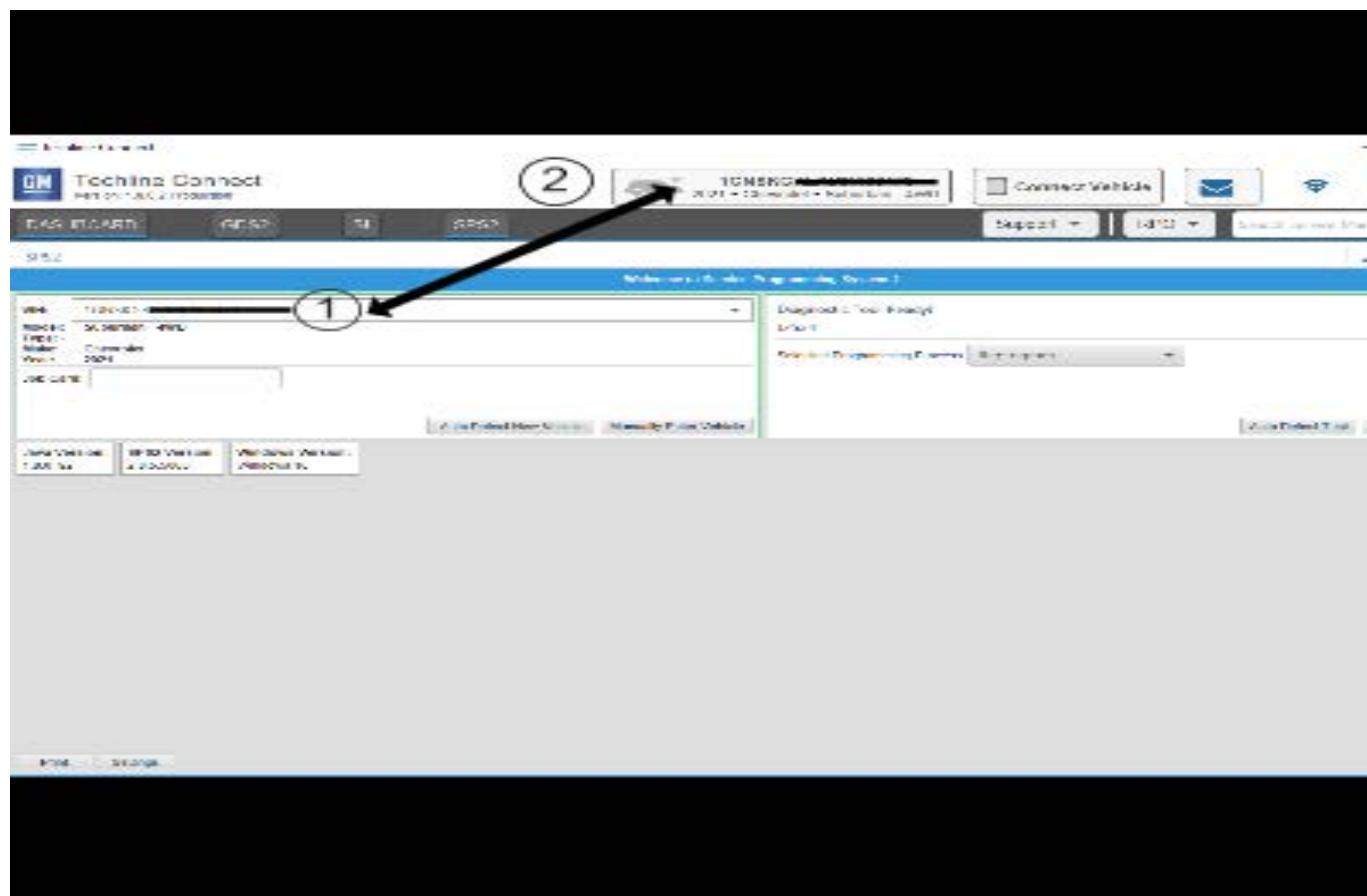
**Caution:** Be sure the VIN selected in the drop down menu (1) is the same as the vehicle connected (2) before beginning programming.

**Important:** Techline Connect screens shown above.

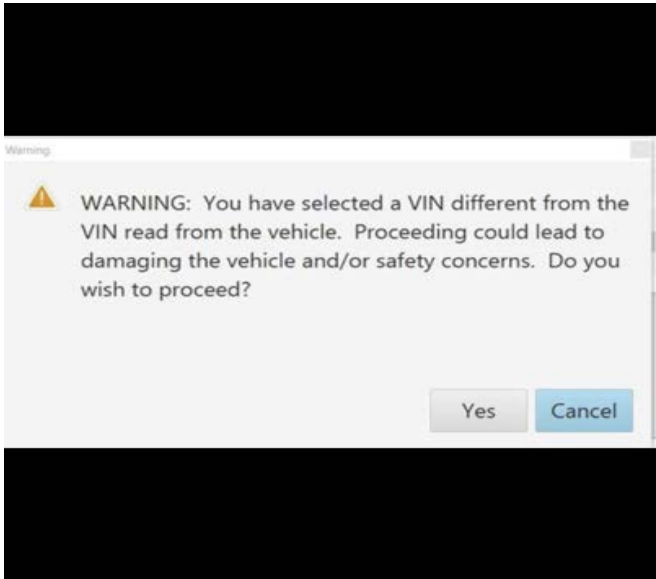
5877000

**Important:** If the vehicle VIN DOES NOT match, the message below will be shown

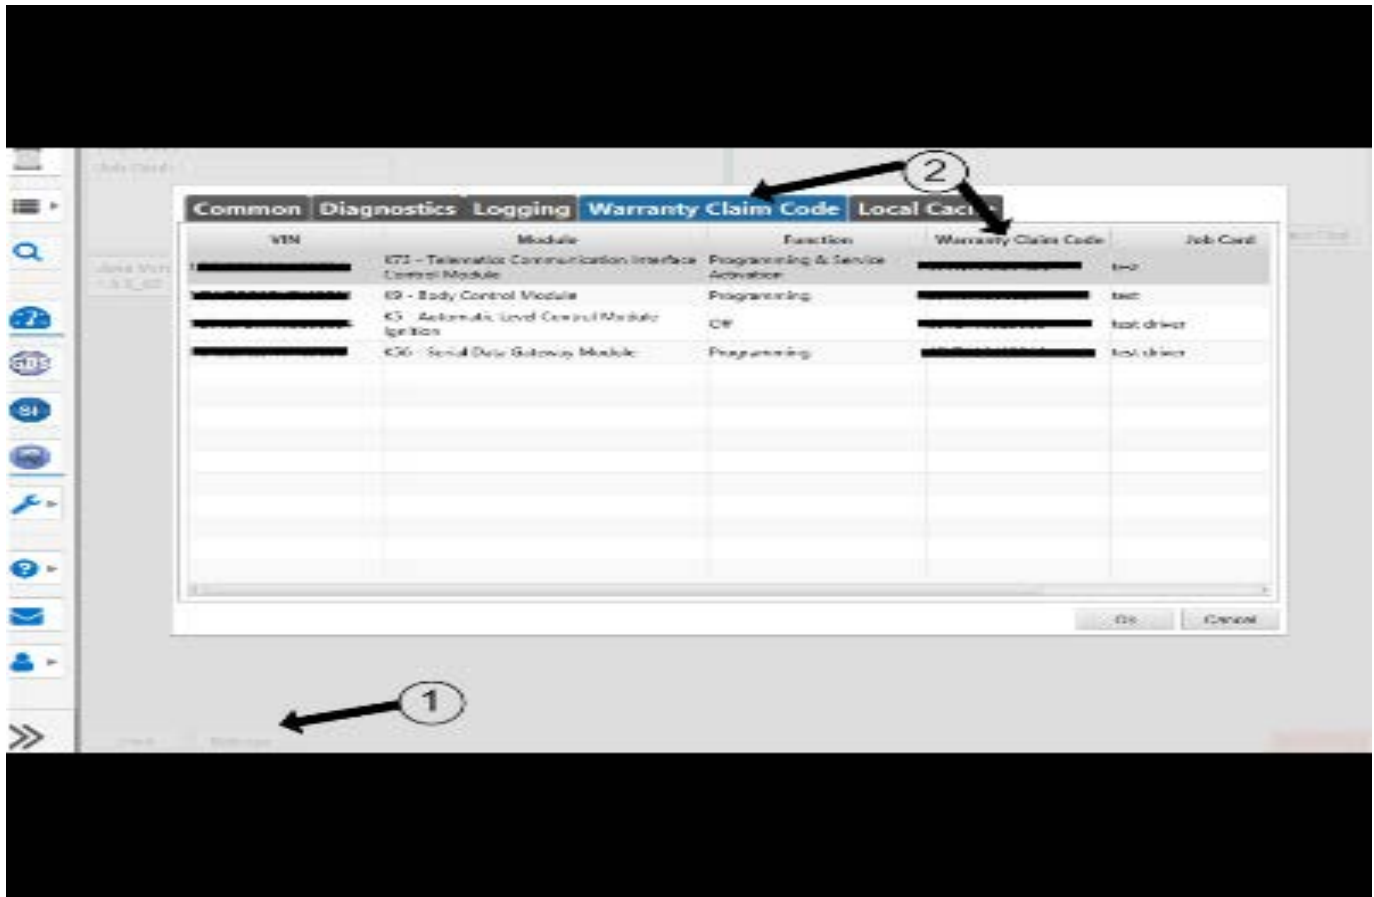
6125774

Warranty Claim Code Information Retrieval

If the Warranty Claim Code was not recorded on the Job Card, the code can be retrieved in the SPS2 system as follows:

The VIN, Warranty Claim Code and Date/Time will be listed on a roster of recent programming events. If the code is retrievable, dealers should resubmit the transaction making sure to include the code in the SPS Warranty Claim Code field.
