INFINITI

TECHNICAL SERVICE BULLETIN

Classification: AN23-006A	Reference: ITB23-010A	Date: April 4, 2023
------------------------------	--------------------------	------------------------

SOFTWARE UPDATE FOR INFOTAINMENT ISSUES

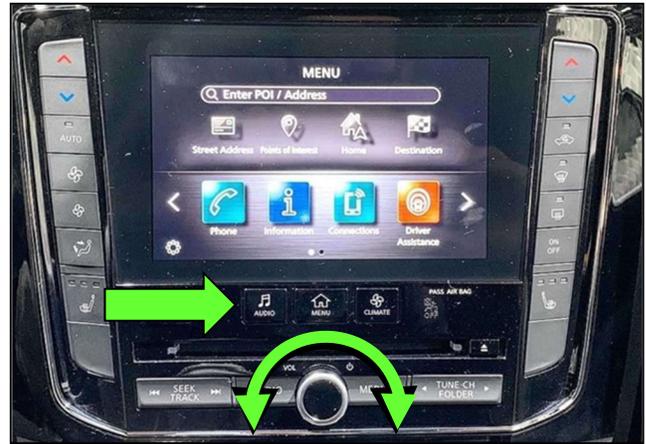
Figure 2

1. Press and hold the **AUDIO** button while, at the same time, rotating the volume knob left-right-left.

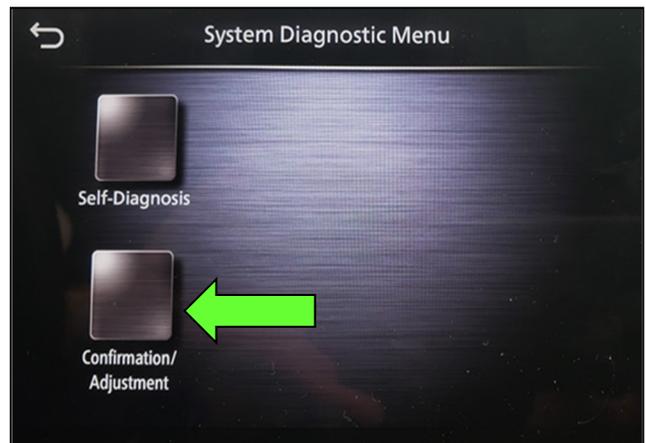
Figure 3

2. Select **Confirmation/Adjustment**.

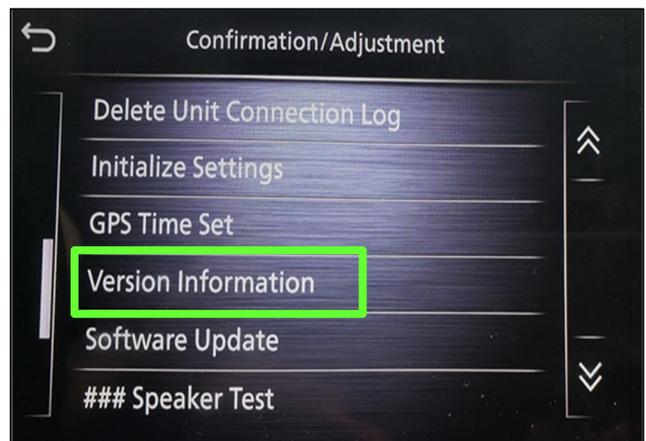
Figure 4

3. Select **Version Information**.

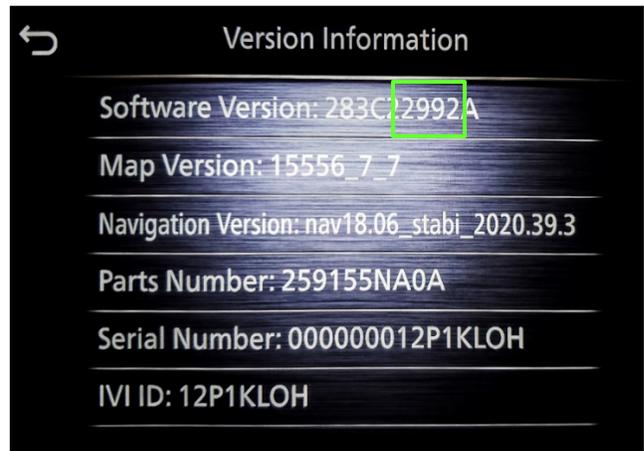
Figure 5

4. Confirm the **Software Version**.

- If the **Software Version** (characters 6-9, as shown in Figure 5) is not the latest software version listed in the vehicle table, select the back icon and continue to step 5.
- If the **Software Version** is the latest software version listed in the vehicle table, an update is not available. Select the back icon and skip to **CLAIMS INFORMATION** on the last page.

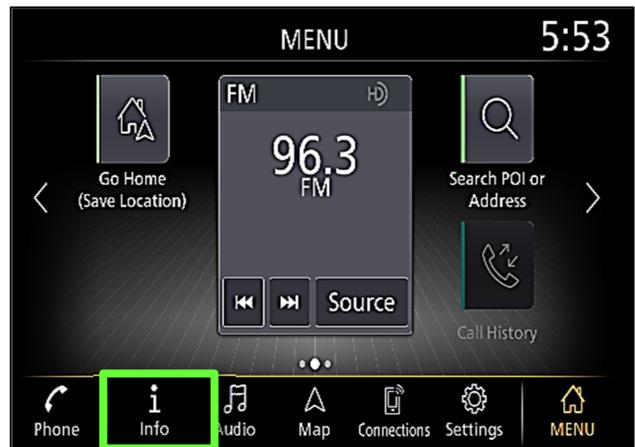
Figure 6

- Starting from the HOME screen (Figure 6), select **Info**.

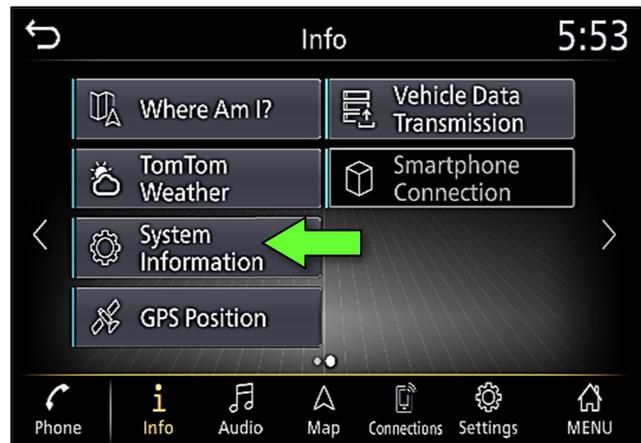
Figure 7

- Select **System Information**.

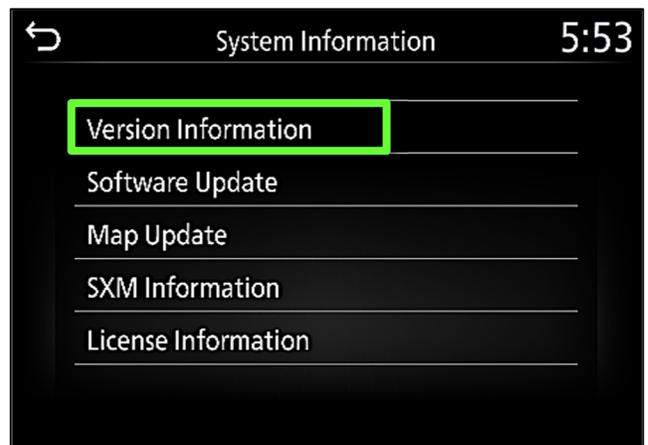
Figure 8

- Select **Version Information**.

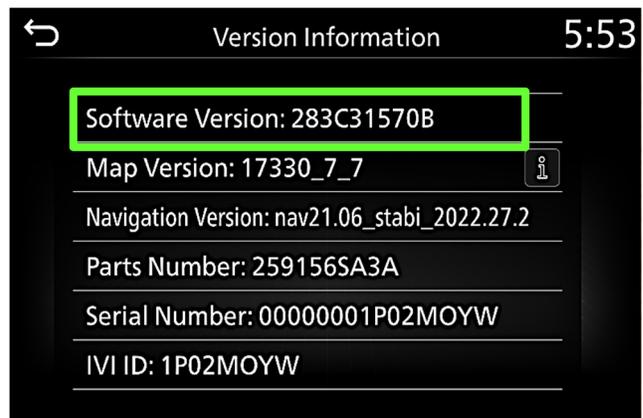
Figure 9

9. Confirm the **Software Version**.
 - If the **Software Version** is not the latest software version listed in the vehicle table, select the back icon and continue to step 10.
 - If the **Software Version** is the latest software version listed in the vehicle table, an update is not available. Select the back icon and skip to **CLAIMS INFORMATION** on the last page.

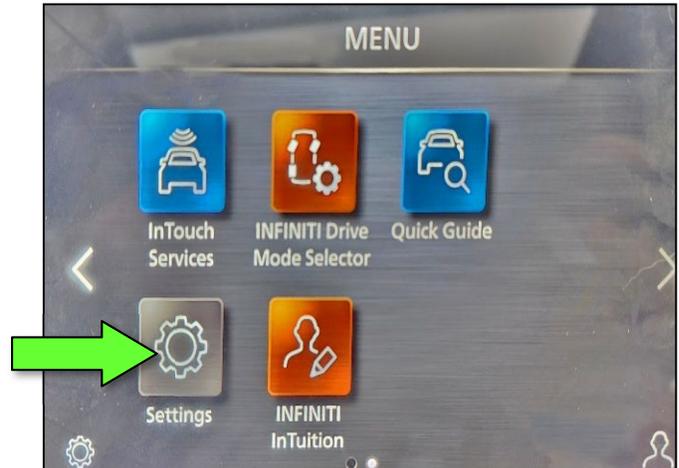
Figure 10

- a. From the **MENU** screen, select **Settings**.

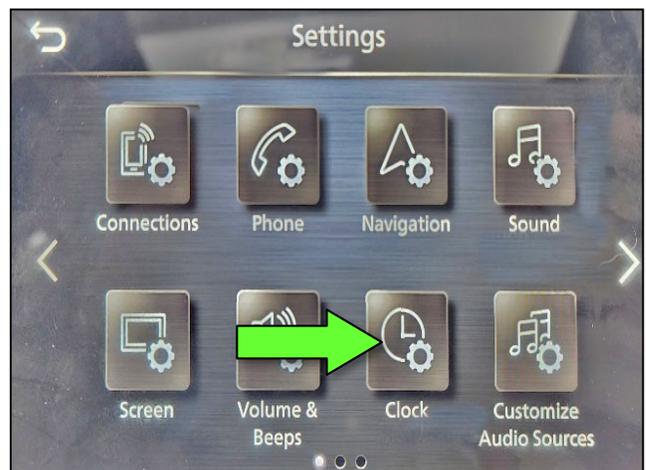
Figure 11

- b. Select **Clock**.

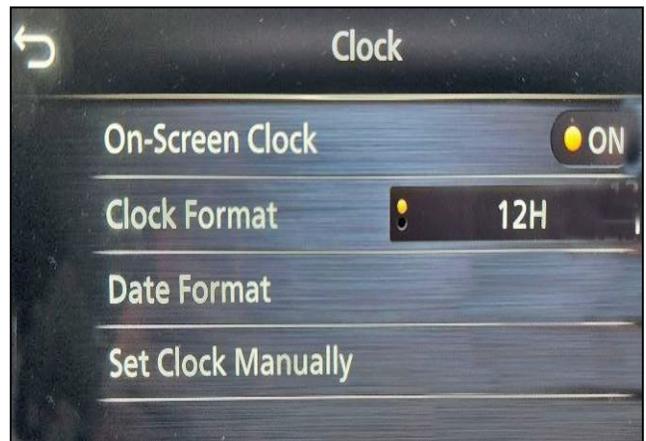
Figure 12

- c. Record all the clock settings.
 - o For vehicles without navigation:
 - **On-Screen Clock**
 - ON/OFF
 - **Clock Format**
 - 12H/24H
 - **Date Format**
 - Select **Date Format** to view and record settings.
 - **Set Clock Manually**
 - Select **Set Clock Manually** to view and record settings.

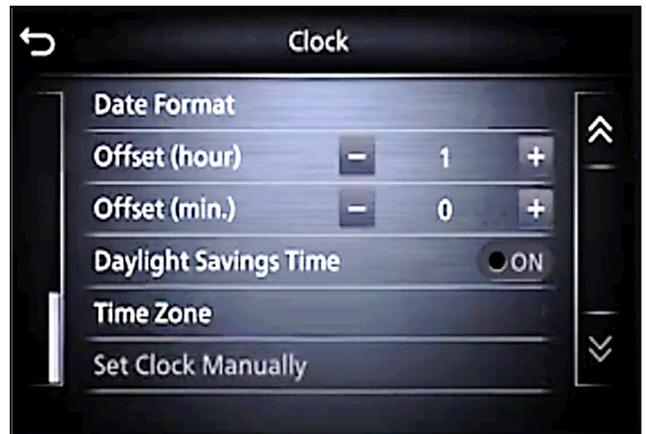
Figure 13

- o For vehicles with navigation:
 - **On-Screen Clock** (not shown)
 - ON/OFF
 - **Clock Mode** (not shown)
 - Auto/Manual/Time Zone
 - **Clock Format** (not shown)
 - 12H/24H
 - **Date Format**
 - Select **Date Format** to view and record settings.
 - **Offset (hour)**
 - **Offset (min.)**
 - **Daylight Savings Time**
 - ON/OFF
 - **Time Zone**
 - Select **Time Zone** to view and record settings.
 - **Set Clock Manually**
 - Select **Set Clock Manually** to view and record settings.

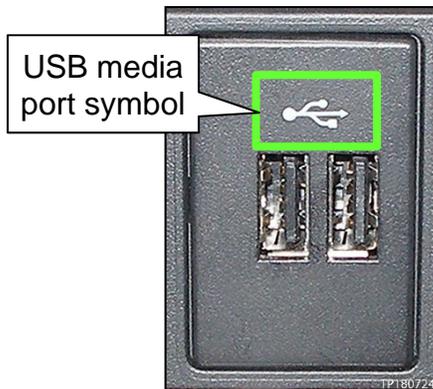
Figure 14

14. Insert the USB drive with the infotainment update-software into the vehicle's USB media port (Figure 14).

Do not insert the USB drive into a charging port. If used, the update-software and/or USB drive may become damaged. Only insert the USB drive in a USB media port.

HINT: Charging ports are marked in the vehicle with a “lightning bolt” symbol.

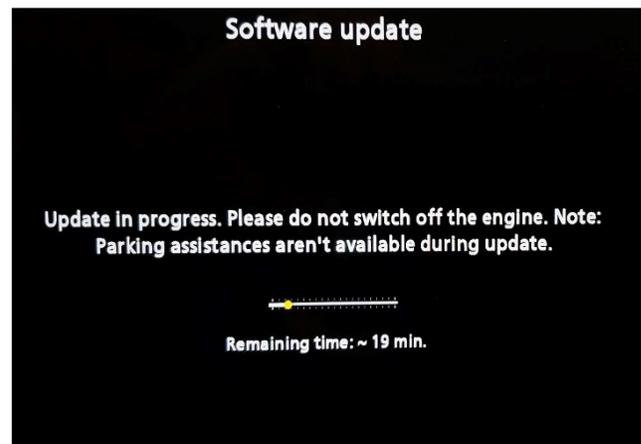
Figure 16

15. Wait for the update to complete.

- Follow the on-screen instructions while waiting.

HINT: The update lasts 15-25 minutes.

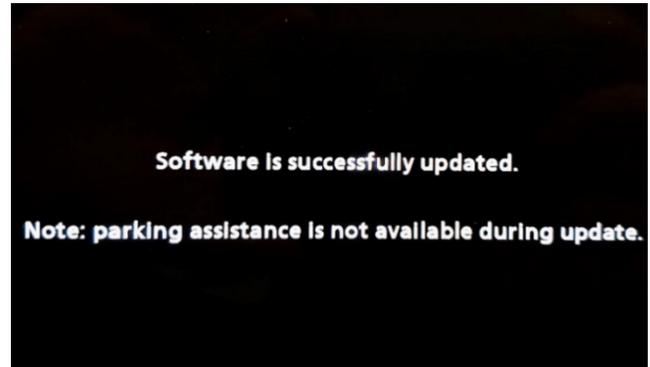
Figure 17

16. Once the update is complete (Figure 17), remove the USB drive; the system will reboot (restart).

HINT: The system will not reboot until the USB drive is removed.

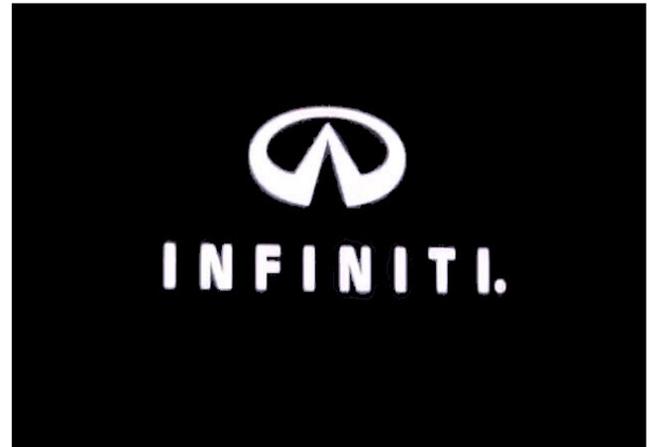
Figure 18

17. Allow the reboot to complete (approximately 30 seconds).
 - The Infiniti logo will be displayed during the reboot.

21. Turn the ignition ON (engine OFF) and wait for the Infiniti logo to appear (Figure 18).
 - If the Infiniti logo does not appear (this might take up to 30 seconds), start over from step 18.

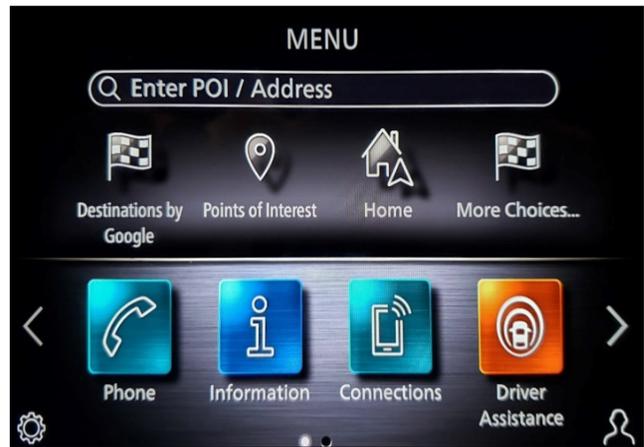
22. After the Infiniti logo appears, wait about 1 minute.

- The MENU (Home) screen in Figure 19 will be displayed.

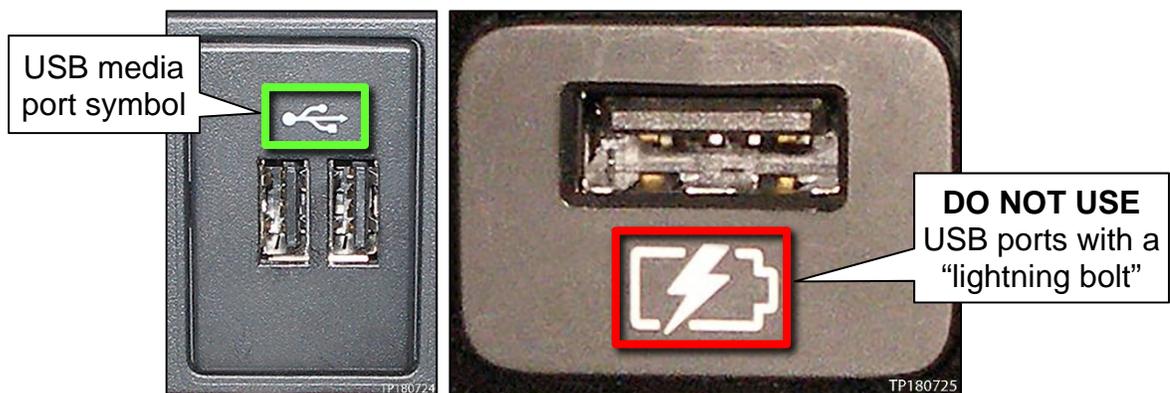
Figure 20

30. Insert the USB drive with the infotainment update-software into the vehicle's USB media port (Figure 20).

Do not insert the USB drive into a charging port. If used, the update-software and/or USB drive may become damaged. Only insert the USB drive in a USB media port.

HINT: Charging ports are marked in the vehicle with a “lightning bolt” symbol.

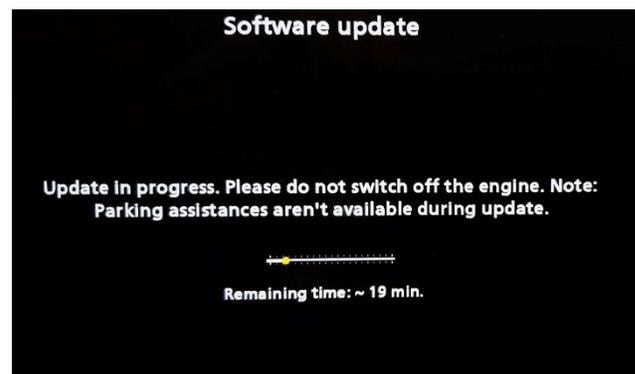
Figure 22

31. Wait for the update to complete.

HINT: The update lasts 20-30 minutes.

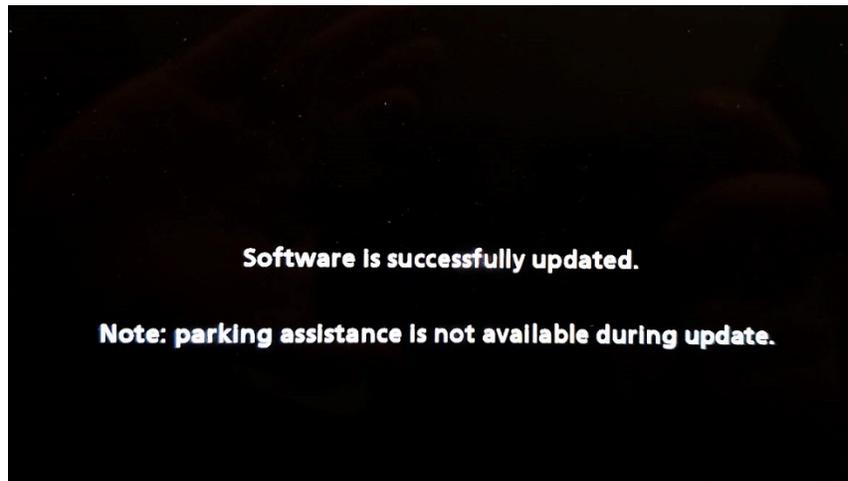
Figure 23

32. Once the update is complete (Figure 23), remove the USB drive; the system will reboot (restart).

HINT: The system will not reboot until the USB drive is removed.

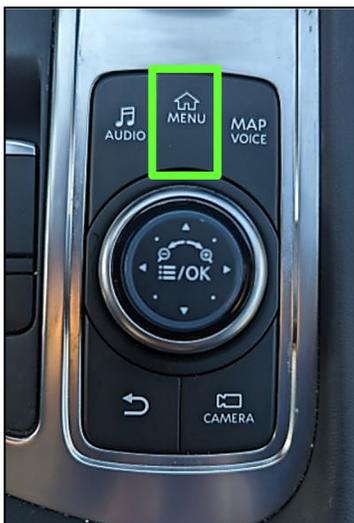
Figure 24

33. Press and hold the **MENU** button on the IT Commander (Figure 24) and turn the AV Control Unit volume knob (Figure 25) left-right-left at the same time.

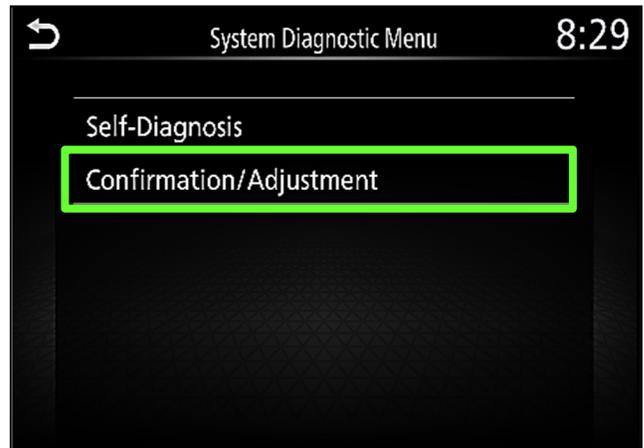
Figure 26

34. Select **Confirmation/Adjustment**.

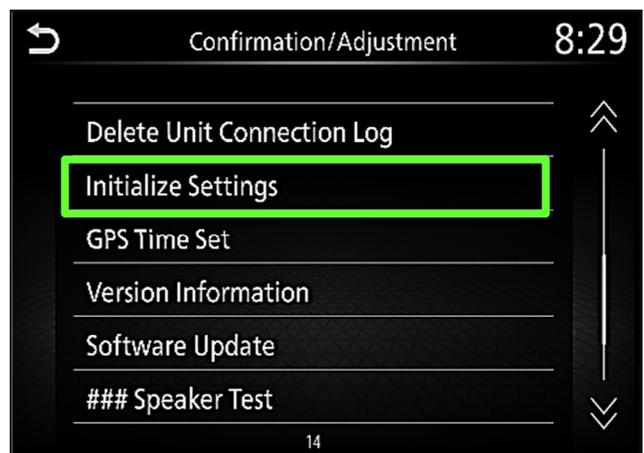
Figure 27

35. Select **Initialize Settings**.

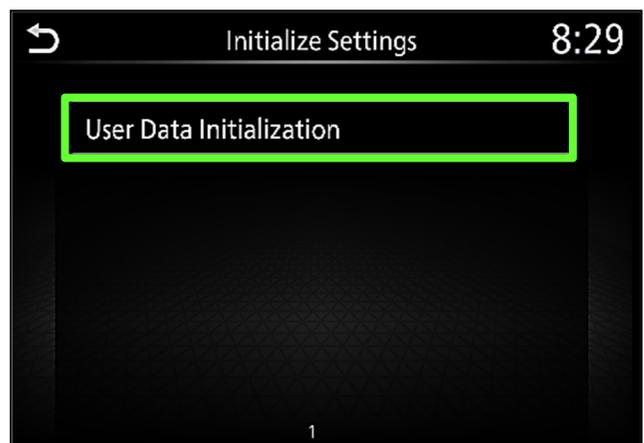
Figure 28

36. Select **User Data Initialization**.

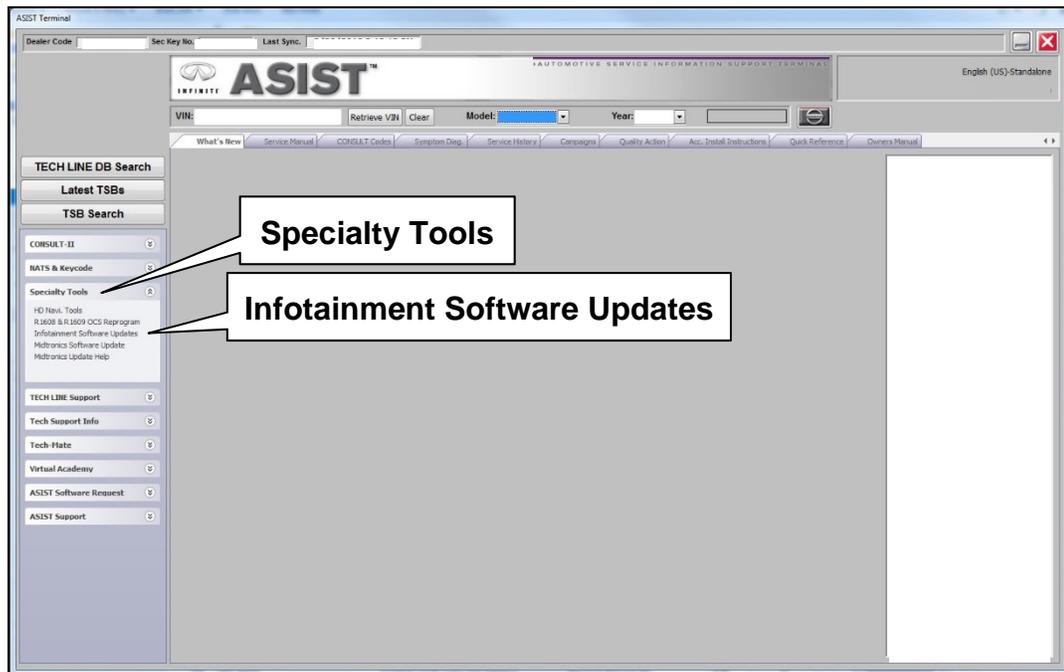
Figure 31

42. Select **Specialty Tools**, and then select **Infotainment Software Updates**.

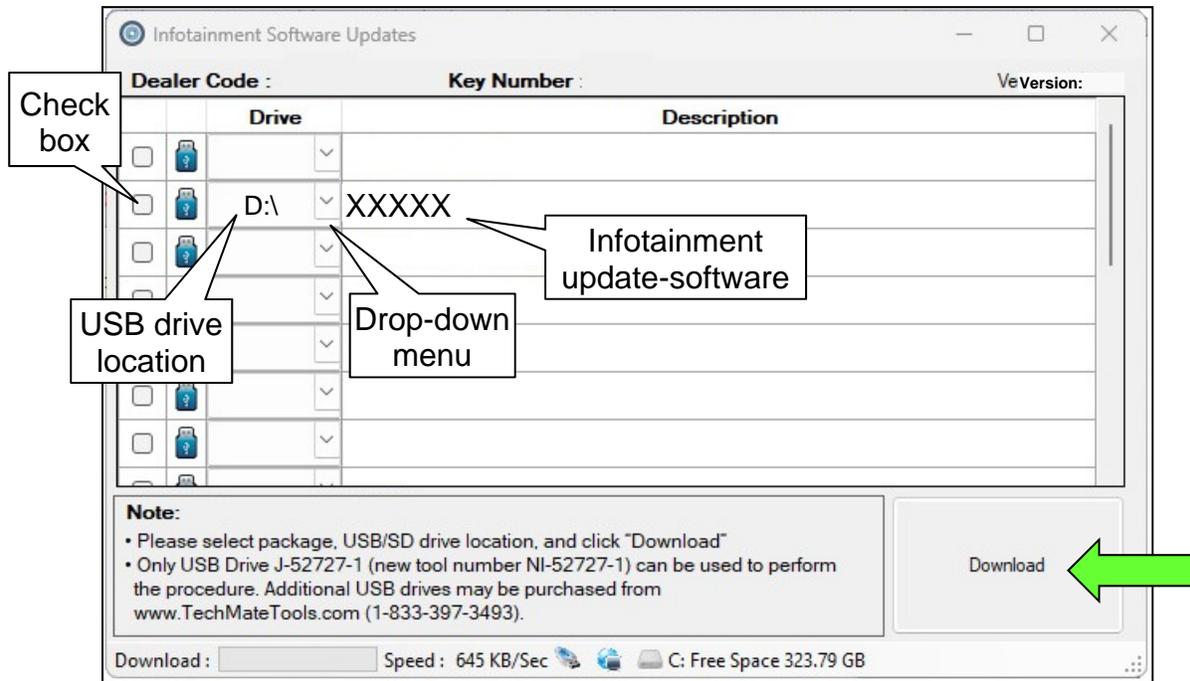
Figure 32

43. Select the check box next to the infotainment update-software (Figure 32).
 - Refer to the appropriate vehicle table to determine the correct infotainment update-software for your vehicle.
44. Use the drop-down menu and select the location of the USB drive that was inserted in step 40 on page 28.

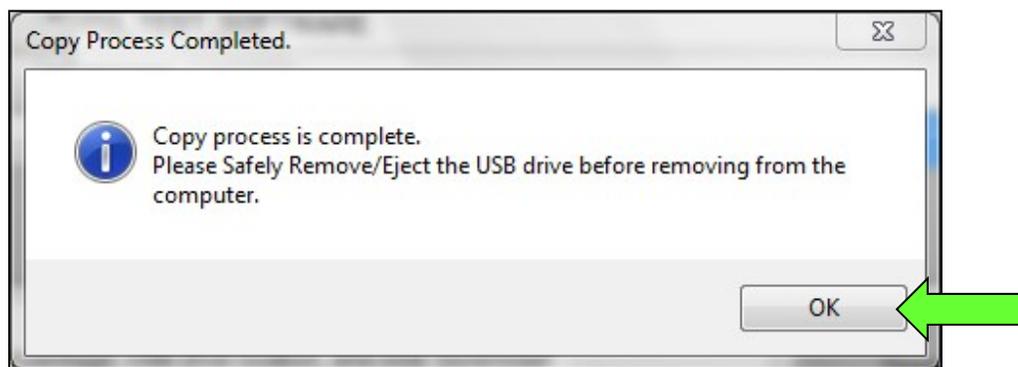
HINT: The update-software is estimated to take 10-15 minutes to download to the USB drive.
46. Select **OK** when the message in Figure 33 is displayed.

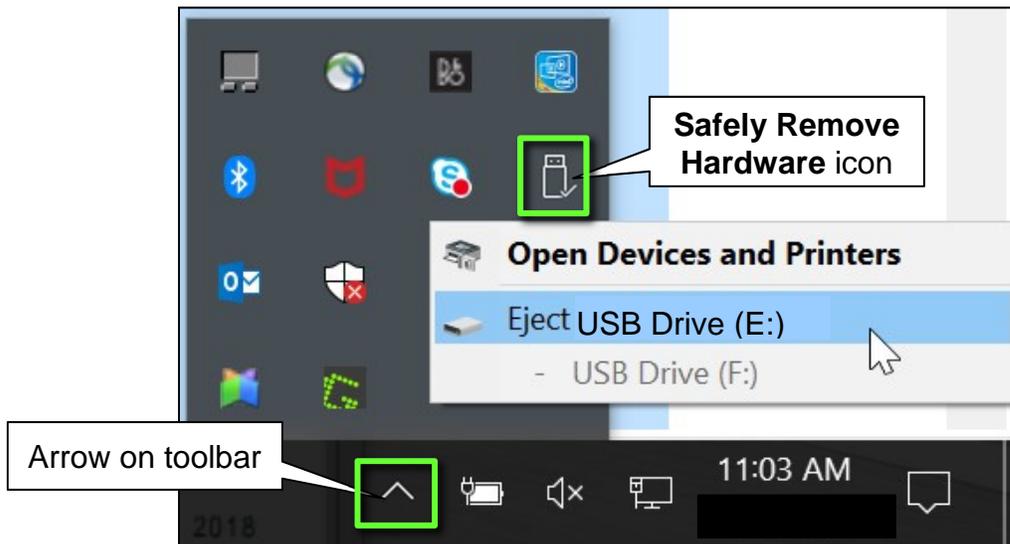
Figure 34

47. Once the transfer is complete, safely remove the USB drive from the CONSULT PC.
 - a. From the PC toolbar, select the **Safely Remove Hardware** icon.
 - o The icon is on the toolbar, or can be found after selecting the arrow.
 - b. Select the USB drive to be removed, and then remove the USB drive from the CONSULT PC.
