TECHNICAL SERVICE BULLETIN

AN21-003C

SOFTWARE UPDATE FOR INFOTAINMENT ISSUES

APPLIED VEHICLES: 2019-2020 Rogue (T32)
2019 Rogue Hybrid (T32H)

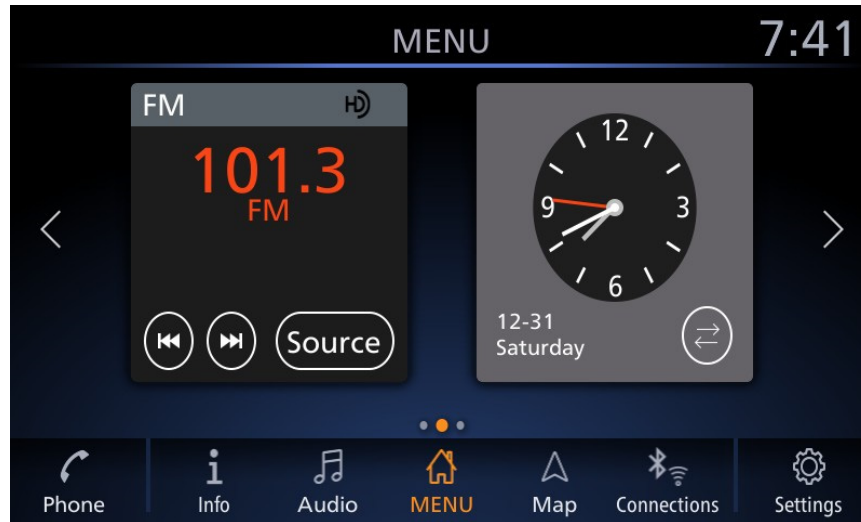
Figure 2

From the **MENU** page shown in Figure 2:

- Push and hold down the **MENU** button (not shown), and at the same time rotate the tuning knob more than three (3) clicks in each direction (back and forth) until the **System Diagnosis Menu**, shown in Figure 3, displays.

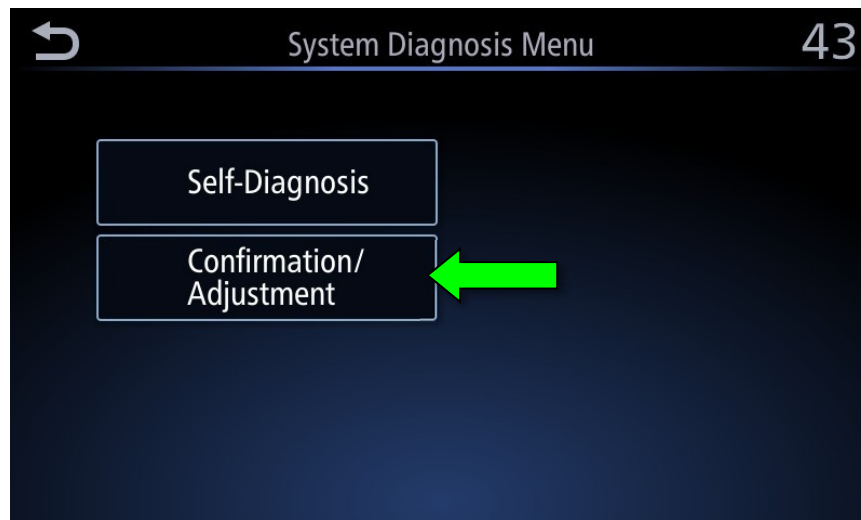
Figure 3

2. Select **Confirmation/Adjustment**.

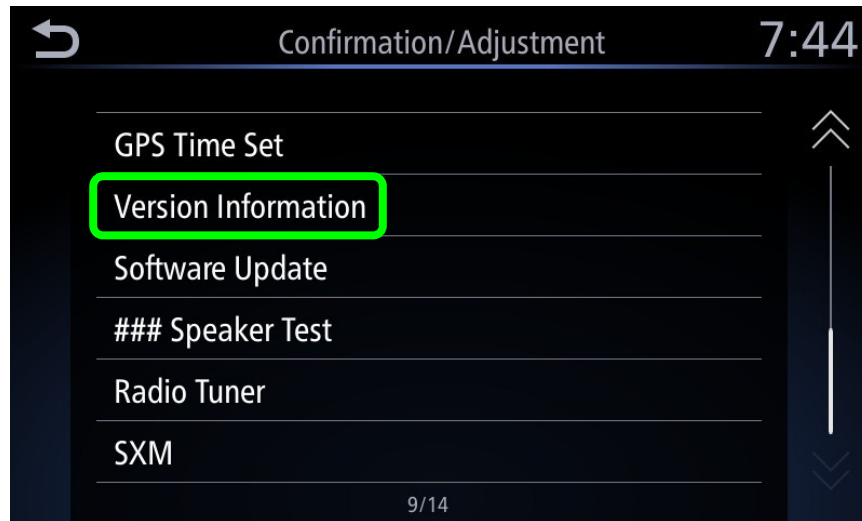
Figure 4

3. Select **Version Information**.

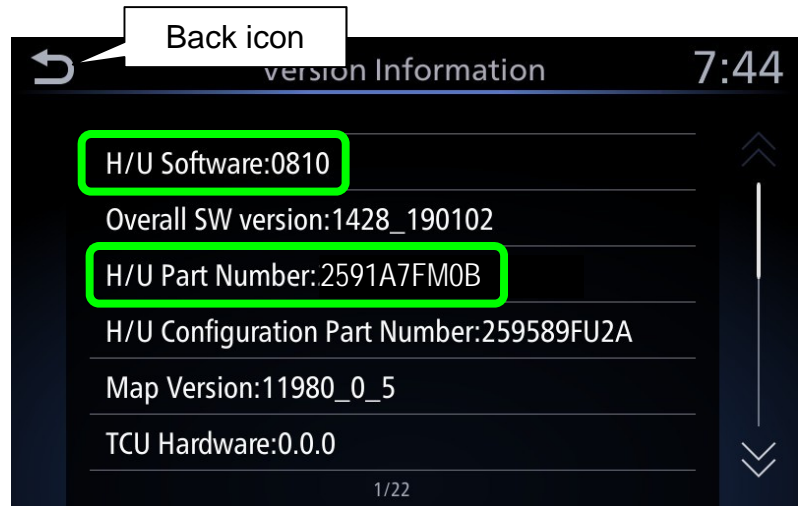
Figure 5

4. Is the **H/U Software** version "0810"?

5. Is the **H/U Part Number** listed below?

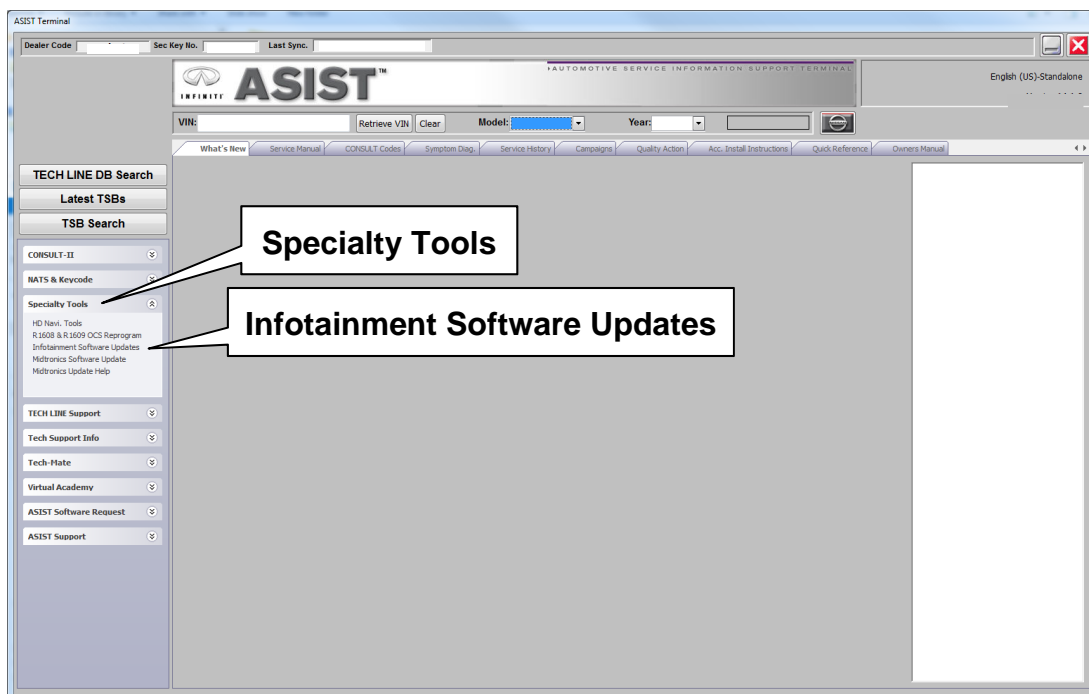
Figure 6

- The CONSULT PC is connected to the Internet.
 - ASIST has been synchronized (updated) to the current date.
6. Insert the special tool USB drive into the CONSULT PC.
 - If the update-software has already been downloaded onto the USB drive from a prior service procedure, skip to step 15 on page 7.
 - The special tool USB drive is the only USB drive approved for use with this procedure.
 - The update-software is estimated to take **4 hours** to download to the USB drive.
 - The update-software must be the only file on the USB drive.
 7. Open ASIST.
 8. Select **Specialty Tools**, and then select **Infotainment Software Updates**.

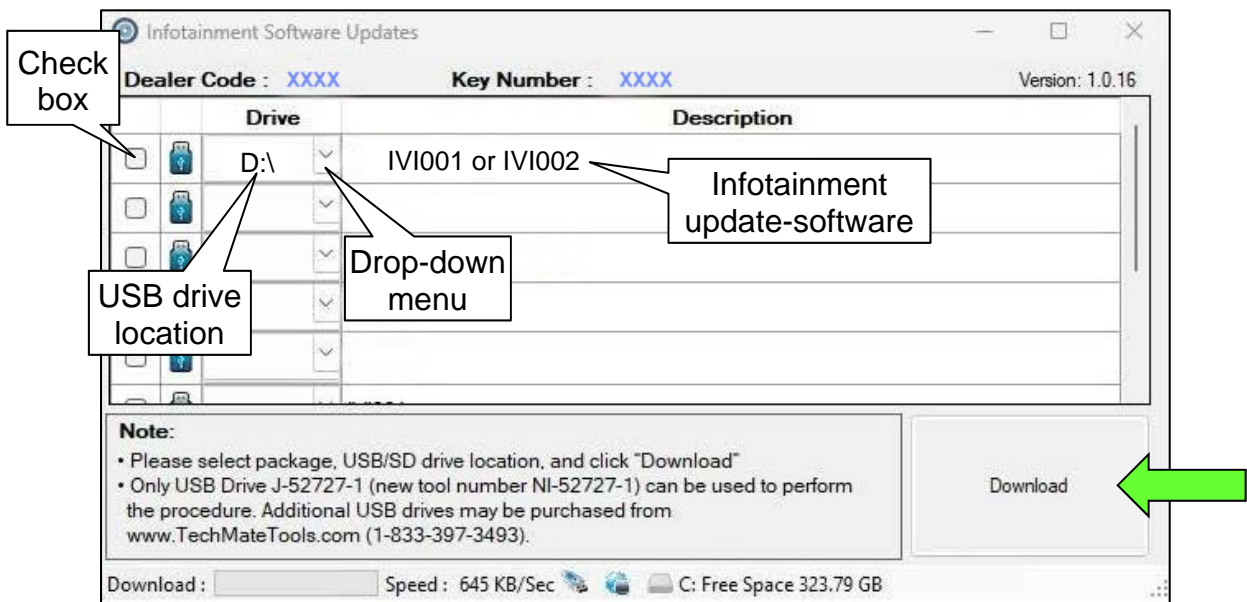
Figure 7

9. Select the check box to the left of the appropriate infotainment update-software (Figure 7).

10. Use the drop-down menu and select the location of the USB drive that was inserted into the CONSULT PC in step 6 on page 5.

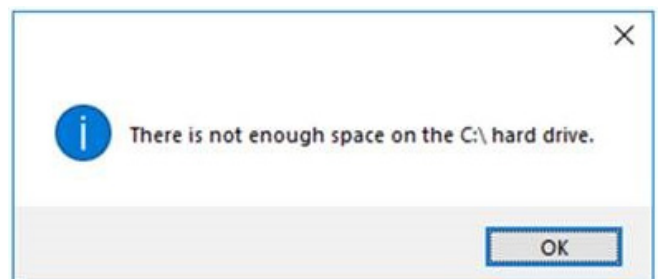
Figure 8

- The update-software is estimated to take 4 hours to download to the USB drive.
- If, while attempting to download the software to the CONSULT PC, you receive the message shown in Figure 8:
 - Attempt to clear space on the CONSULT PC hard drive.

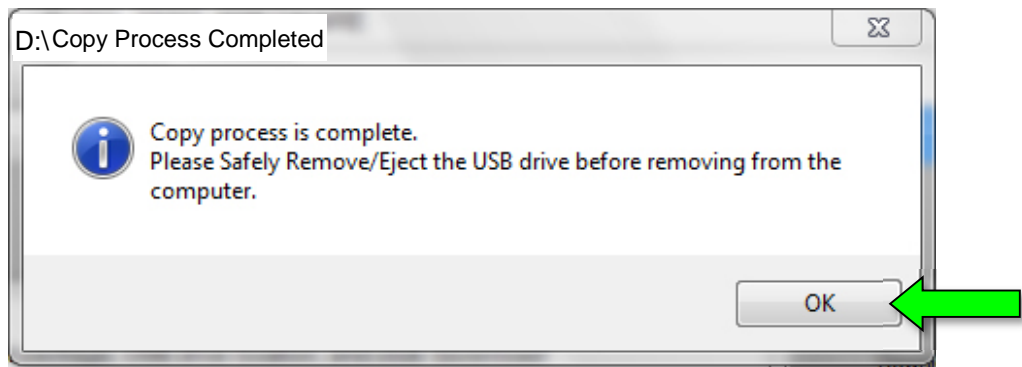
Figure 9

12. Select **OK**.

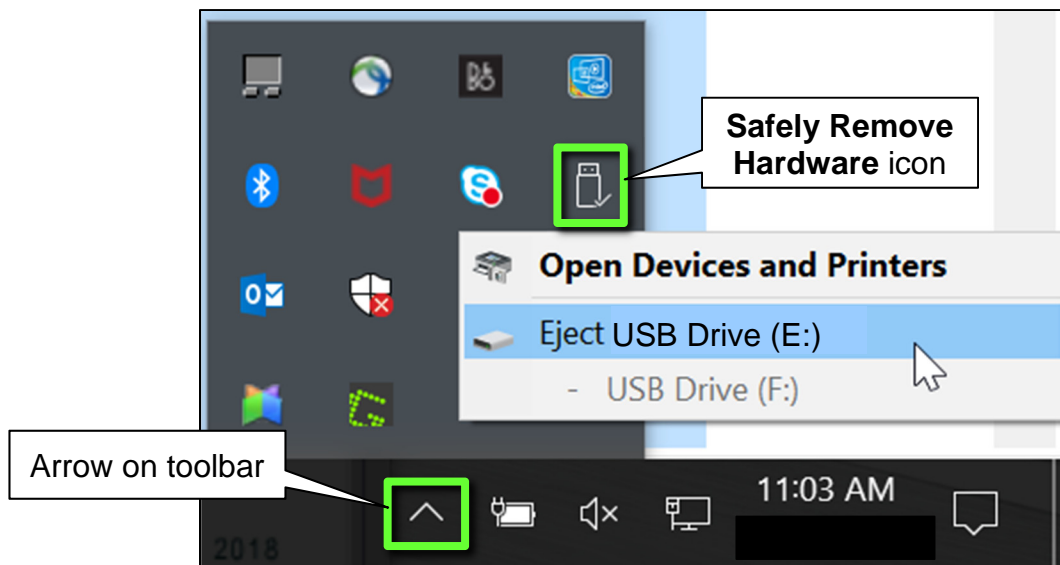
Figure 10

13. Once the transfer is complete, safely remove the USB drive from the ASIST station.
- From the PC toolbar, select the **Safely Remove Hardware** icon (Figure 10).
 - The icon is on the toolbar or can be found after selecting the arrow.
 - Select the USB drive to be removed, and then remove the USB drive from the CONSULT PC.

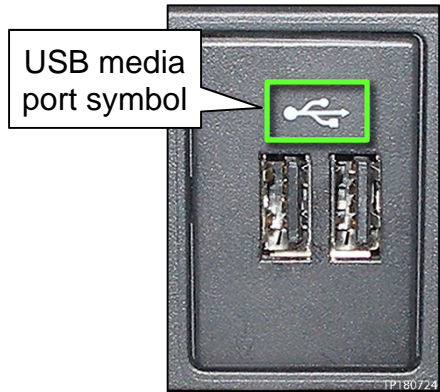
Figure 11

17. Insert the USB drive with infotainment update-software into the vehicle's USB media port (see Figure 11).
- Do not remove the USB drive during the update to the vehicle until instructed to.

Do not insert the USB drive into a charging port. If used, the update-software and/or USB drive may become damaged. Only insert the USB drive in a USB media port.

HINT: Charging ports are marked in the vehicle with a “lightning bolt” symbol.

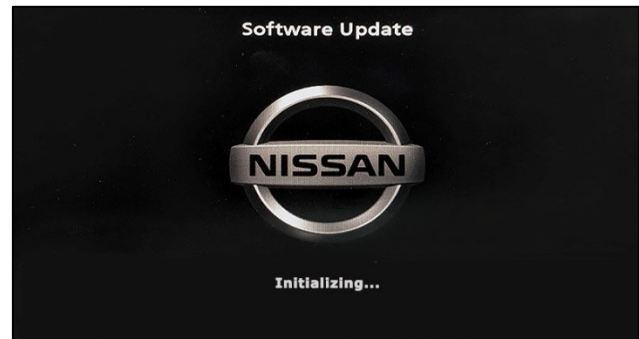
18. Wait approximately 10-30 seconds for the screen in Figure 13 to appear.

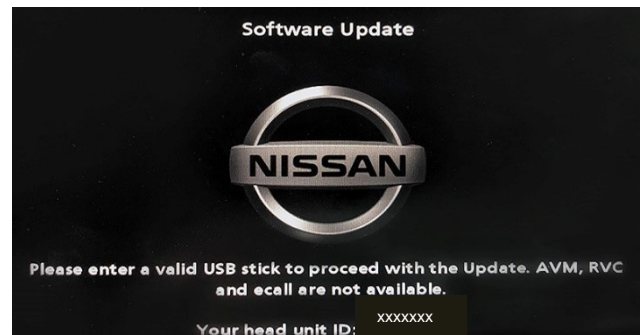
- The screen in Figure 14 may briefly appear. **Do not remove the USB drive.** The audio system will detect the USB drive and continue the update.

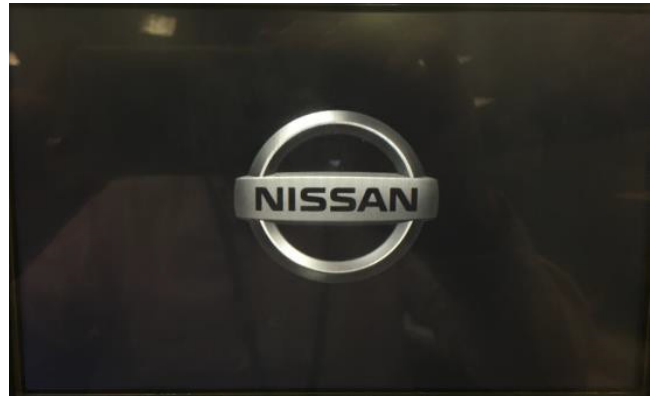
Figure 17

25. Turn the ignition ON (engine OFF) and wait for the Nissan logo to appear (Figure 17).
 - If the Nissan logo does not appear (this might take up to 30 seconds), start over from step 22.

21. Allow the reboot to complete (approximately 30 seconds).
 - The Nissan logo will be displayed during the reboot.
22. Turn the ignition OFF.

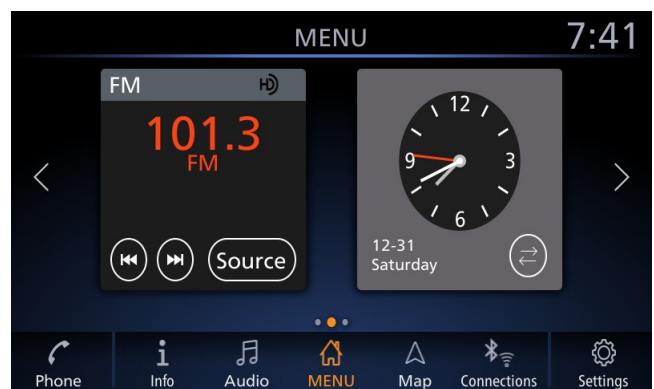
26. After the Nissan logo appears, wait about 1 minute.
 - The MENU (Home) screen in Figure 18 will be displayed.
