FIELD SERVICE CAMPAIGN – 23104

Reprogram Power Take-Off Module (PTOM) and Engine Control Module (ECM).

International® CV™ Series trucks

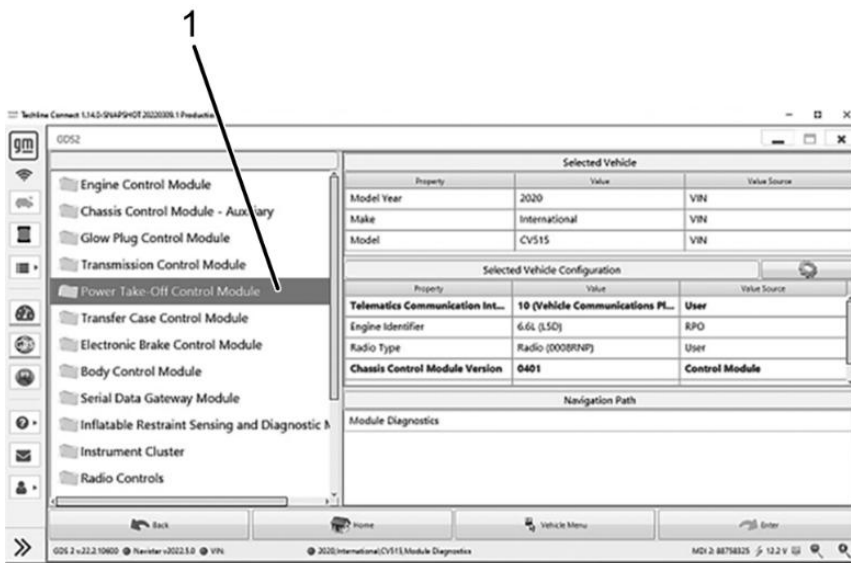
Figure 1. GDS2 Screen

1. Power Take-Off Control Module

7. Using Techline Connect and MDI 2 Adapter, connect to vehicle Power Take-Off Control Module (Figure 1, Item 1).

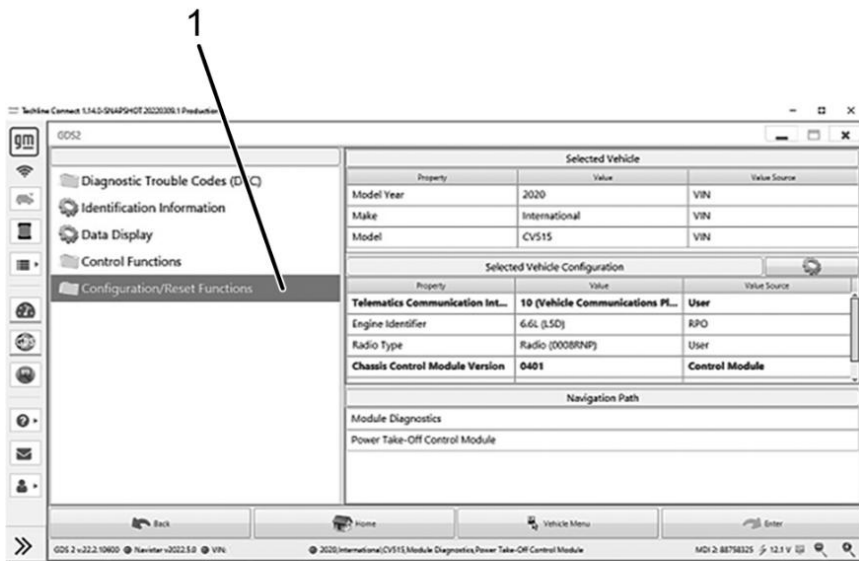
Figure 2. GDS2 Screen

1. Configuration/Reset Functions

8. Select **Configuration/Reset Functions** (Figure 2, Item 1).

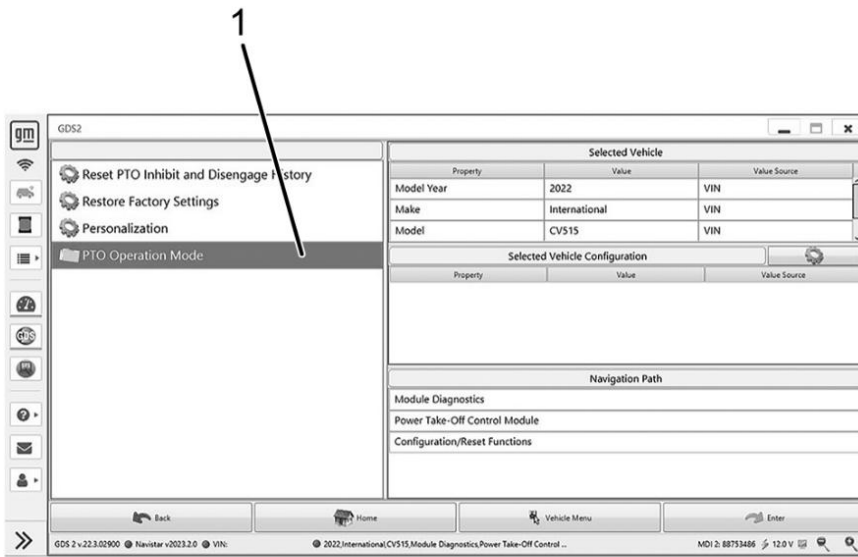
Figure 3. GDS2 Screen

1. PTO Operation Mode
9. Select **PTO Operation Mode** (Figure 3, Item 1).

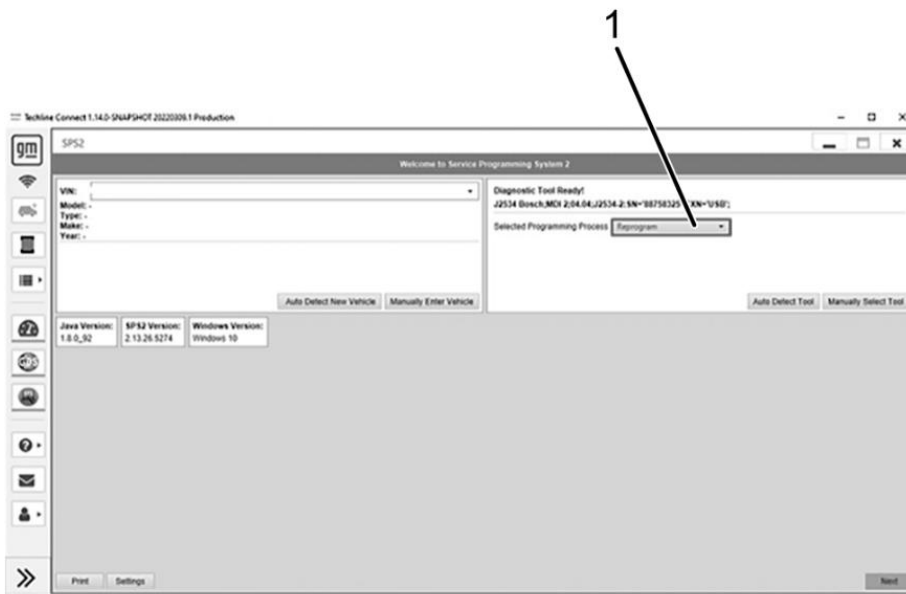
Figure 5. SPS2 Screen

1. Reprogram tab
12. Select **Reprogram** tab (Figure 5, Item 1).

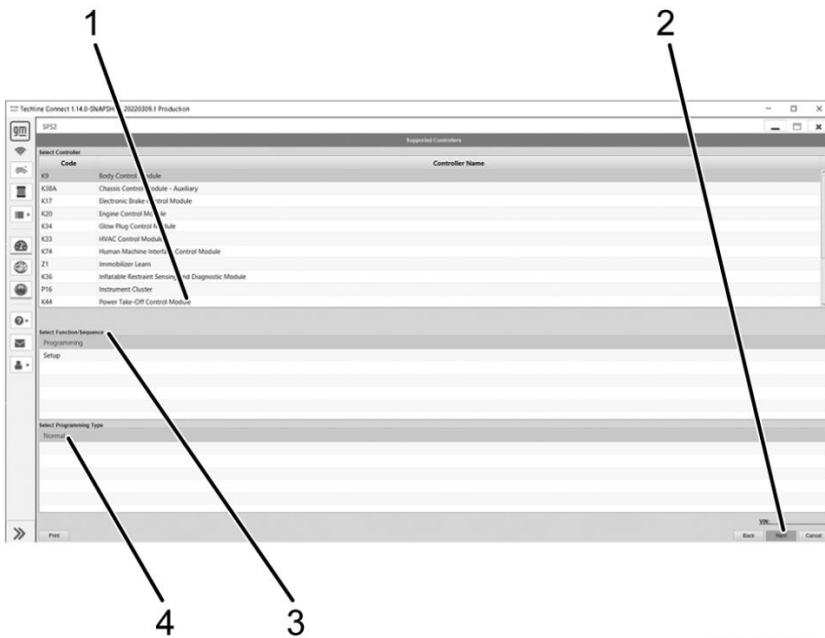
Figure 9. SPS2 Screen

1. K44 Power Take-Off Control Module
2. Next tab
3. Programming
4. Normal

18. Select **K44 Power Take-Off Control Module** (Figure 9, Item 1).

19. Select **Programming** (Figure 9, Item 3).

20. Select **Normal** (Figure 9, Item 4) and **Next** tab (Figure 9, Item 2).

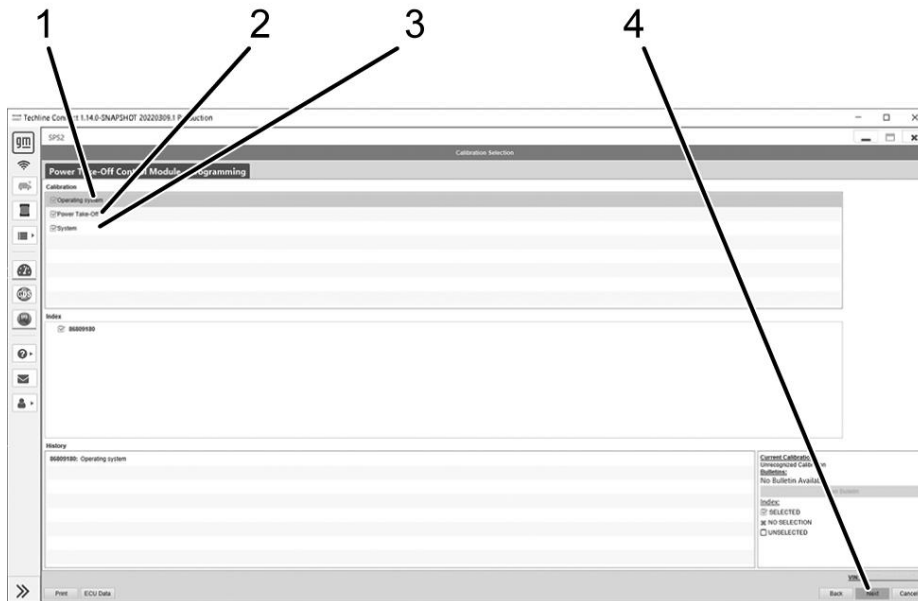
Figure 10. SPS2 Screen

1. Operating System
2. Power Take-Off
3. Systems
4. Next tab

21. Select the following Power Take-Off Control Module options:

- a. **Operating System** (Figure 10, Item 1).
- b. **Power Take-Off** (Figure 10, Item 2).
- c. **Systems** (Figure 10, Item 3).

22. Click **Next** tab (Figure 10, Item 4).

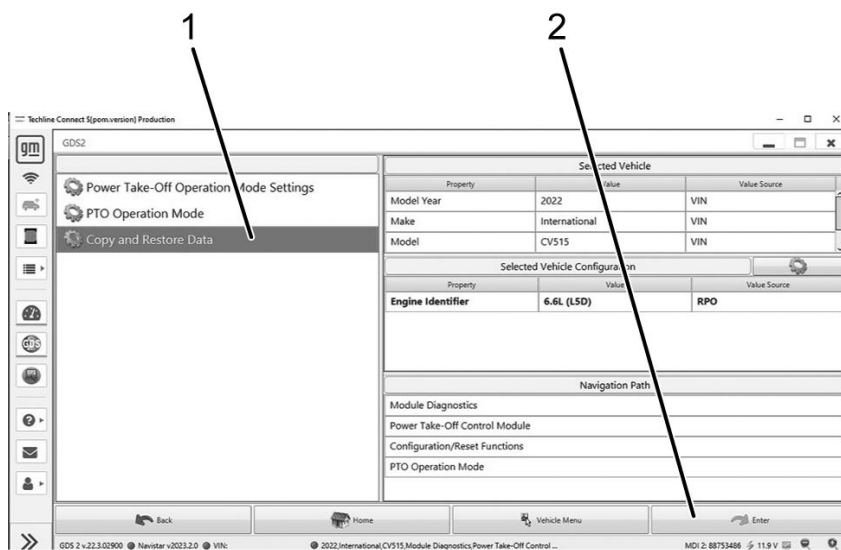
Figure 13. GDS2 Screen

1. Copy and Restore Data
 2. Enter tab
25. Minimize SPS2 and reopen GDS2 located on the Techline Connect Homepage. Select **Copy and Restore Data** (Figure 13, Item 1), then click **Enter** tab (Figure 13, Item 2). You will be directed to use saved data. Confirm message and continue to restore PTOM Data.
 26. GDS directs you to the previous menu (alternatively, use the Back button to return to the previous menu).

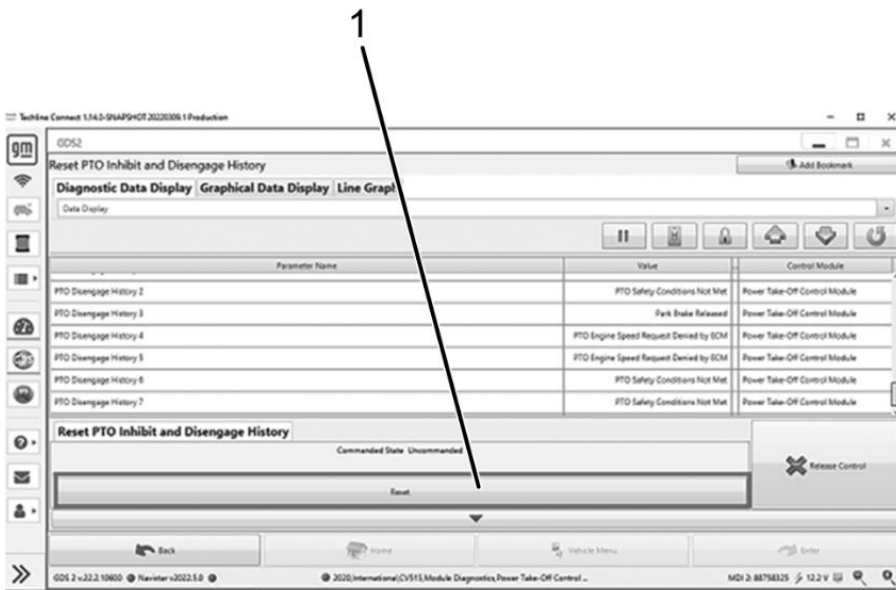
Figure 15. GDS2 Screen

28. Select **Reset** tab (Figure 15, Item 1).
29. Set park brake, disconnect scan tool, turn ignition to Key OFF position, and remove key from ignition.
30. Test PTO operation.
