Head Unit Software Update (Panasonic)

Service Category Audio/Visual/Telematics

Section Navigation/Multi Info Display

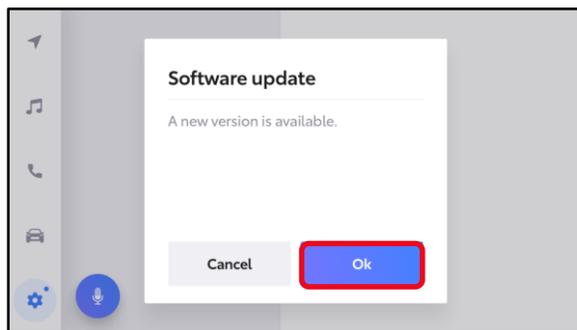
Figure 1.

Vehicle operators can perform this update directly by accepting the on-screen notification (see Figure 1), advising the software update is available, or by locating the software update from the Settings menu and initiating the available update (see Figure 2). The release notes text below will be displayed to the customer:

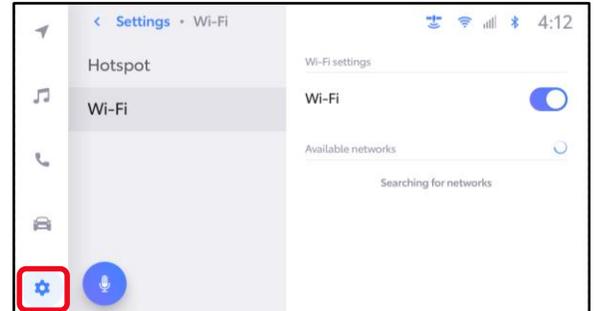
Figure 3.

1. Turn ON the ignition.
2. Select the gear icon in the lower left corner of the radio screen.

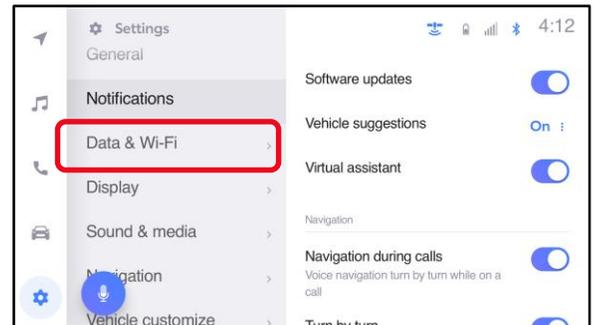
Figure 4.

3. Select Data & Wi-Fi.

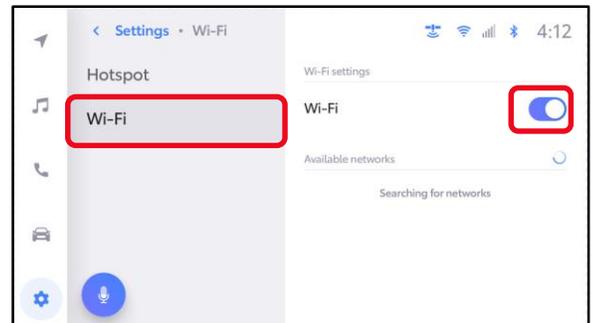
Figure 5.

4. Select Wi-Fi and turn the Wi-Fi toggle to ON.

- This step is used to connect the vehicle to an EXTERNAL Wi-Fi source.
- Wi-Fi connection is NOT required for updates that are delivered through DCM data.

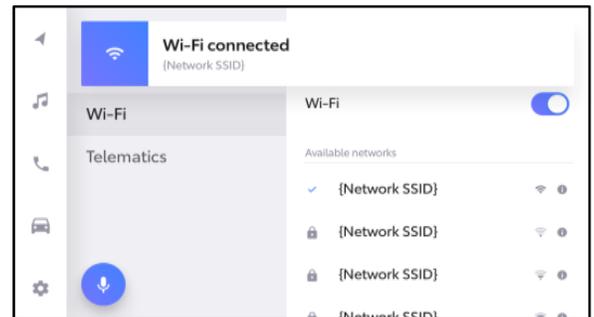
Figure 7.

6. Follow the on-screen instructions. A message will appear confirming that the vehicle is successfully connected to the network.

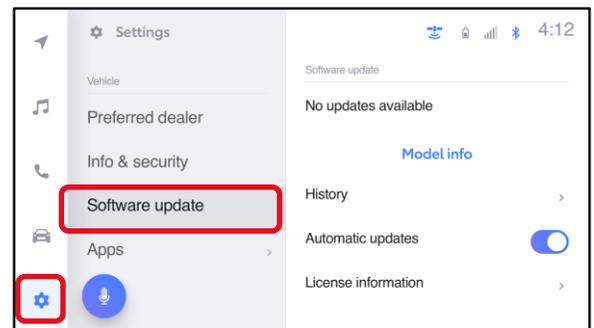
Figure 8.

1. Select the gear icon, scroll down, and select Software update.

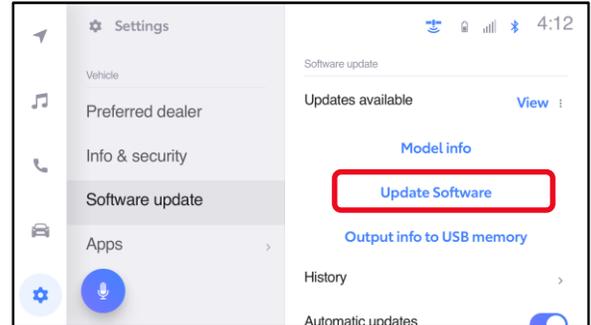
Figure 13.

6. Select Update Software.

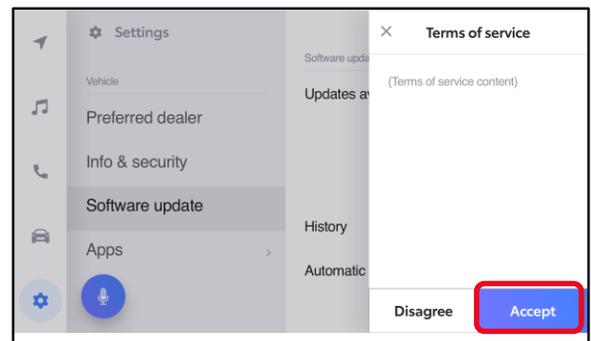
Figure 14.

7. Select Accept on the Terms of service screen.

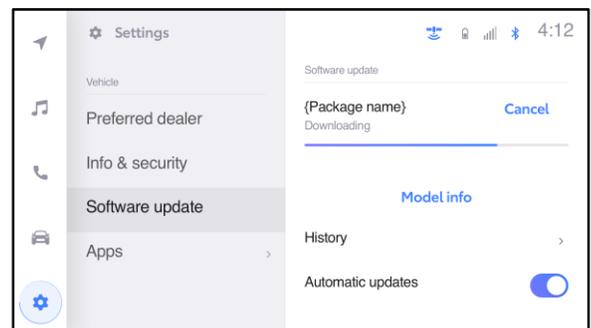
Figure 15.

8. Wait for the update to download.

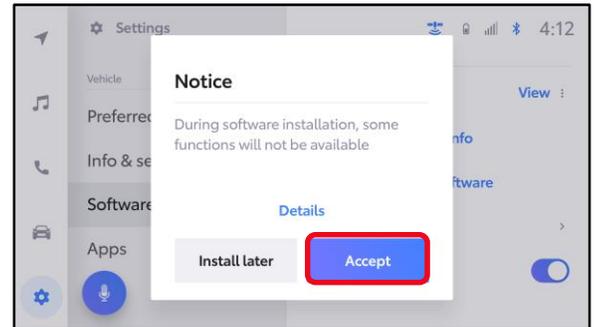
Figure 16.

9. Select Accept on the Notice pop-up message.

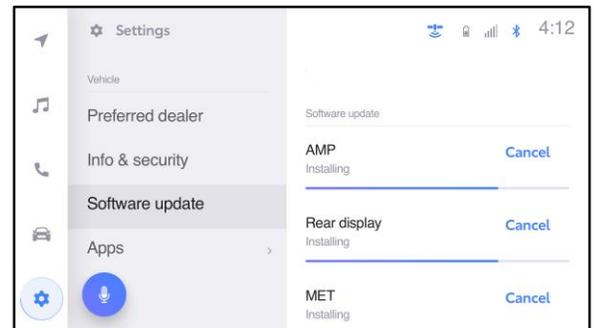
Figure 17.

10. Wait for the update to download. Once the head unit begins installation, the update will take about 10 minutes.

- Do NOT turn OFF the engine or ACC BEFORE the software is ready for updating.
- Selecting Cancel will cancel the installation of the specific component, but it can be installed manually later.

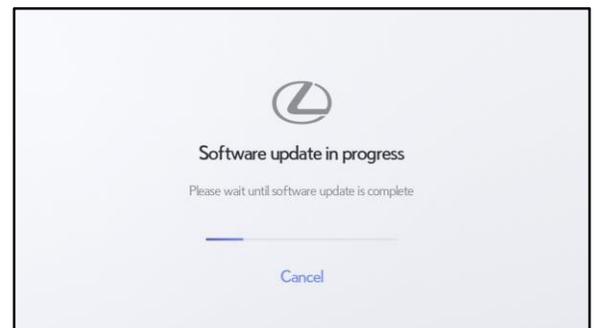
Figure 18.

11. If a major update is being installed the message "{Software update in progress}" will be displayed.

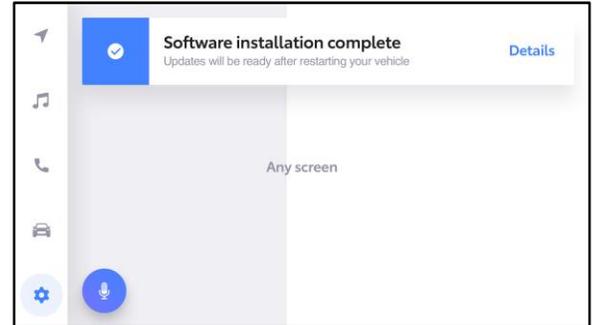
Figure 19.

- The software installation is complete when either a “Software installation complete” banner (Figure 19) or the “Software update complete” screen (Figure 20) is displayed.

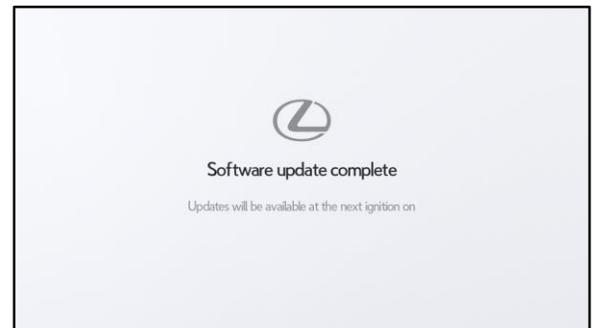
Figure 20.

If the vehicle has installed a major update, and the “Software update complete” screen is displayed, then an IG-OFF/ON will need to be performed prior to attempting to operate any of the infotainment functions.

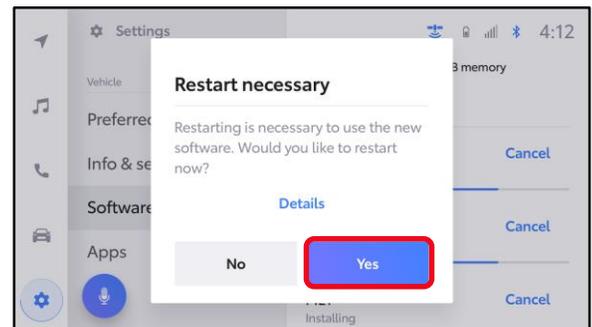
Figure 21.

- If a restart is necessary, select Yes to restart the head unit.

If No is selected or the vehicle is switched to IG-OFF, the installation will occur at the next IG-ON.

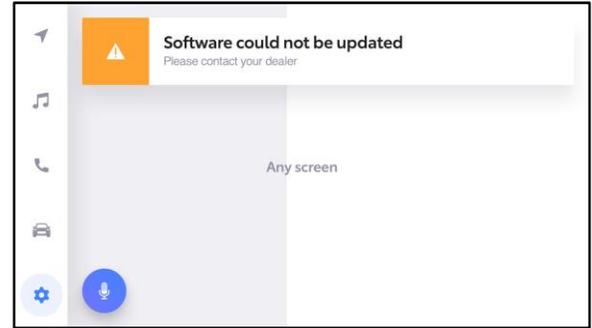
Figure 22.

14. If after IG-OFF/ON a “Software could not be updated” banner appears, continue to the [USB Update Procedure](#) subsection.

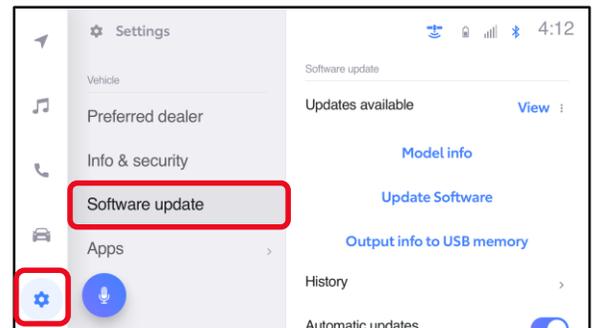
Figure 23.

2. Select the gear icon and scroll down to Software update.

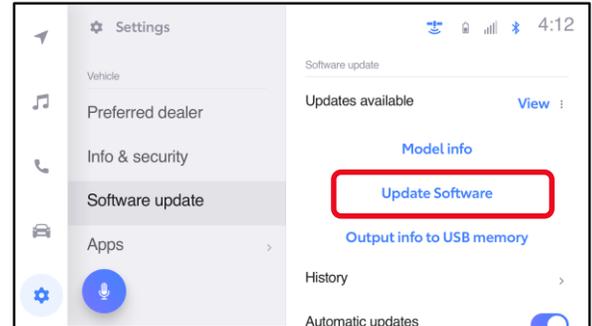
Figure 25.

The Update Software button may not be available immediately after inserting the USB flash drive. The head unit is unzipping the software update file, and it may take up to 10 minutes for this button to become available to press.

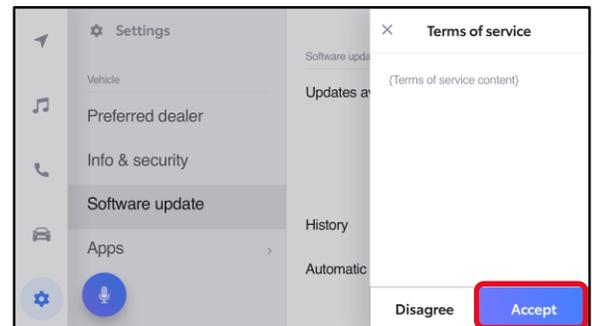
Figure 26.

5. Select Accept on the Terms of service screen.

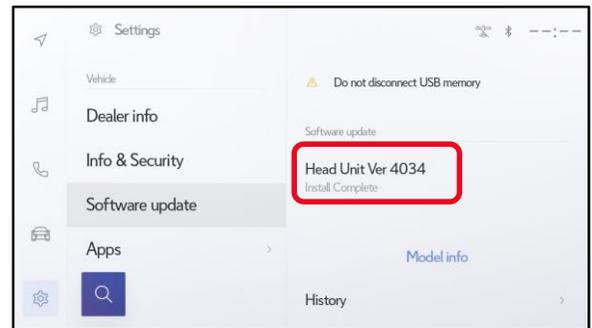
- A. When the update is complete, “Install Complete” will show on the head unit, as shown in Figure 28.
- B. The “Software update” pop-up message may also appear, as shown in Figure 29.

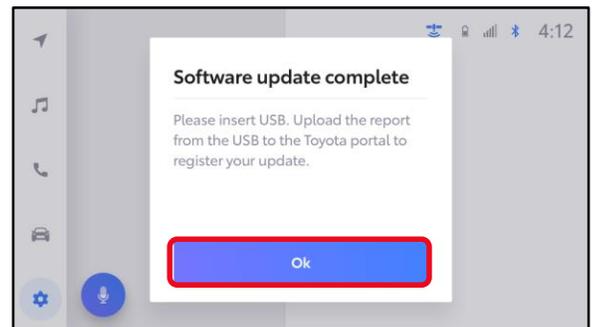
Figure 30.

If you are prompted to upload a report as shown in Figure 30, insert a blank USB to remove the .JSON files. These files are NOT needed at this stage of the process.
