Head Unit Software Update (Panasonic)

Service Category Audio/Visual/Telematics

Section Navigation/Multi Info Display

YEAR(S)	MODEL(S)	ADDITIONAL INFORMATION
2022	Tundra, Tundra HV

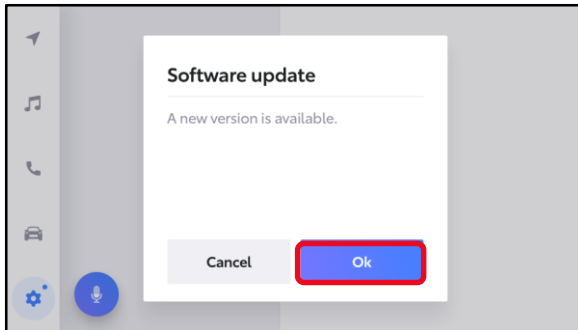
Figure 1.

Vehicle operators can perform this update directly by accepting the on-screen notification (see Figure 1) advising the software update is available or by locating Software update from the Settings menu and initiating the available update (see Figure 2). The release notes text below will be displayed to the customer:

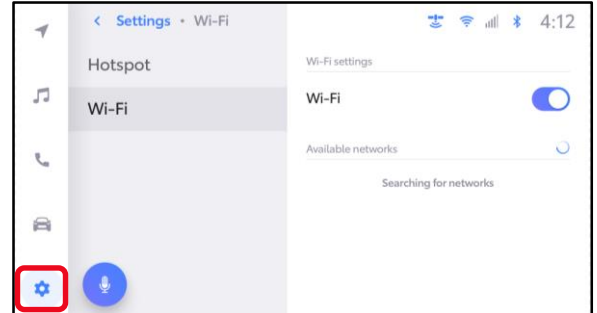
Figure 3.

1. Turn ON the ignition.
2. Select the gear icon in the lower left corner of the radio screen.

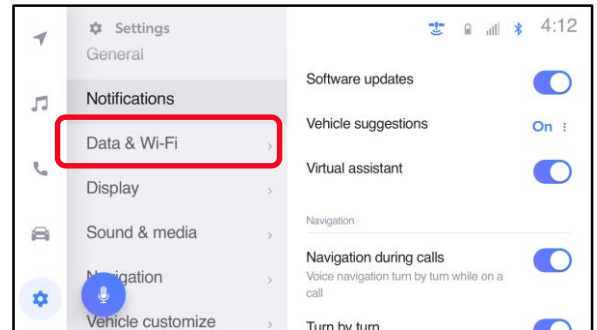
Figure 4.

3. Select Data & Wi-Fi.

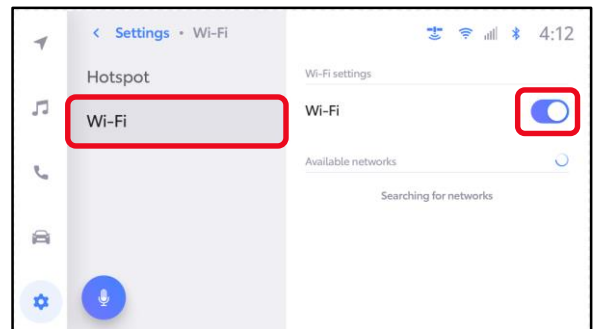
Figure 5.

4. Select Wi-Fi and turn the Wi-Fi toggle to ON.

- This step is used to connect the vehicle to an EXTERNAL Wi-Fi source.
- Wi-Fi connection is NOT required for updates that are delivered through DCM data.

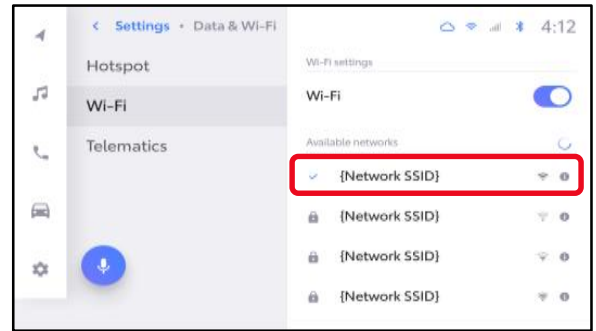
Figure 6.

NOTE
It is NOT possible to connect to a Wi-Fi source that requires a username and password to be entered in a browser.

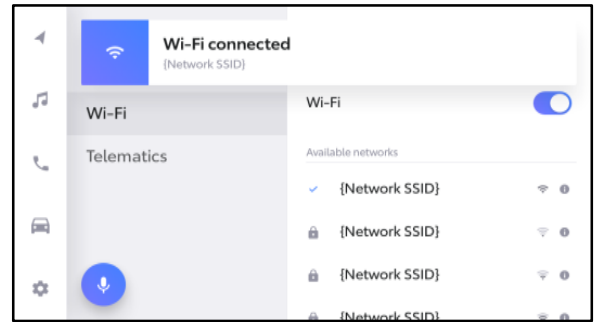
Figure 7.

6. Follow the on-screen instructions. A message will appear confirming that the vehicle is successfully connected to the network.

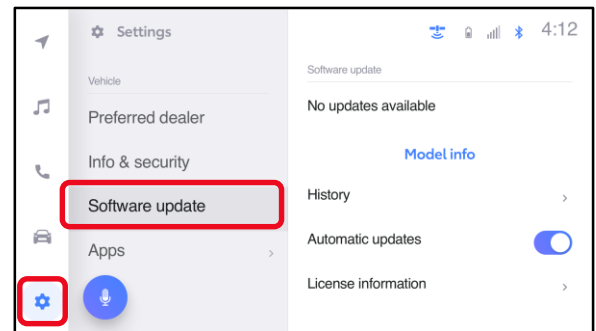
Figure 8.

1. Select the gear icon, scroll down, and select Software update.

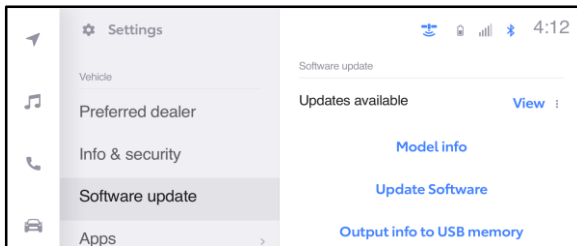
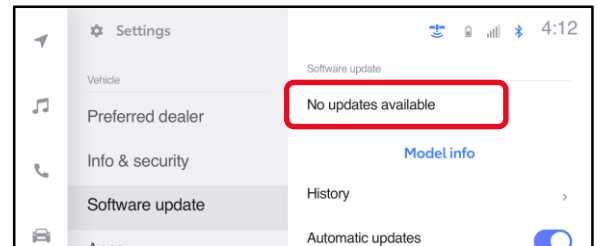
2. Are software updates available?
 - **YES** — Continue to step 3 to update the vehicle.
 - **NO** —This bulletin does NOT apply, continue diagnosis using the applicable Repair Manual.

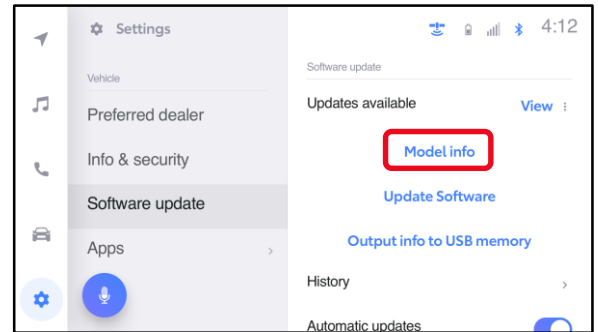
Figure 11

3. Is the head unit software up to date? (Refer to Table 1 below.)
 - **YES** — This bulletin does NOT apply, continue diagnosis using the applicable Repair Manual.
 - **NO** — Continue to step 4.

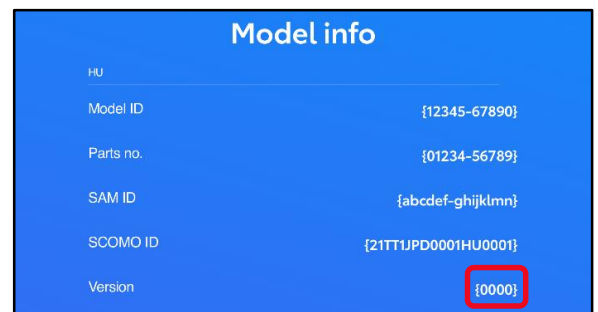
Figure 12

4. Is the head unit software version in the vehicle one of the previous versions listed in Table 1?
 - **YES** — Continue to step 5.
 - **NO** —Go to the [USB Update Procedure](#) subsection.

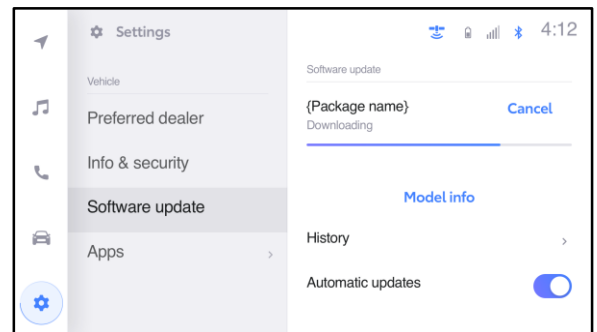
Figure 15.

8. Wait for the update to download.

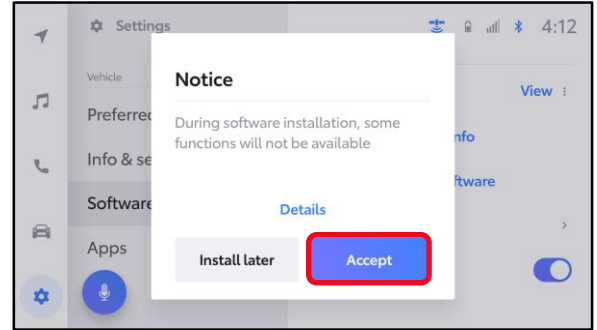
Figure 16.

9. Select Accept on the Notice pop-up message if it appears.

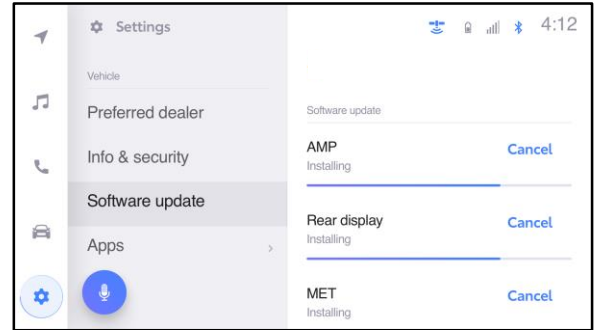
Figure 17.

10. Wait for the update to download. Once the head unit begins installation, the update will take 10 minutes or less.

- Do NOT turn OFF the engine or ACC BEFORE the software is ready for updating.
- Selecting Cancel will cancel the installation of the specific component, but it can be installed manually later.

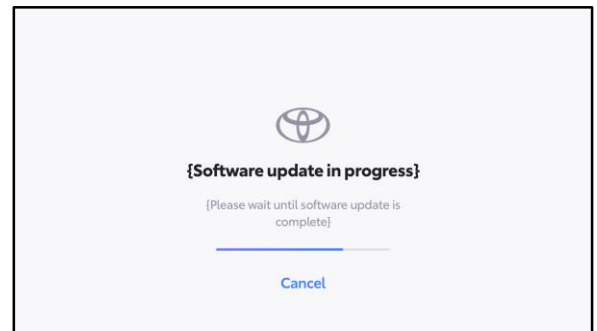
Figure 18.

11. If a major update is being installed the message "{Software update in progress}" will be displayed.

- Do NOT turn OFF the engine or ACC BEFORE the software is ready for updating.
- Selecting Cancel will cancel the installation of the specific component, but it can be installed manually later.

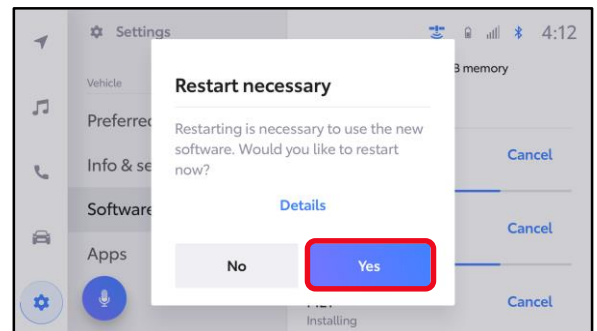
Figure 21.

- If a restart is necessary, select Yes to restart the head unit.

If No is selected or the vehicle is switched to IG-OFF, the installation will occur at the next IG-ON.

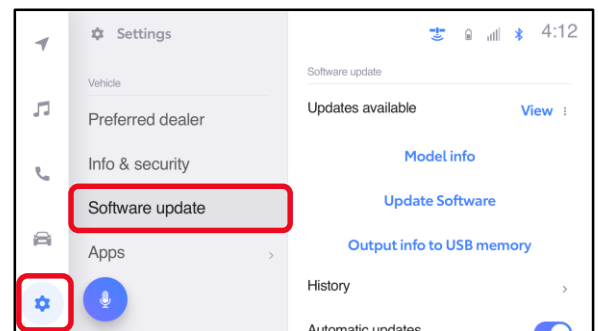
Figure 23.

- Select the gear icon and scroll down to Software update.

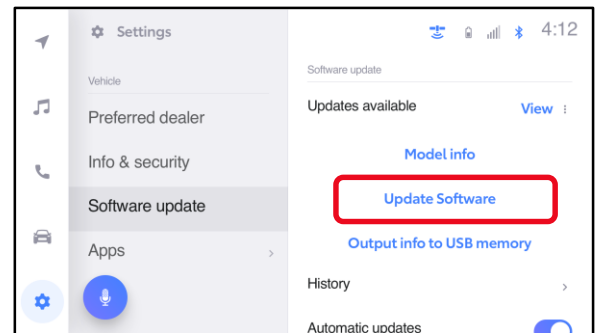
Figure 25.

NOTE
 The Update Software button may not be available immediately after inserting the USB flash drive. The head unit is unzipping the software update file, and it may take up to 10 minutes for this button to become available to press.

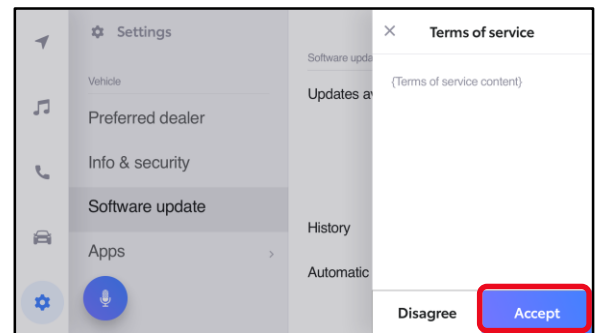
Figure 26.

5. Select Accept on the Terms of service screen.

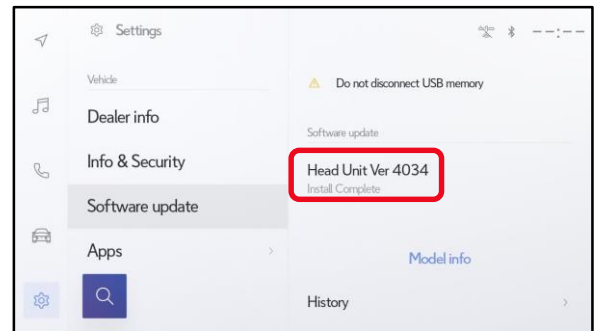
- A. When the update is complete, “Install Complete” will show on the head unit, as shown in Figure 28.
- B. The “Software update” pop-up message may also appear, as shown in Figure 29.

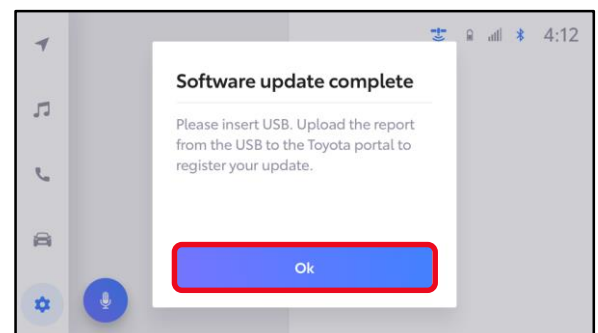
Figure 30.

If you are prompted to upload a report as shown in Figure 30, insert a blank USB to remove the .JSON files. These files are NOT needed at this stage of the process.
