Service Action Code: 93P7

Subject	HV Battery Cell Module(s)																		
Revision Date	May 16, 2023																		
REVISION SUMMARY	<p>Updated vehicle counts for USA only</p> <p>Added important cell module balancing instructions</p>																		
IMPORTANT! Battery Cell Evaluation/Replacement	<ul style="list-style-type: none"> Vehicles with CRITERIA 02 in ELSA have already been identified by the factory as requiring battery cell module replacement(s). Owners of these vehicles MUST schedule this service action directly with a certified Volkswagen battery repair dealer. Vehicles with CRITERIA 04 in ELSA can be scheduled for battery cell evaluation with any authorized Volkswagen dealer; however if the evaluation indicates battery cell replacement(s) is needed, the dealer performing the replacement(s) MUST be a certified Volkswagen battery repair dealer. 																		
Affected Vehicles

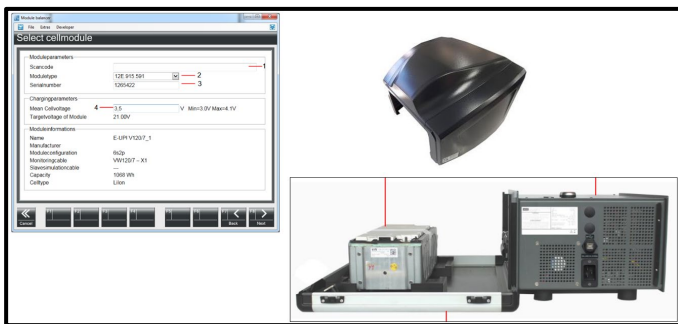
Perform cell balancing on new cell module:

- Check Measured Value Block (MVB) “maximum voltage for battery cells, IDE08217.
- The voltage reading listed will be entered in the DSS Manager program when balancing the new cell module.

- Follow the VAS6910 operating instructions in conjunction with the DSS Manager program to perform the cell balancing on the new cell module.

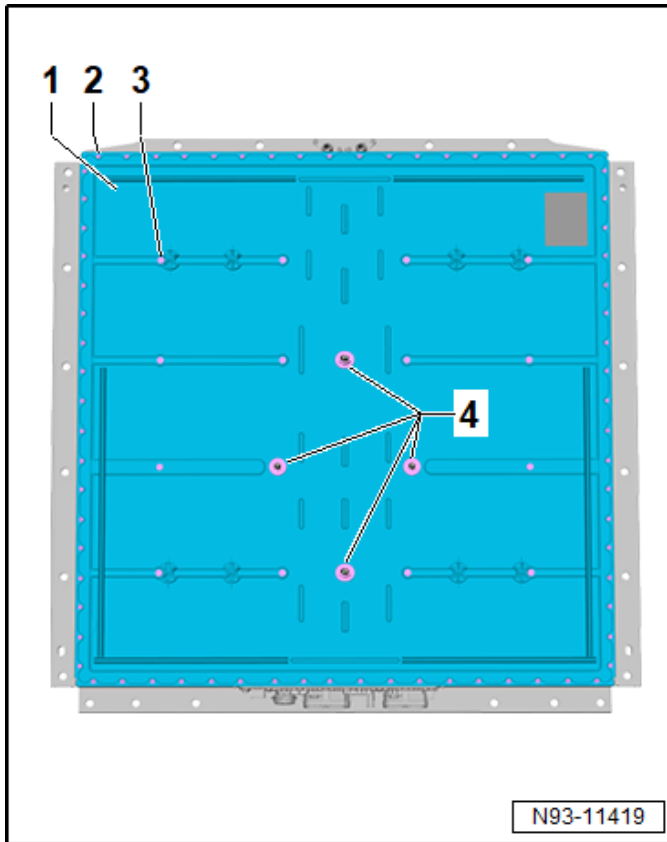
Clean high-voltage battery cover:

- Vacuum all loose dirt and debris from high-voltage battery.
- Clean the connection element threads using pipe brush -VAS294029- (or equivalent) as shown.

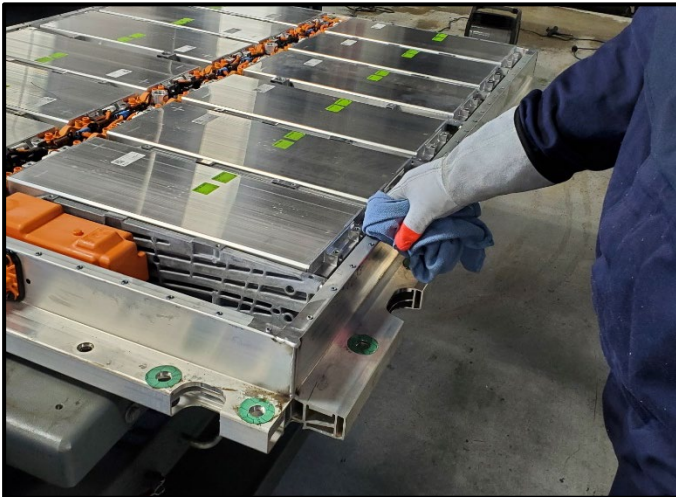
Perform insulation measurement:

- Perform insulation measurement according to ELSA Repair Manual: *Repair Manual > Motor > Electric Drive Rear Wheel Drive EIP220 and All Wheel Drive EIA200, EIP220 > 93 Electric drive > High-Voltage Battery Unit > Voltage and Insulation Measurement, 82 kWh*
- Perform the measurement in conjunction with ODIS test plan, "HV measurement module VAS6558/VAS6558A."

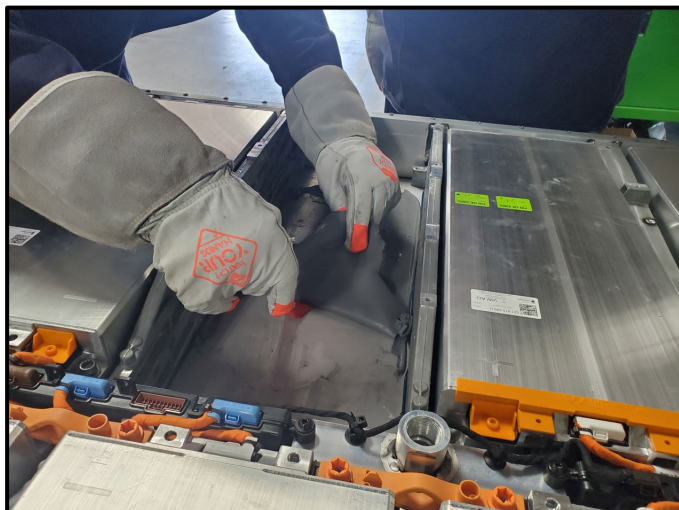
Remove the cell module:

- See ELSA Repair manual: *Repair Manual > Motor > Electric Drive Rear Wheel Drive EIP220 and All Wheel Drive EIA200, EIP220 > 93 Electric drive > High-Voltage Battery Components > Battery Module, Removing*
- Ensure the shock protection is installed on ALL open high-voltage connections.

The cell module can be freed from the adhesive bond from either end of the cell module.

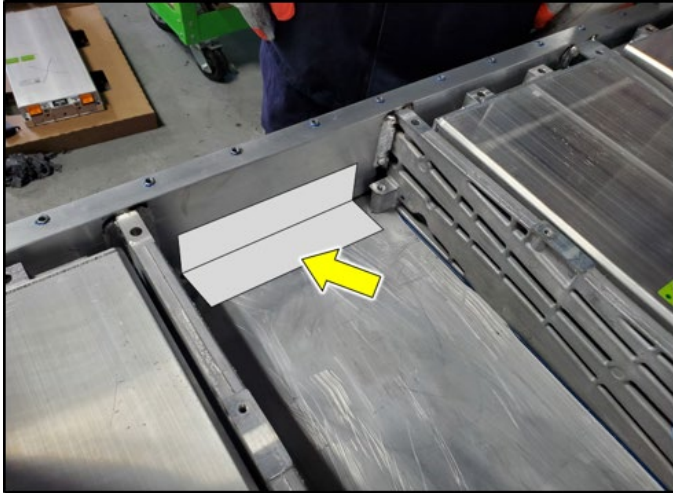
- Reference ELSA Repair manual: *Repair Manual > Motor > Electric Drive Rear Wheel Drive EIP220 and All Wheel Drive EIA200, EIP220 > 93 Electric drive > High-Voltage Battery Components > Battery Module, installing*
- Note the following when installing the new cell module(s):
- Peel off the protective backing and apply the separating foil <arrow> as needed along the outer frame edges, in the area where the cell module is mounted.

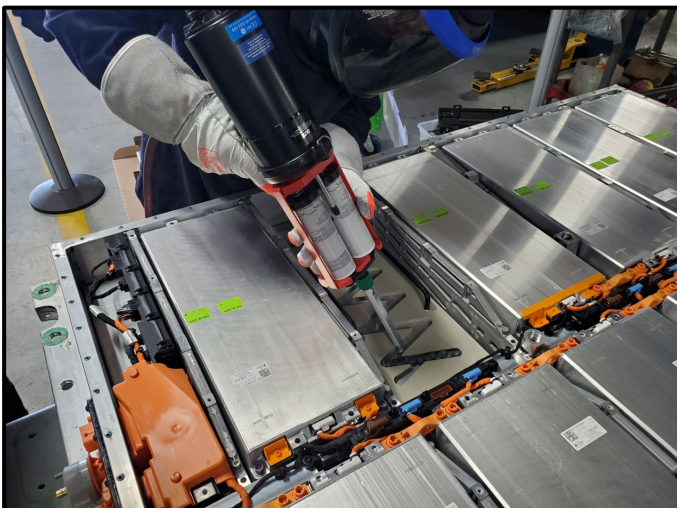
- Double check the expiration date of the paste before applying.
- Use Double Cartridge Adhesive Gun -VAS5237- to apply the heat paste.

- Before applying the heat paste, release a small amount through the applicator to ensure the paste is mixing properly.

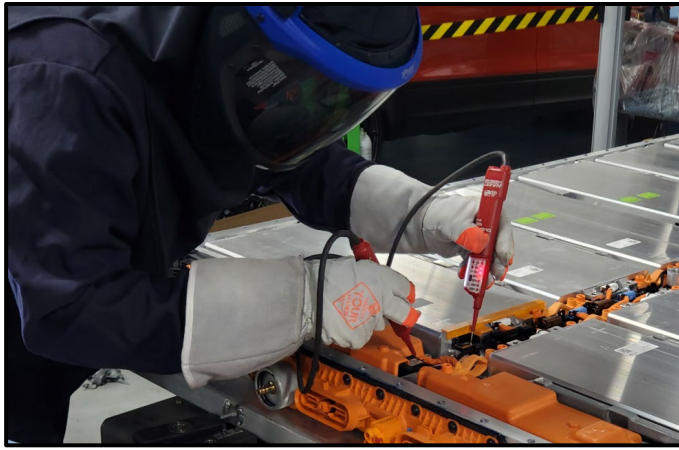
- Torque bolts <3> for the high-voltage connection <4> to 8 Nm.

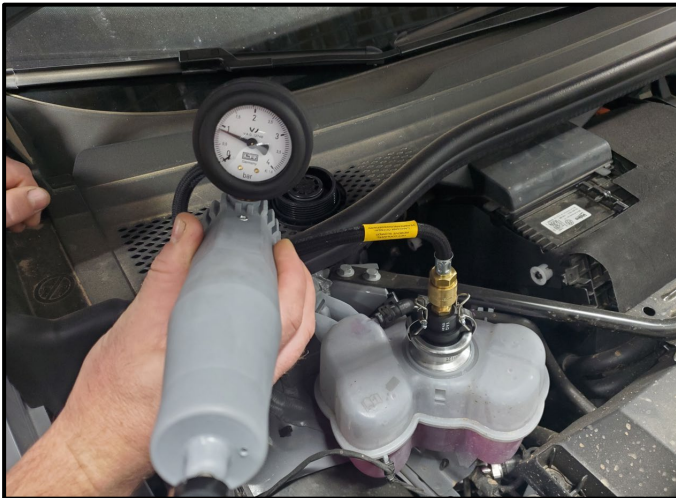
Fill cooling system

(option 1 – without VAS531011):

- Top off coolant.
- Select “Self Test” and populate test plan, “0001 – Fill/bleed cooling system.”

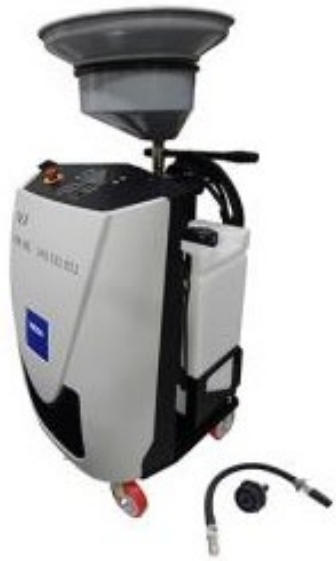
- Connect the Cooling System Tester -VAG1274B- and create a pressure of 1.0 bar using the hand pump.
- Run the test plan “0001 – Fill/bleed cooling system” and follow the on-screen prompts.
- Once the test is successfully completed, repeat the test plan a second time.
- Top off coolant.
