GROUP	MODEL
ELE	2019-2022MY Niro EV (DE EV)
NUMBER	DATE
293	May 2023

TECHNICAL SERVICE BULLETIN

SUBJECT: **BMS DTC JUDGEMENT LOGIC IMPROVEMENT**

This bulletin provides the procedure to update the software logic of the Battery Management System (BMS) on some 2019-2022MY Niro EV (DE EV) vehicles produced from December 5, 2018 through April 12, 2022. The BMS ECU monitors voltage deviation between battery cells, poor insulation, abnormal cell voltage changes after charging, abnormal current change during charging, over-voltage, temperature deviation or average cell deviation during driving is detected. These conditions can cause the BMU to set DTC P1AA600. The affected vehicles may exhibit a reduction in power and speed (limp home mode) and a MIL 'ON' with DTC P1AA600 stored. This BMS DTC logic improvement will expand DTC P1AA600 into multiple DTCs to aid in proper diagnosis, which reduces the required time and steps outlined in the 'DTC Inspection' on KGIS to determine the fault using 'freeze frame' data (refer to table below). Follow the procedure outlined in this publication to apply the improved logic to the 'BMS' system using the KDS ECU Upgrade function as described in this bu

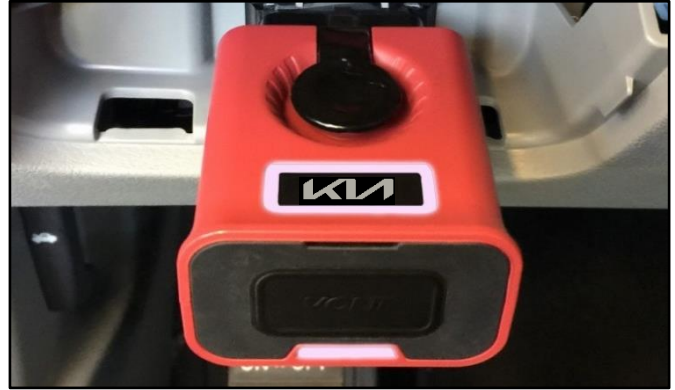
The ECU upgrade function on KDS operates wirelessly. It is not necessary to perform the upgrade via USB cable.

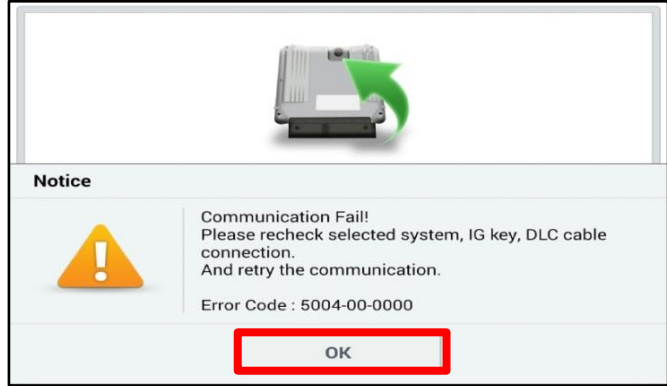
- If a "Communication Fail" screen appears, verify that the VCI-II and KDS are communicating properly. Select 'OK' and restart the from step 4.

If an error notice continues to appear or if the upgrade cannot be performed, DO NOT disconnect the KDS/VCI-II. Contact GIT America Help Desk at (888) 542-4371 or Techline.
