GROUP	MODEL
ELE	2022-2023MY EV6 (CV)
NUMBER	DATE
290 (Rev 1, 05/24/2023)	April 2023

TECHNICAL SERVICE BULLETIN

SUBJECT: BMS DTC JUDGEMENT LOGIC IMPROVEMENT (P1AA600)

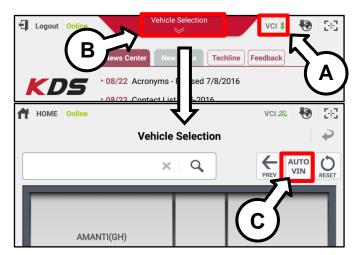
Confirm communication with VCI (A) and then configure the vehicle (B) using the 'AUTO VIN' (C) feature.
