HYUNDAI Technical Service Bulletin	GROUP CAMPAIGN	NUMBER 23-01-043H
	DATE MAY, 2023	MODEL(S) IONIQ 6 (CE1)
SUBJECT: IONIQ 6 (CE1) SMART APPROACH UNLOCK SYSTEM (IBU UPDATE) (SERVICE CAMPAIGN TAE)

This bulletin provides the service procedure to update the IBU (Integrated Body Control Unit) software to resolve the condition stated above.

IBU-BCM SOFTWARE UPDATE PROCEDURE

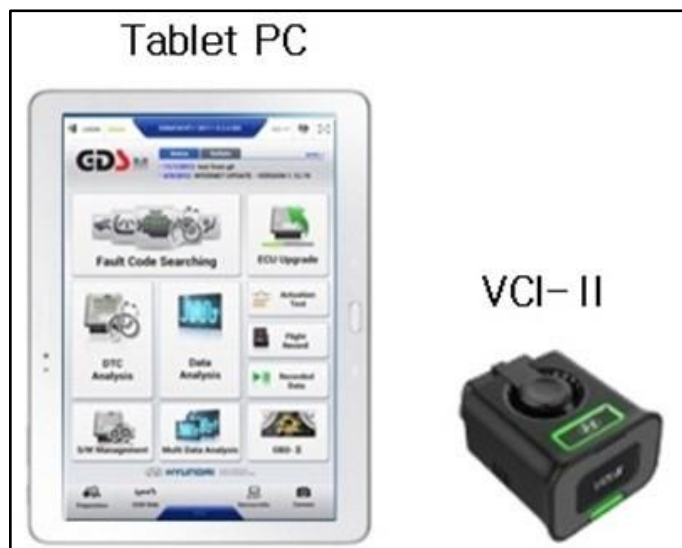
ECU upgrade function on GDS-Mobile is basically operating in wireless communication and Wi-Fi direct. Also, it is possible to be performing via USB cable between Tablet PC and VCI-II.

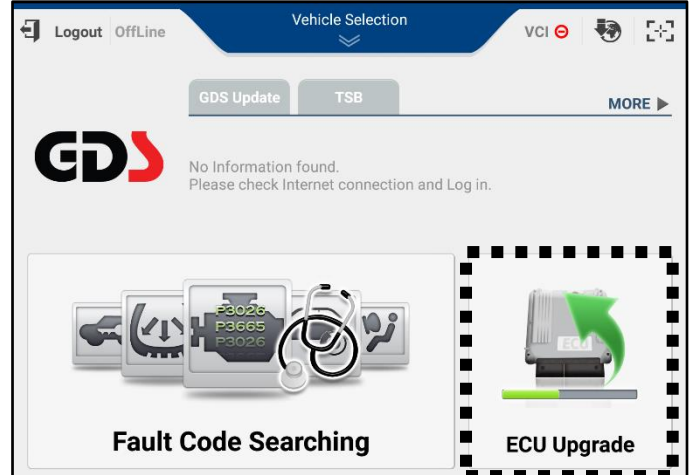
- 2. Select ECU Upgrade on the initial screen after entering the vehicle information and select Auto Mode.

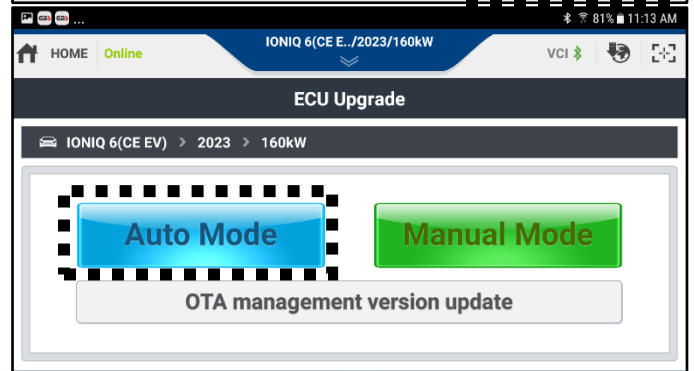
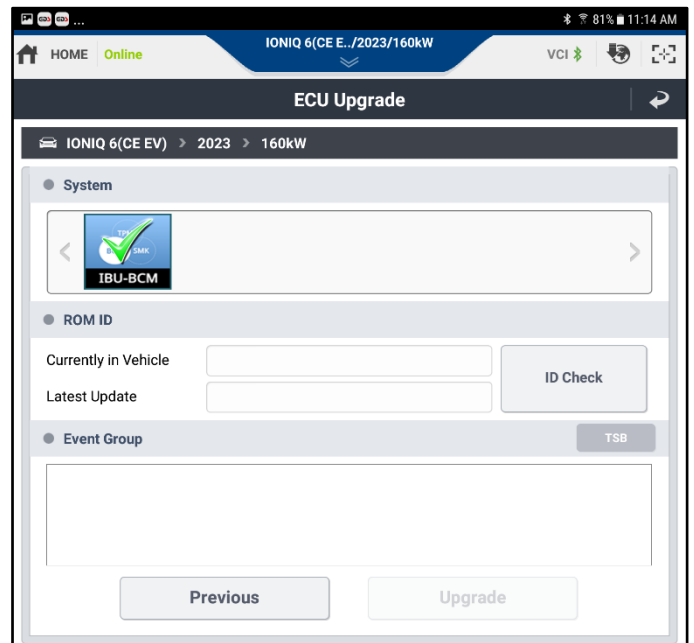
- 3. Select IBU-BCM system.

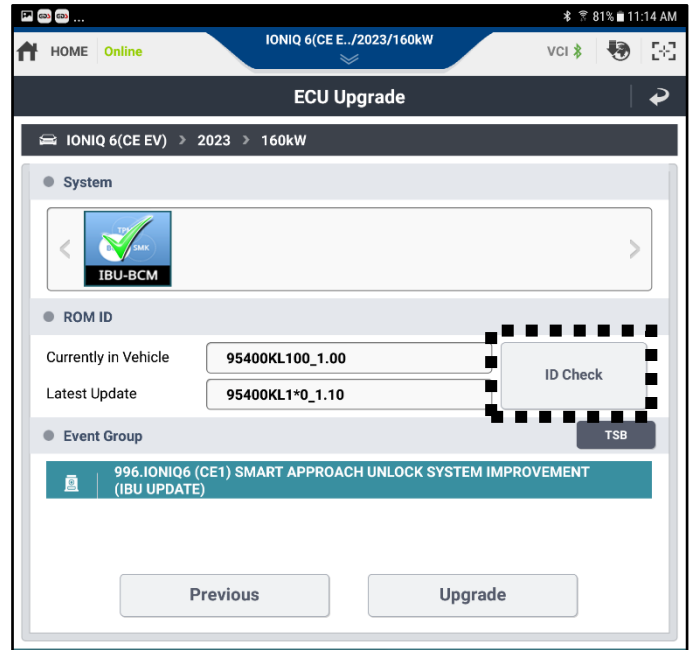
4. Select **ID Check** and GDS will read the current ROM ID in vehicle and check the newest upgrade event.

Check the current version of the IBU-BCM ROM ID and compare it to the ROM ID Information Table before attempting to perform the software update.

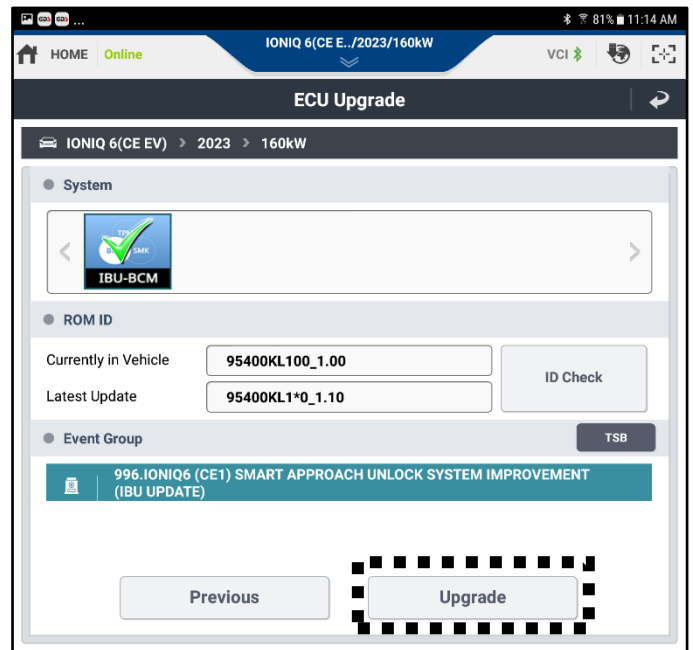
5. Select **Upgrade** after confirming correct Event is selected.

"996.IONIQ6 (CE1) SMART APPROACH UNLOCK SYSTEM IMPROVEMENT (IBU UPDATE)"

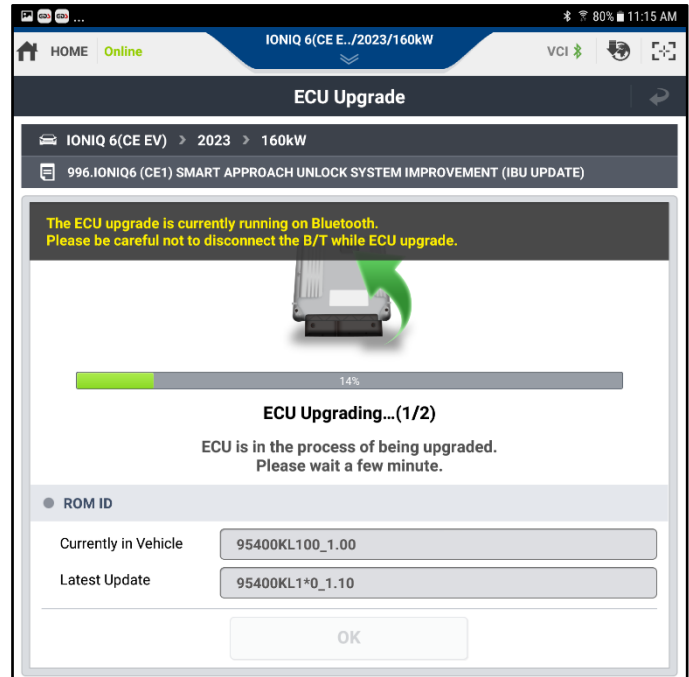
7. Upgrade (1/2) will begin, and the progress of the upgrade will appear on the bar graph.

Upgrade (1/2) will occur until 100% is reached on the bar graph.

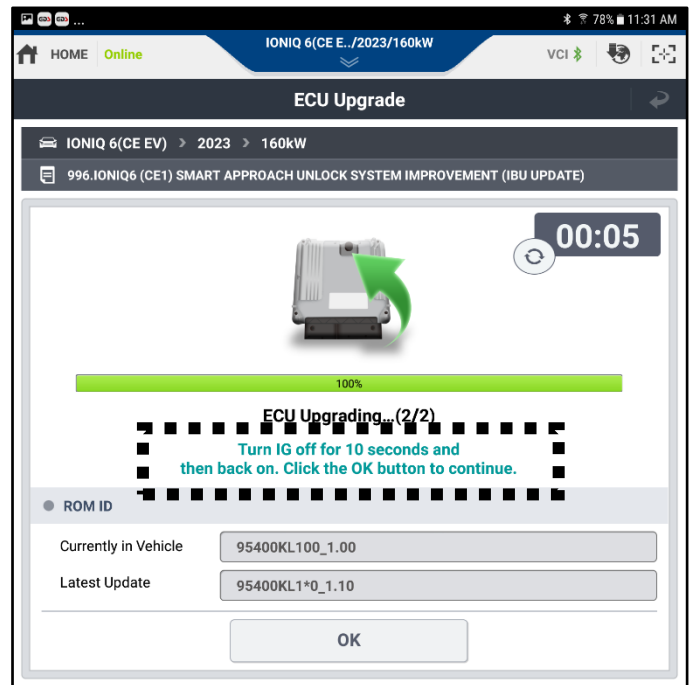
8. Upgrade (2/2) will begin, and the progress of the upgrade will appear in the bar graph.

Upgrade (2/2) will occur until 100% is reached on the bar graph.

When upgrade reaches 100%, follow GDS instructions to "Turn IG off for 10 seconds and then back on. Click the OK button to continue."

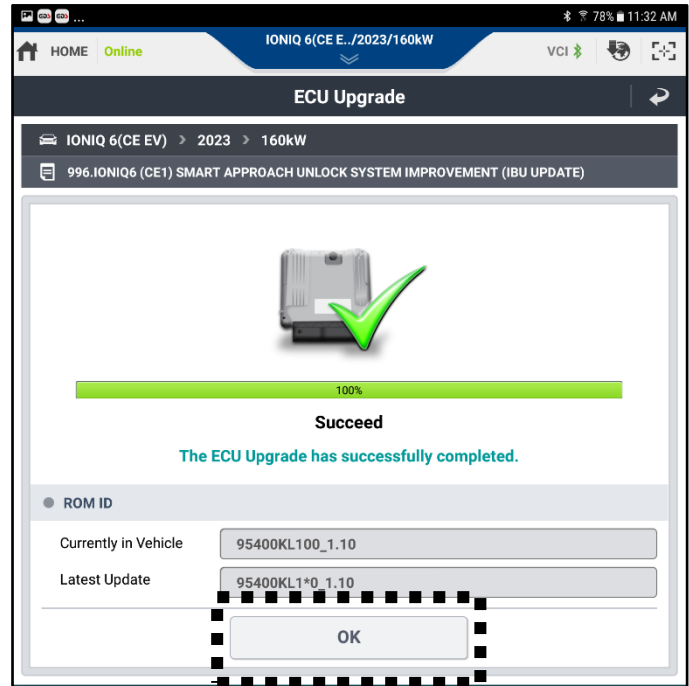
- 9. Click **OK** on the final screen, which indicates upgrade is complete.

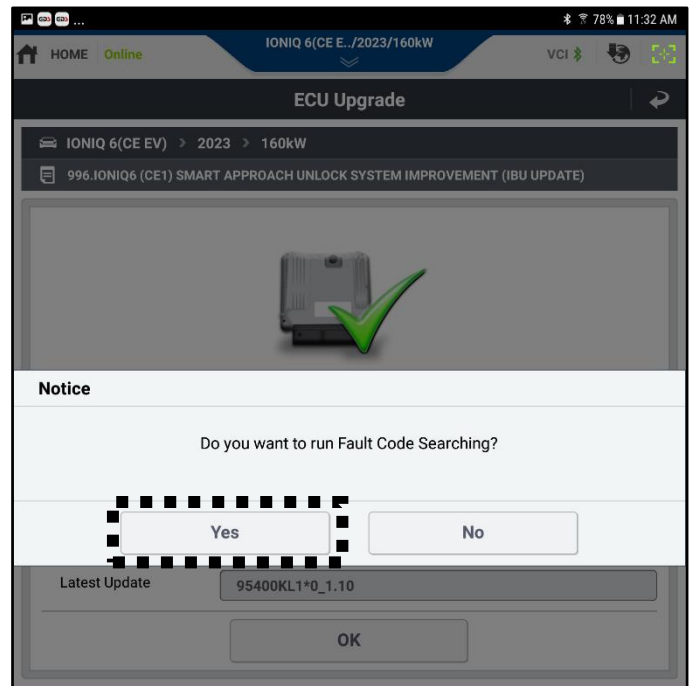
- 10. Check if any incidental Diagnostic Trouble Codes (DTC) have been created by the upgrade and clear the DTC(s) present.

Start the engine to confirm proper operation of the vehicle. Stop engine and exit vehicle to confirm proper operation of the smart approach unlock.

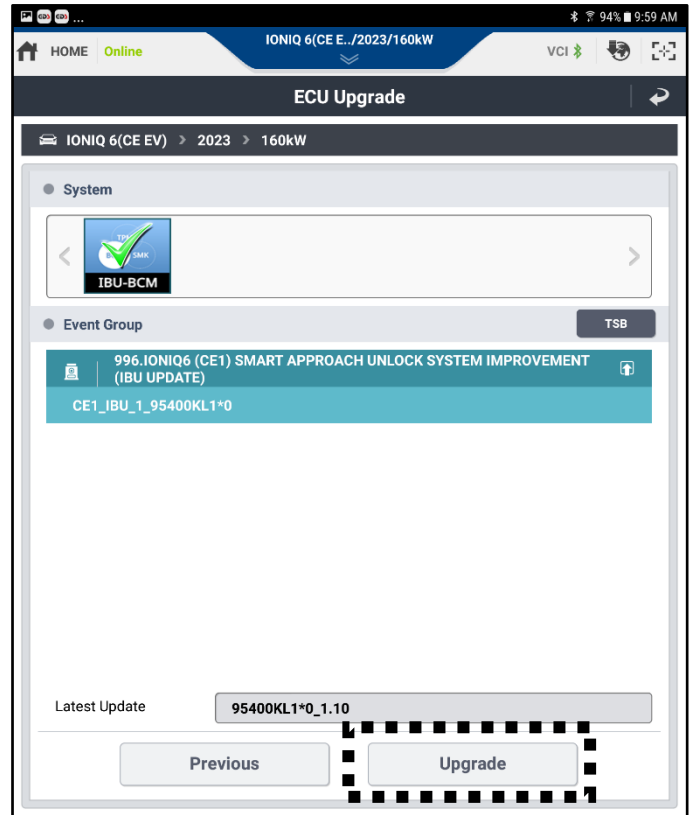
13. Check that the newest event with reference to the above ROM ID Information Table is selected and select **Upgrade**.

"996.IONIQ6 (CE1) SMART APPROACH UNLOCK SYSTEM IMPROVEMENT (IBU UPDATE)"

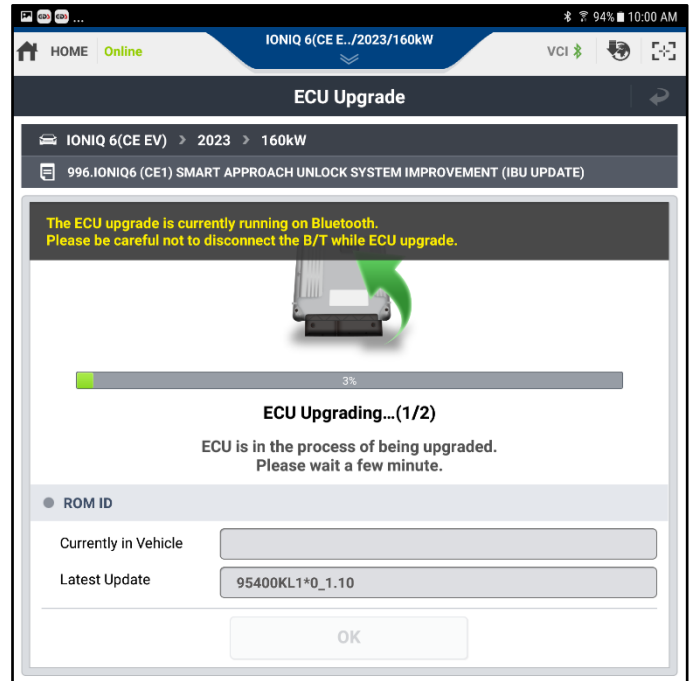
16. Upgrade (1/2) will begin, and the progress of the upgrade will appear on the bar graph.

Upgrade (1/2) will occur until 100% is reached on the bar graph.

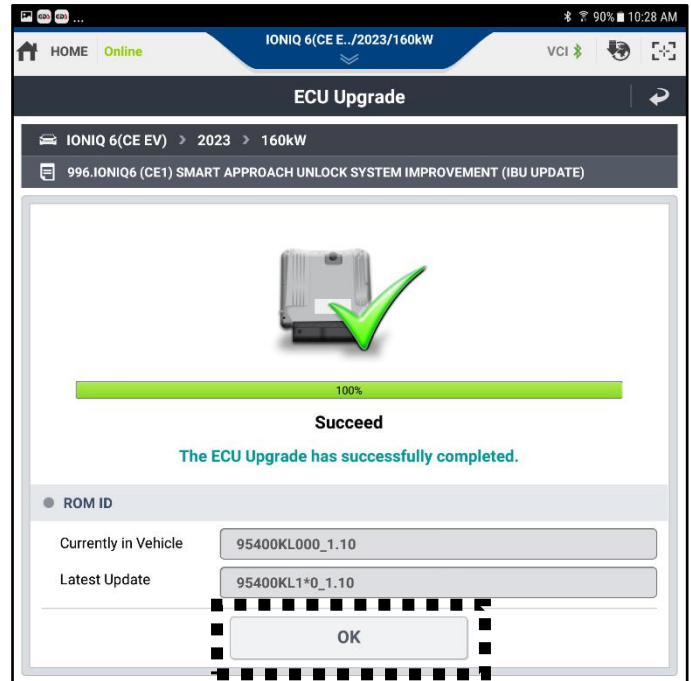
- 18. Click **OK** on the final screen, which indicates upgrade is complete.

Check the ICU ROM ID and compare it to the ROM ID Information Table to confirm latest ROM ID was updated.

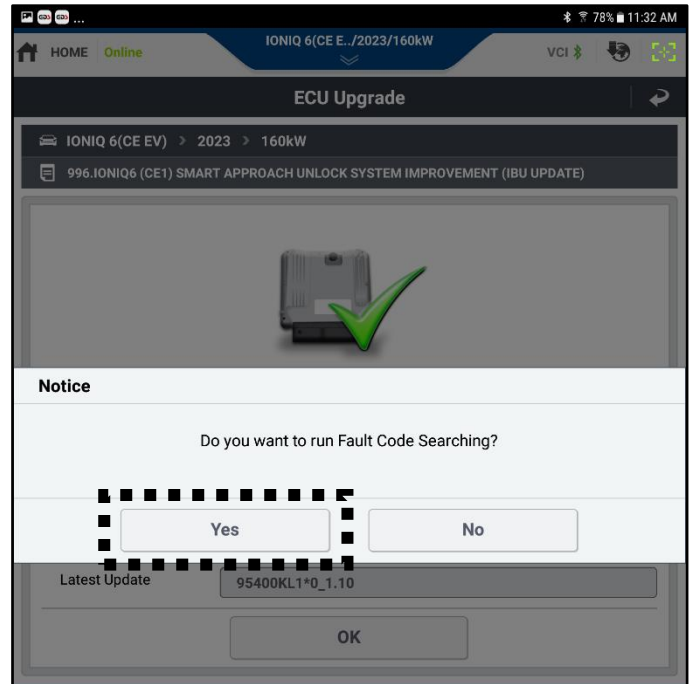
- 19. Check if any incidental Diagnostic Trouble Codes (DTC) have been created by the upgrade and clear the DTC(s) present.

Start the engine to confirm proper operation of the vehicle. Stop engine and exit vehicle to confirm proper operation of the smart approach unlock.
