2011, 2013MY Sportage (SL) w/2.4L MPI

PI2103 (Rev 1, 06/26/2023)

SUBJECT: THETA 2.4L MPI - KNOCK SENSOR DETECTION SYSTEM (KSDS) ECU LOGIC IMPROVEMENT (PI2103)

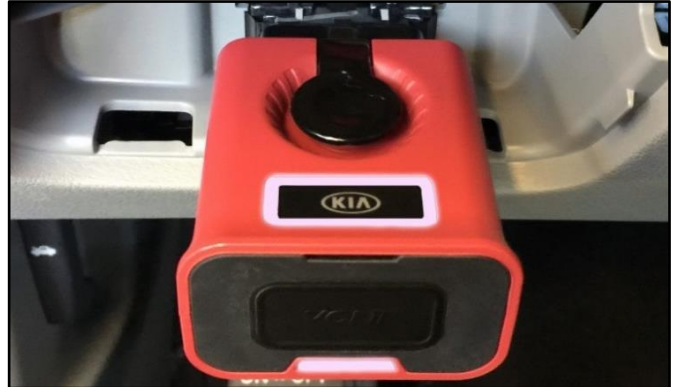
2. With the ignition ON, turn ON the KDS tablet. Select **KDS** from the home screen.

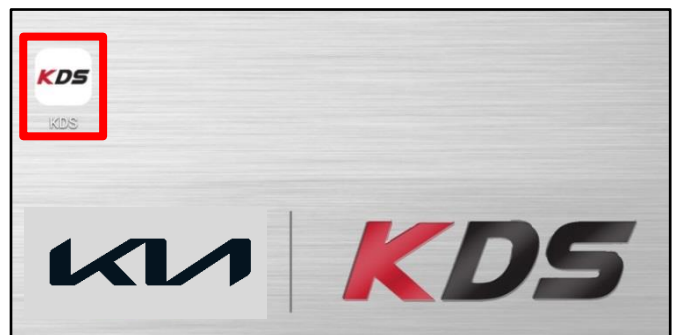
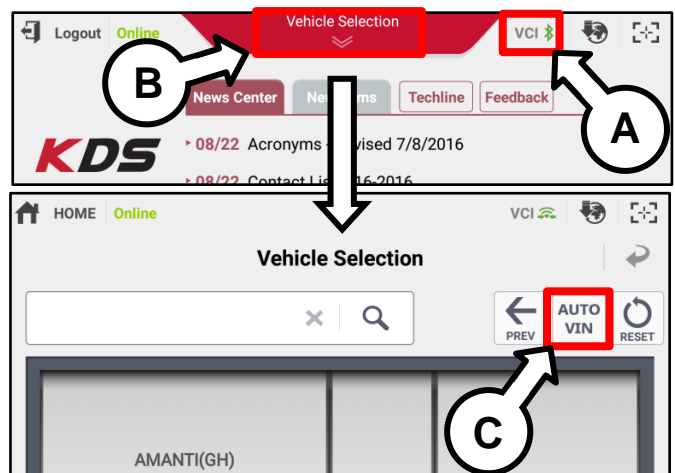
3. Confirm communication with VCI (A) and then configure the vehicle (B) using the **AUTO VIN** (C) feature.

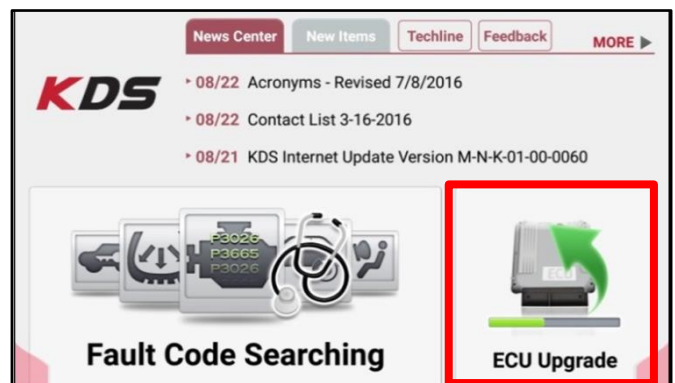
4. Select **ECU Upgrade**.

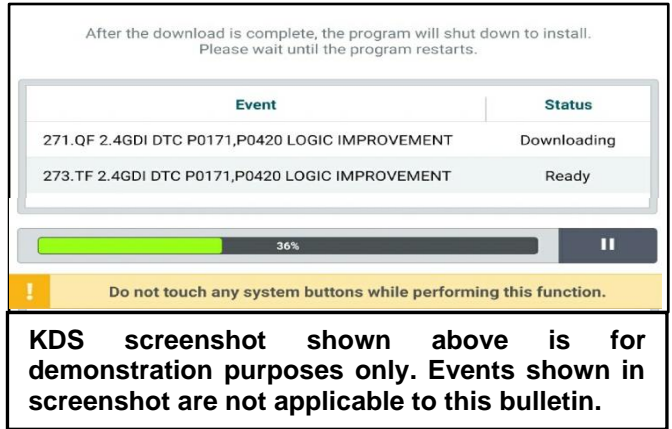
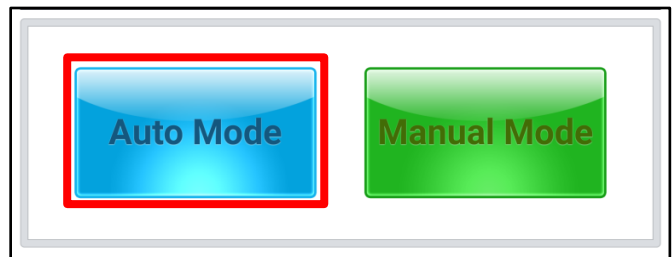
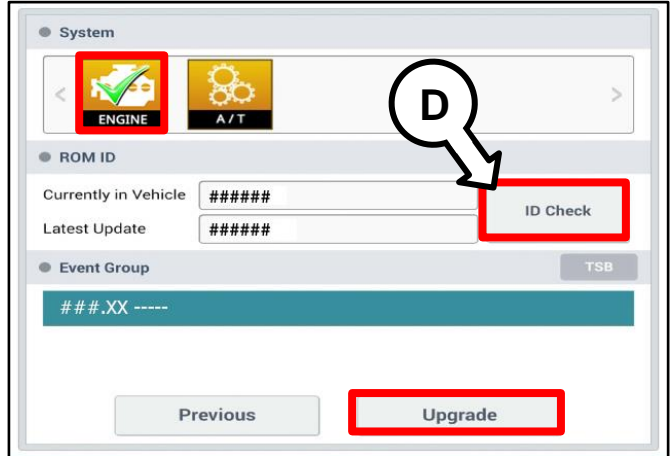
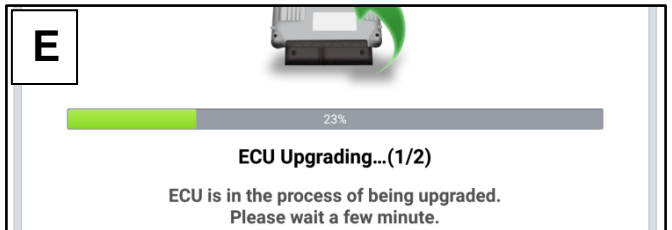
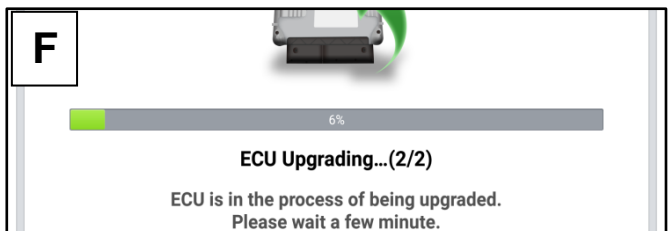
- The KDS will check the server for recently uploaded Events and then automatically download **Upgrade Event #548**.

- Select **Auto Mode**.

- Select the **ENGINE** system under the System selection menu.

Touch **ID Check** (D) and confirm that the latest update is available.

Select **Upgrade Event #548** and select **Upgrade** to continue.

- The ECU upgrade will begin and the progress of the upgrade will appear on the bar graph. Upgrade part (1/2) (E) will download the upgrade event to the VCI-II. Upgrade part (2/2) (F) will upgrade the ECU.

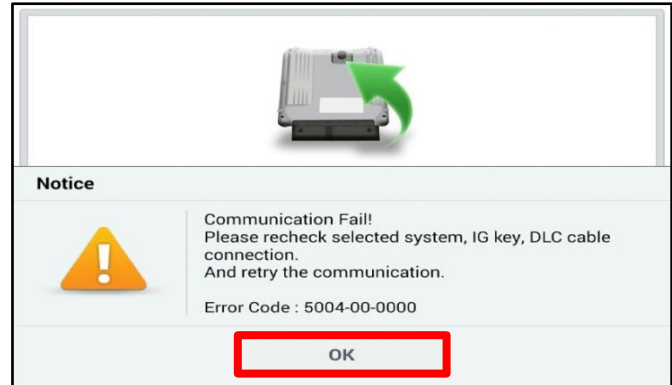
9. If a “Communication Fail” screen appears, verify that the VCI-II and KDS are communicating properly. Touch **OK** and restart the procedure from step 4.

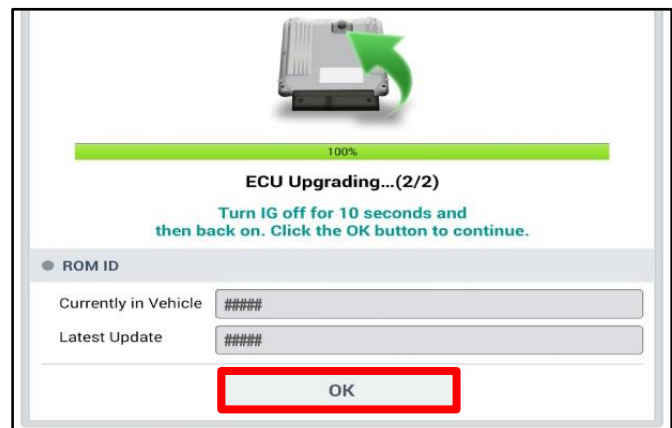
10. When instructed on the KDS, turn the ignition **OFF** for ten (10) seconds then back on. Touch **OK** to continue.

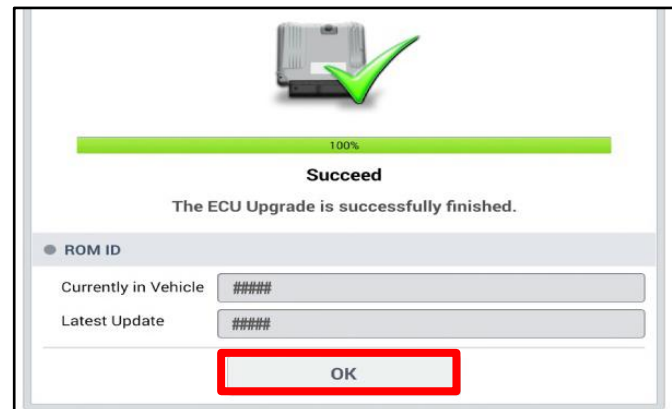
11. Once the upgrade is complete, touch **OK** to finalize the procedure.

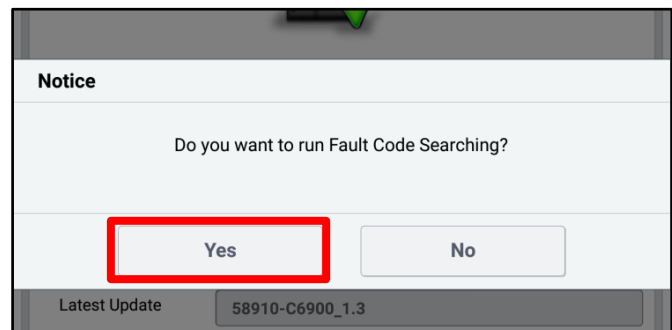
12. When prompted, select **YES** to check for Diagnostic Trouble Codes (DTC) and erase any DTCs stored such as EPS, ESC, and TPMS that may have been set during the upgrade.
