June 2023  
SF672 A-B

## Subject: Common Telematics Platform Software Update

**Models Affected: Specific model years 2018-2024 Freightliner 108SD, 114SD, M2 106, Cascadia, eCascadia; and Western Star 47X, 48X, 49X, 57X vehicles, manufactured February 10, 2017, through March 3, 2023.**

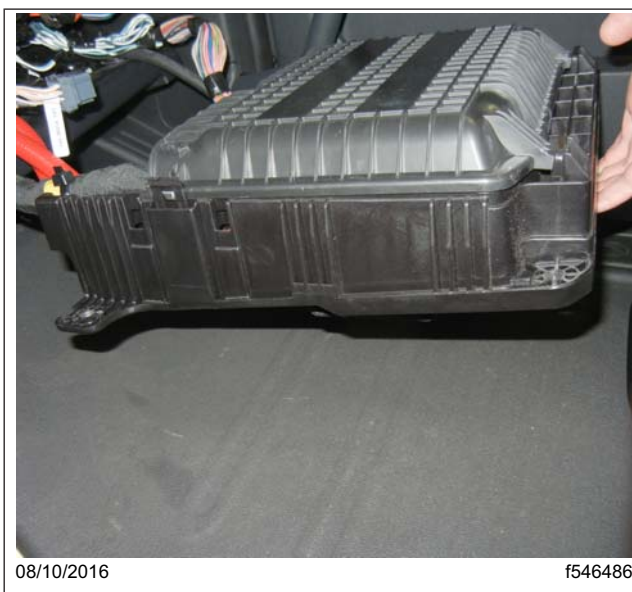
**Fig. 11, Lowering the VPDM to the Cab Floor**

13. Remove the four VPDM mounting fasteners, then gently lower the VPDM on to the cab floor. See [Fig. 11](#).

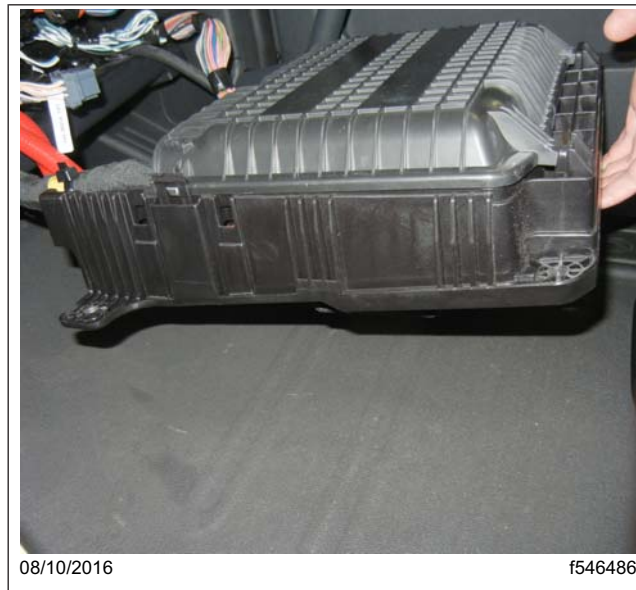
**Fig. 27, Lowering the VPDM to the Cab Floor**

13. Remove the four VPDM mounting fasteners, then gently lower the VPDM on to the cab floor. See [Fig. 27](#).
