SERVICE CAMPAIGN BULLETIN

SUBJECT: ENGINE ECU REPROGRAMMING FOR MIL-ILLUMINATION ON 2022-2023 OUTLANDER WITH AWD		No: SC-23-001	
		DATE: June 2023	
		MODEL: 2022-2023 Outlander	
CIRCULATE TO:	<input type="checkbox"/> GENERAL MANAGER	<input checked="" type="checkbox"/> PARTS MANAGER	<input checked="" type="checkbox"/> TECHNICIAN
<input checked="" type="checkbox"/> SERVICE ADVISOR	<input checked="" type="checkbox"/> SERVICE MANAGER	<input checked="" type="checkbox"/> WARRANTY PROCESSOR	<input type="checkbox"/> SALES MANAGER

This bulletin provides instructions to reprogram the Engine ECU software for MIL illumination on 2022-2023 Outlander with AWD.

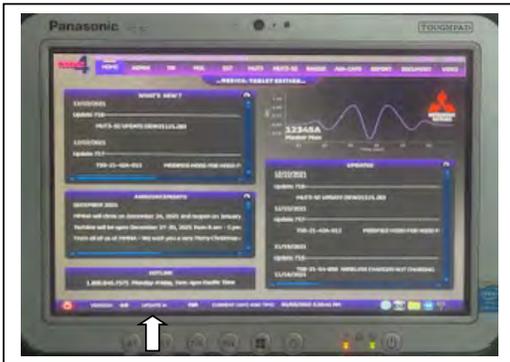
2. Verify the MEDIC 3.5/4 is at version 3.5 and at update **798** or higher.
If your **MEDIC 3.5/4 update is at least 798**, continue with the Reprogramming Procedure. If your **MEDIC 3.5/4 update is below 798**, update your MEDIC as follows:

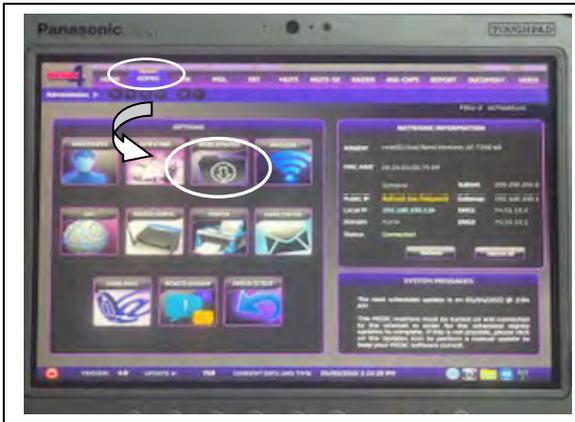
3. Select the MEDIC 3.5/4 Admin tab and click on "Updates".

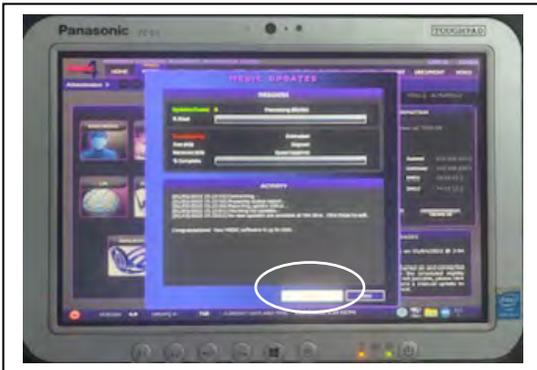
4. If the MEDIC update screen advises updates are available, click the "Begin" button. After all updates are complete, **GO TO THE REPROGRAMMING PROCEDURE.**

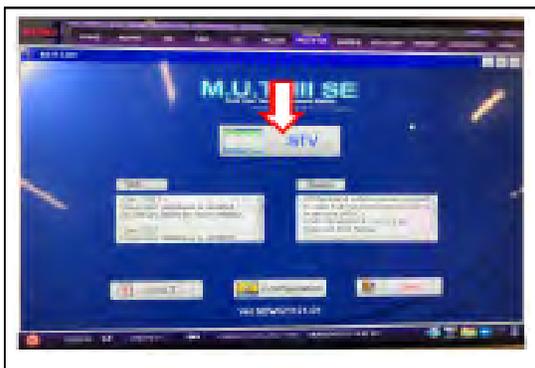
- a. Press the MUT-III SE STV icon.

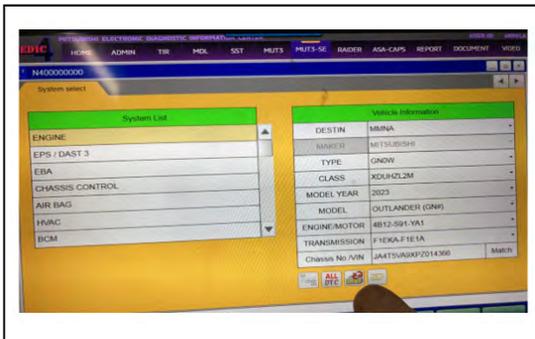
b. Press the Reprogramming button once the vehicle information is entered.

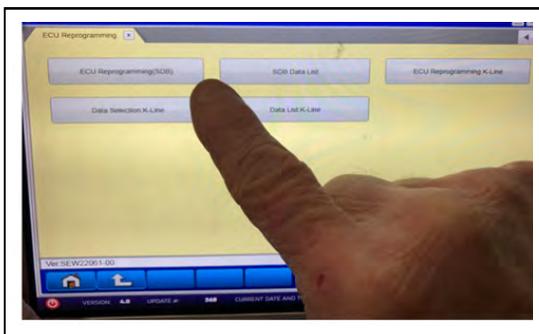
c. Press "ECU Reprogramming (SDB)" button.

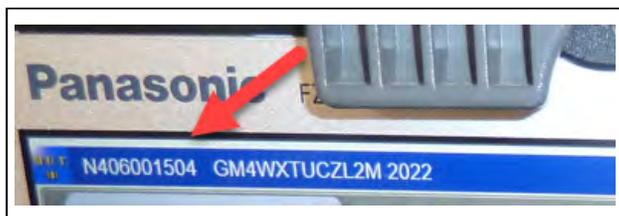
d. Confirm that the database number displayed in the upper right above the chart is **N406001504** or higher.

- i. If the database number displayed on your MUT-III SE is **798** or greater, continue to the next section.
- ii. If the reprogramming database number displayed on your MUT-III SE is lower than **798**, then the MUT-III SE database needs to be updated.
- iii. Once the database number is confirmed, hit the Home button to go back to the System Select screen.

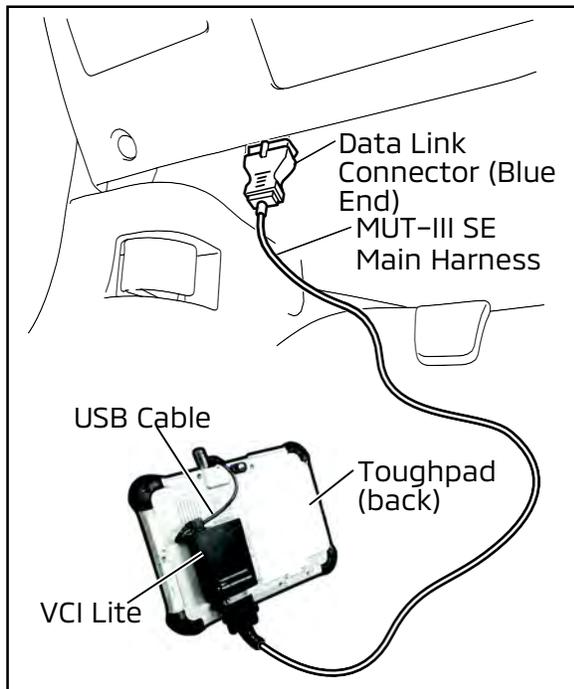
1. Connect the equipment as follows:

NOTE: VCI Lite and MEDIC 4.0 Toughpad shown for illustration purposes only.

- Turn the MEDIC PC/tablet on. If the battery indicator in the lower right hand corner of the screen does not show a full charge, it is recommended that either the battery be charged prior to beginning or be used with the A/C power adaptor connected.
- Connect the USB cable to the VCI/VCI Lite. When the laptop/tablet displays the MUT-III SE main screen, connect the USB cable to the device.
- Connect the MUT-III SE main harness with the blue DLC connection to the VCI/VCI Lite. Connect the blue connection of the MUT-III SE main harness to the vehicle's data link connector.
- For VCI only: Turn the VCI power switch ON. Verify that the indicator lamp in the upper right corner of the screen is green.

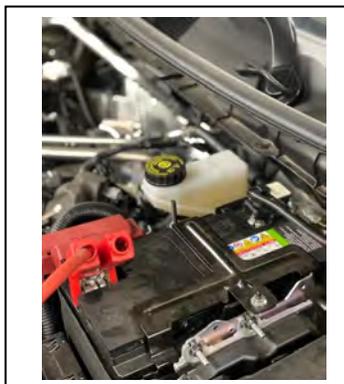
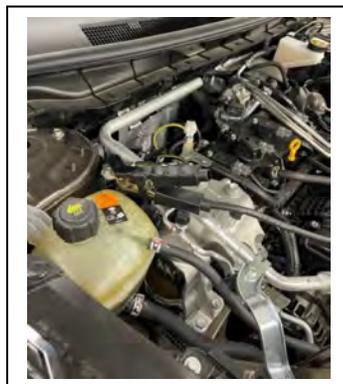
NOTE: Due to limited space it may be easiest to connect battery charger cable onto ground point.

To ensure that the vehicle battery maintains 12V during the procedure, hook-up a battery charger to the vehicle during the procedure.

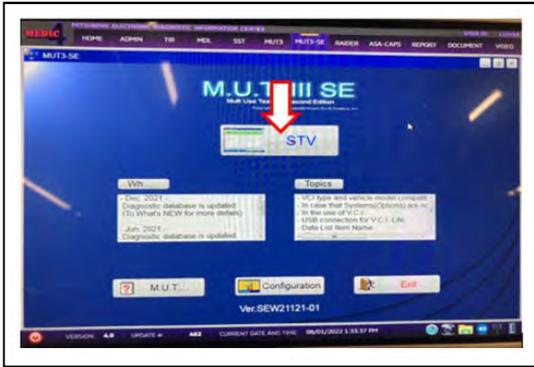
a. Press MUT-III SE STV icon.

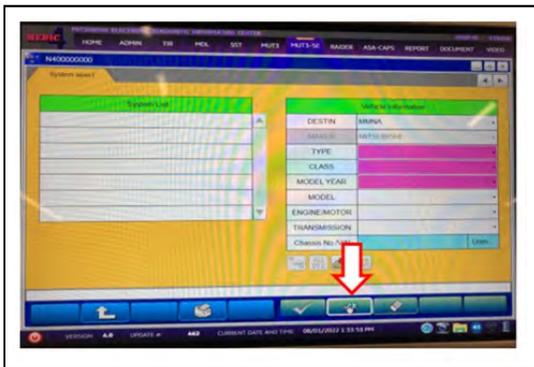
b. Press the model information display button (car icon) and verify all vehicle info is correct.

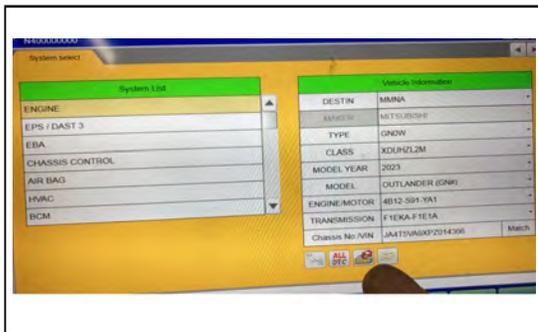
c. Select Engine and press the reprogramming icon button.

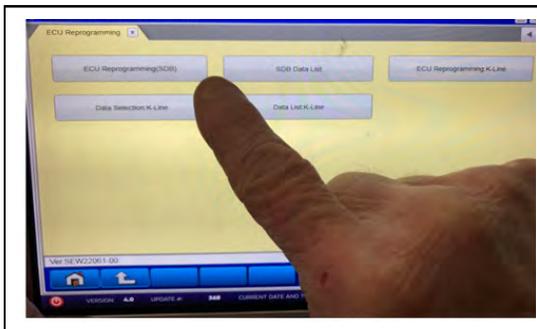
d. Press the "ECU reprogramming" (SDB) button.

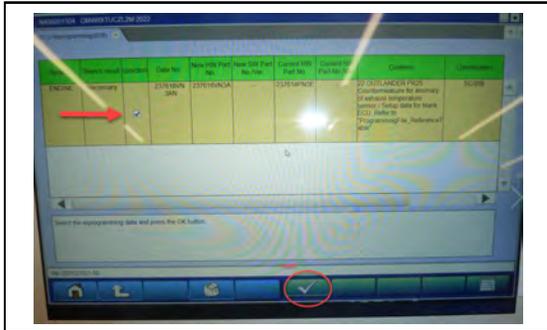
- e. The Automatic ECU Reprogramming (SDB) database screen will display. Press the OK button.
- Verify the correct software is listed in the table.

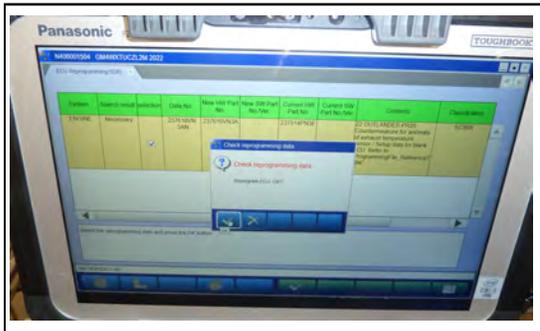
- f. Press the OK button and type AS2 account information to start the reprogramming.

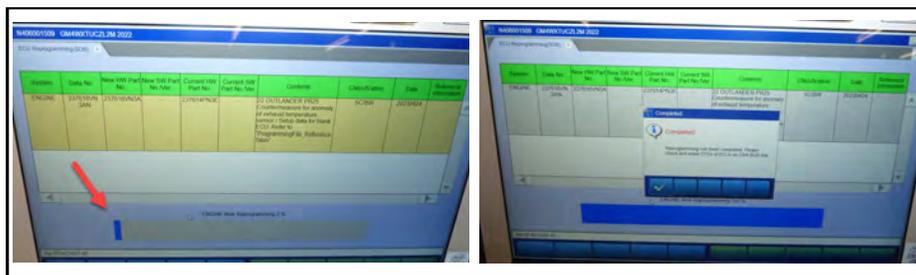
- g. Once the reprogramming is initiated the screen (shown below) will indicate the reprogramming progress. It may take up to 10 minutes to complete.

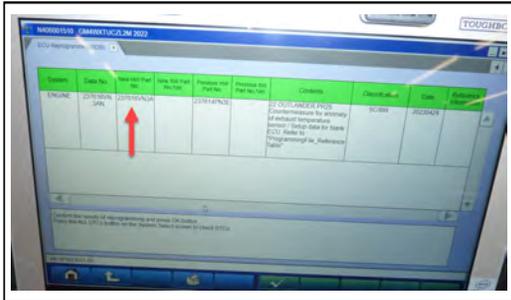
h. Verify that the software version has been updated to the new data number.

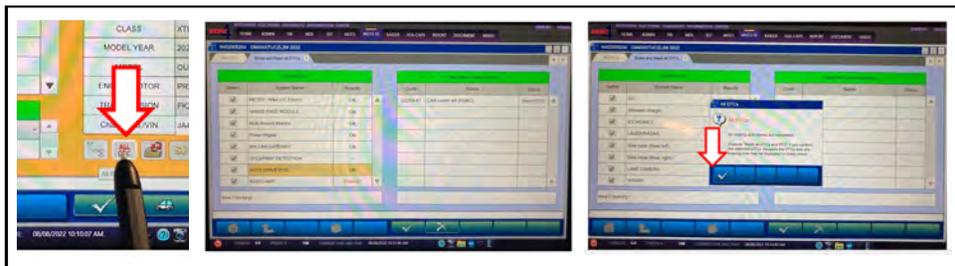
i. Press "ALL DTC" button to initiate the "Erase and Read all DTCs". Press OK when complete.

IMPORTANT: The "Erase and Read all DTCs" must be performed since DTCs may be generated and stored.

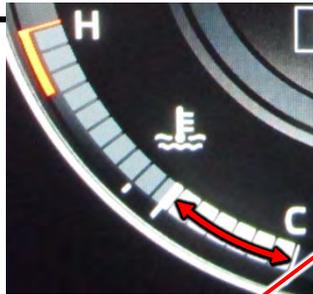
<Rough indication of 70°C/158°F at water temperature gauge>

[Classic mode]

12.3" Full Digital Driver Display

- The learning condition is water temperature of 70°C/158°F or higher. Carry out warm up driving if the water temperature is below 70°C/158°F.

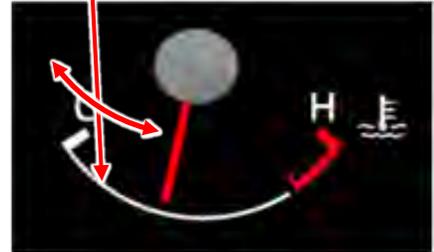
Rough indication of water temperature

7.0" Multi-information Display

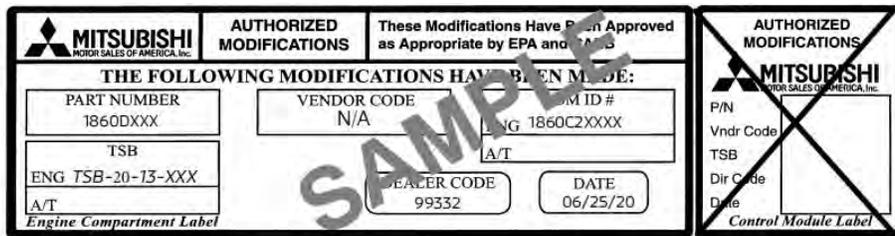
6. Using a ball-point pen, enter the appropriate ECU part number, Software Part Number (ROM ID#), this Technical Service Bulletin number, your dealer code, and the current date on the Engine Compartment/Control Module Label (p/n MSSF024G00). The Vendor Code is not applicable. The label is available from your facing PDC.
