CUSTOMER SATISFACTION NOTIFICATION

Radio Software Update

FCA US LLC

Reference: ZD7

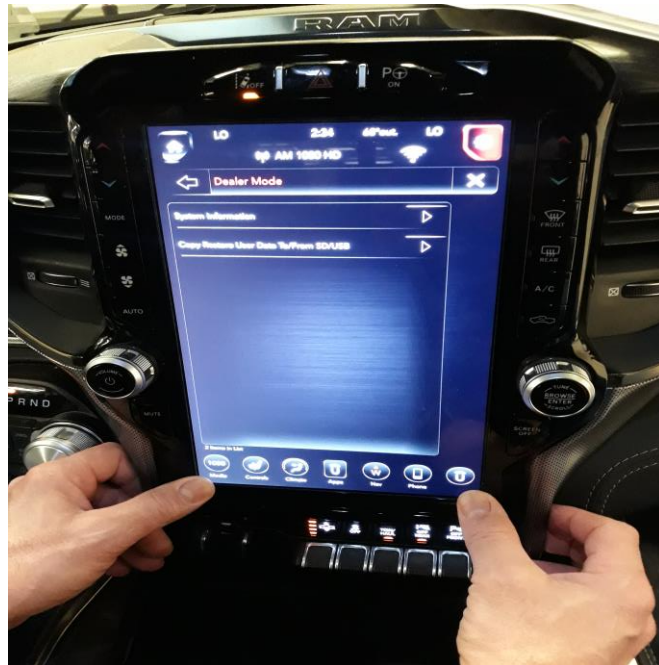
Figure 1 – Display Screen

1. Using the radio touch screen, simultaneously place both thumbs on the corners of the touch screen and hold for approximately 6 seconds or until the “Dealer Mode” screen is displayed (Figure 1).

2. Select “System Information”.
3. Select “Radio Part Information”.
4. Read “Application Version”.
5. Verify that the software version is at PR40.1 or above for 12” radio QR40.1 above for 8.4” radio.

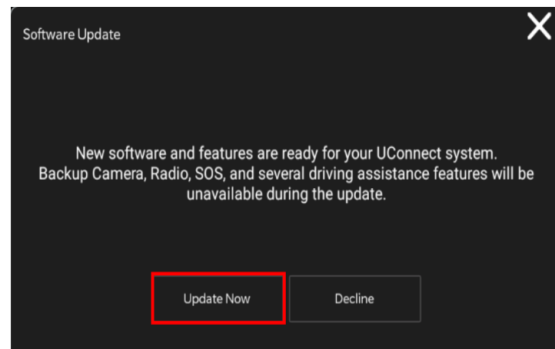
Figure 1

1. Start Engine
2. Insert the provided USB into the vehicles USB media port.
3. Display screen will display “Update Now” or “Decline” (Figure 1).
4. Select “Update Now” to update the radio software (Figure 1).
5. “Updating” screen will display (Figure 2).
