Technical Service Bulletin

GROUP BODY ELECTRICAL	NUMBER 23-BE-005G
DATE JULY 2023	MODEL(S) GV60 (JW1)

SUBJECT: IAU LOGIC – SOFTWARE ENHANCEMENT (OTA)

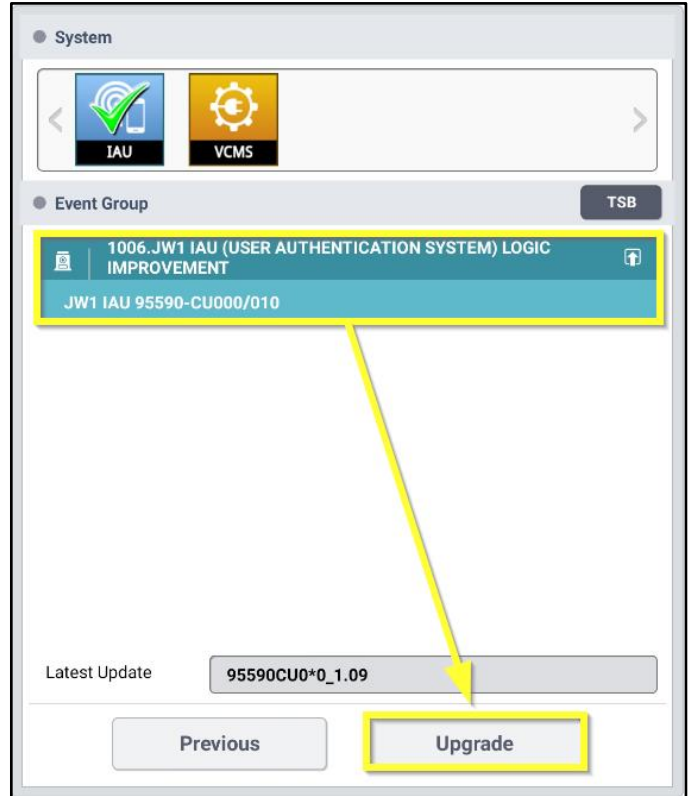
2. Under System, select **IAU** to generate the Event Group.

- After selected, Event group will display for #1006.

Confirm the ROM ID is correct from the Information Table listed above and proceed with **Upgrade**.

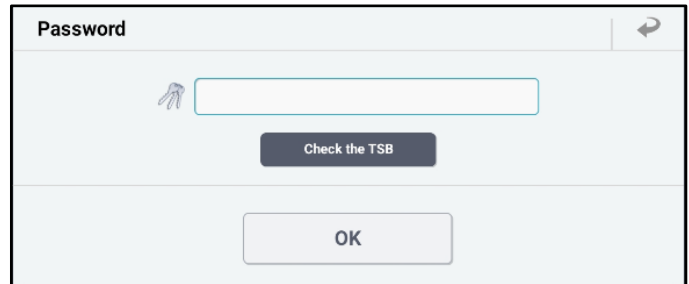
- Enter the password from the below table then touch OK.

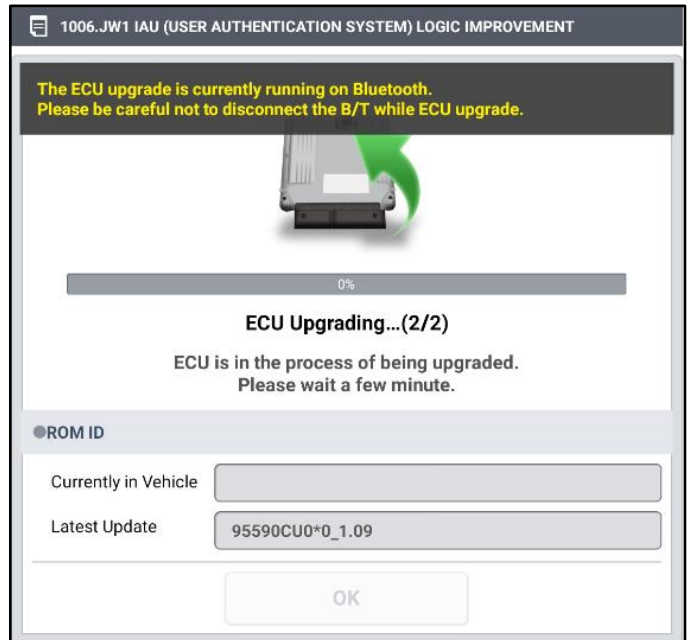
- 7. Upgrade (2/2) will begin and the progress of the upgrade will appear in the bar graph.

Upgrade (2/2) will occur until 100% is reached on the bar graph. Turn the vehicle off for 10 seconds by pressing the Start/Stop button, place it back in the key on position and then tab OK to continue according to information displayed on the screen.

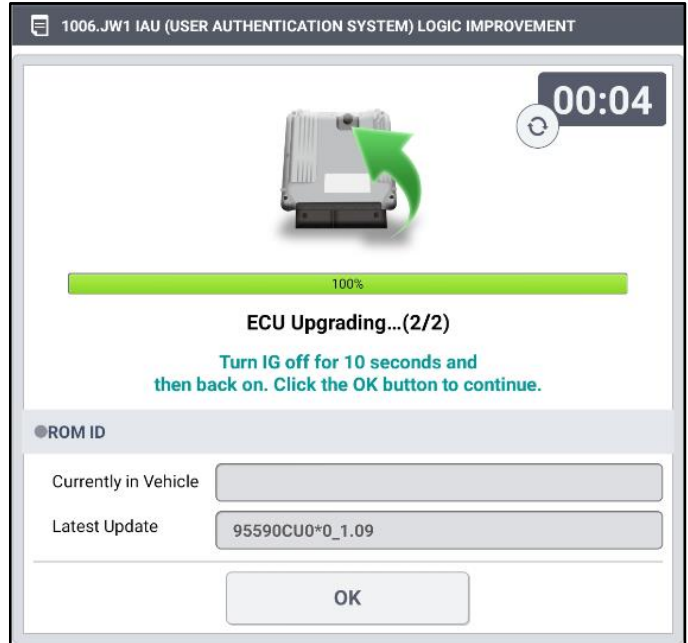
8. Follow the instructions on the screen and turn IG off for 10 seconds.

After completing, select OK.

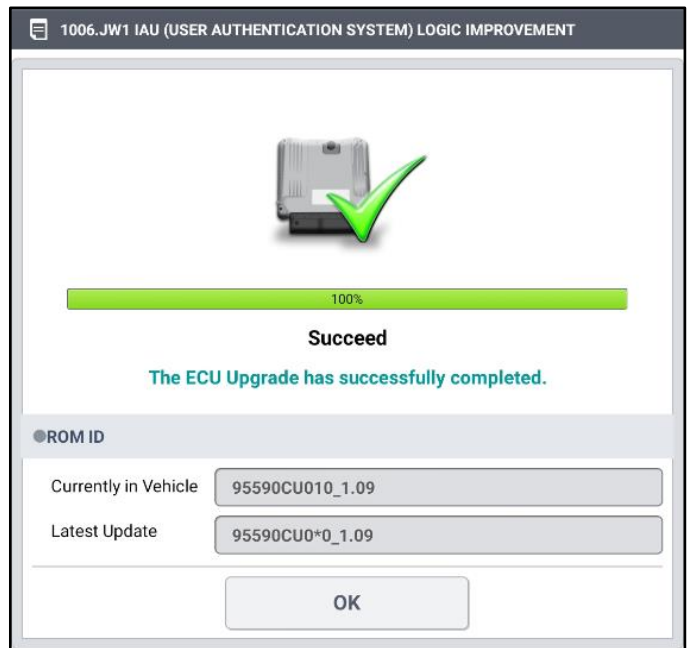
9. After receiving **Succeed**, select OK.

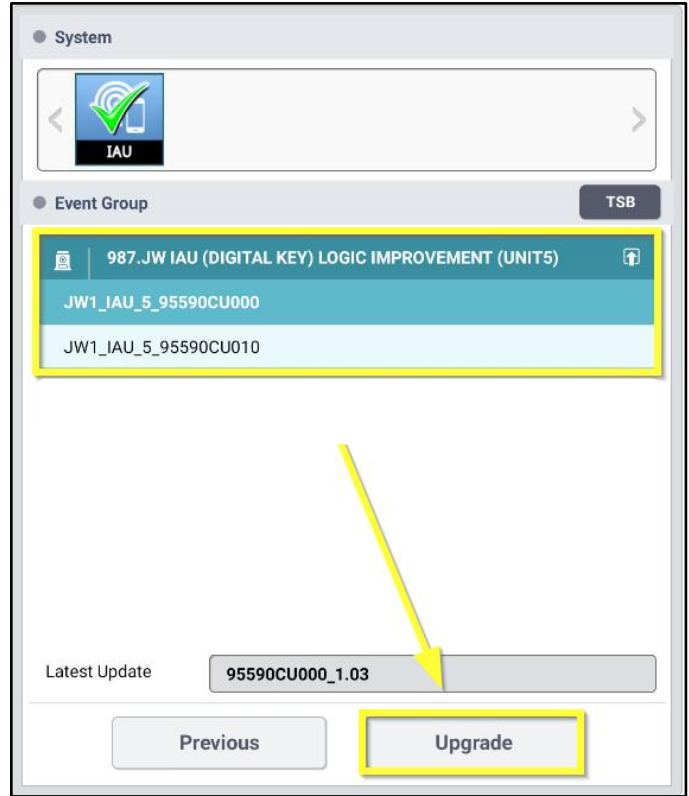
11. Return to the system page and **complete Event #987**.

Select the vehicle’s part number, followed with **Upgrade**.

Please note that #987 only needs to be completed for vehicles with Performance Trim.

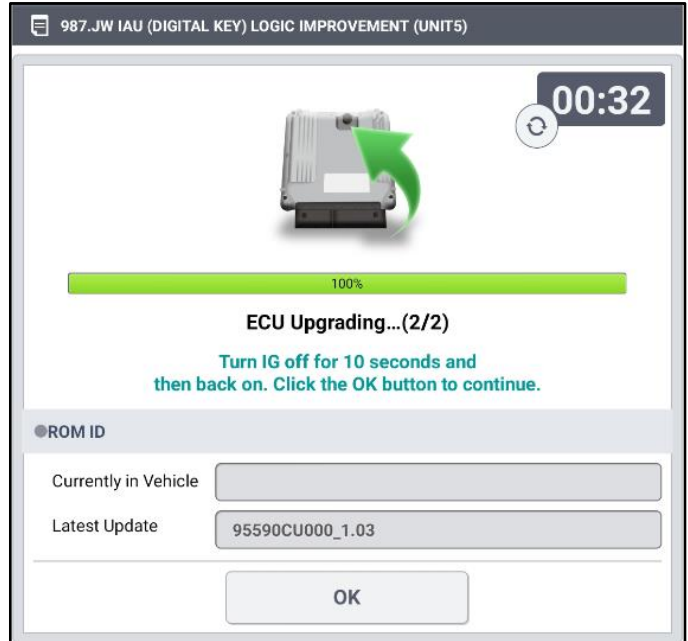
16. Follow the instructions on the screen and turn IG off for 10 seconds.

After completing, select OK.

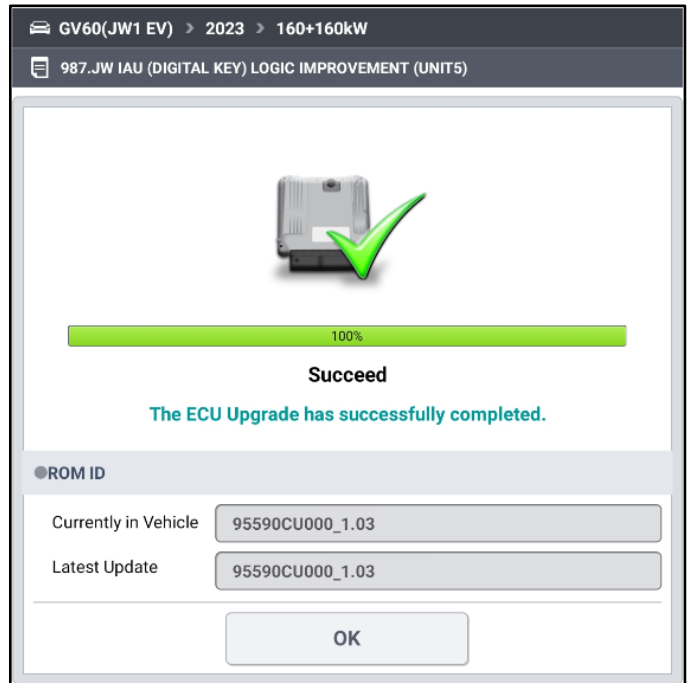
17. After receiving **Succeed**, select OK.

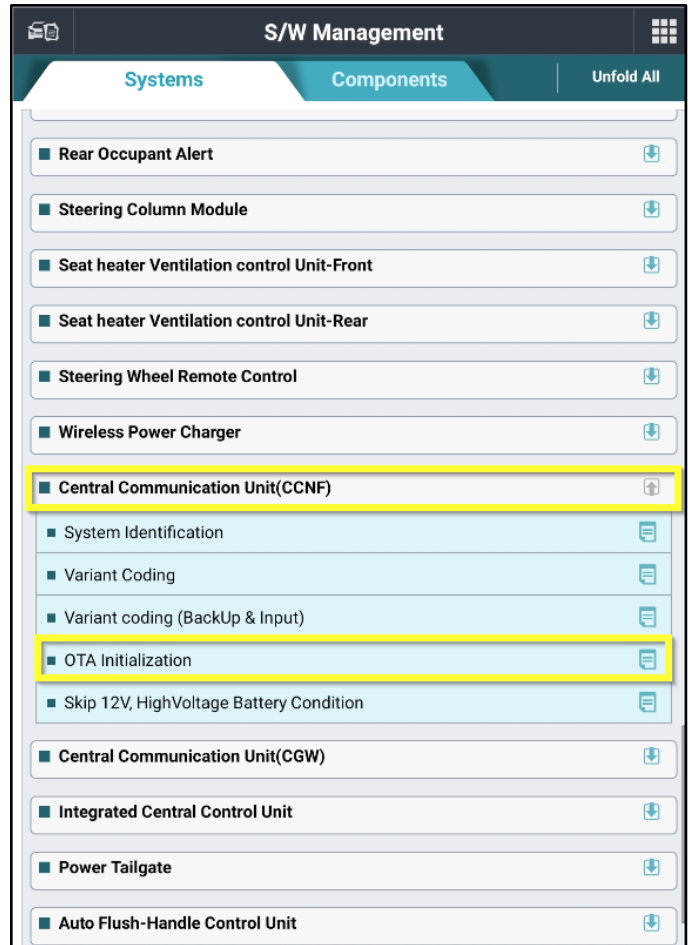
19. After the upgrade is completed, **the OTA initialization process must be carried out.**
- Connect the GDS-M
 - Select S/W Management
 - Go to Central Communication Unit (CCNF)
 - Select OTA Initialization
 - Follow the instructions on the screen
