HYUNDAI

Technical Service Bulletin

GROUP CAMPAIGN	NUMBER 23-01-059H
DATE JULY 2023	MODEL(S) IONIQ 5 (NE1) IONIQ 6 (CE1)

SUBJECT: POWER TAILGATE CONTROL LOGIC IMPROVEMENT
(SERVICE CAMPAIGN T9Z)

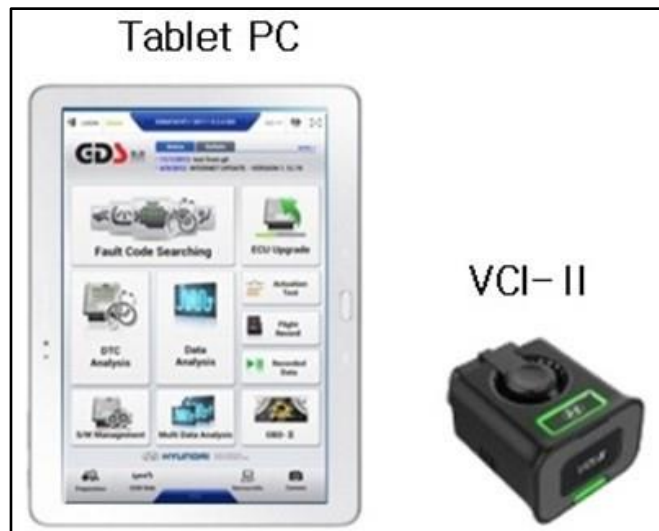
NOTICE

Only perform manual upgrade.

MANUAL UPGRADE PROCEDURE USING THE GDS-MOBILE

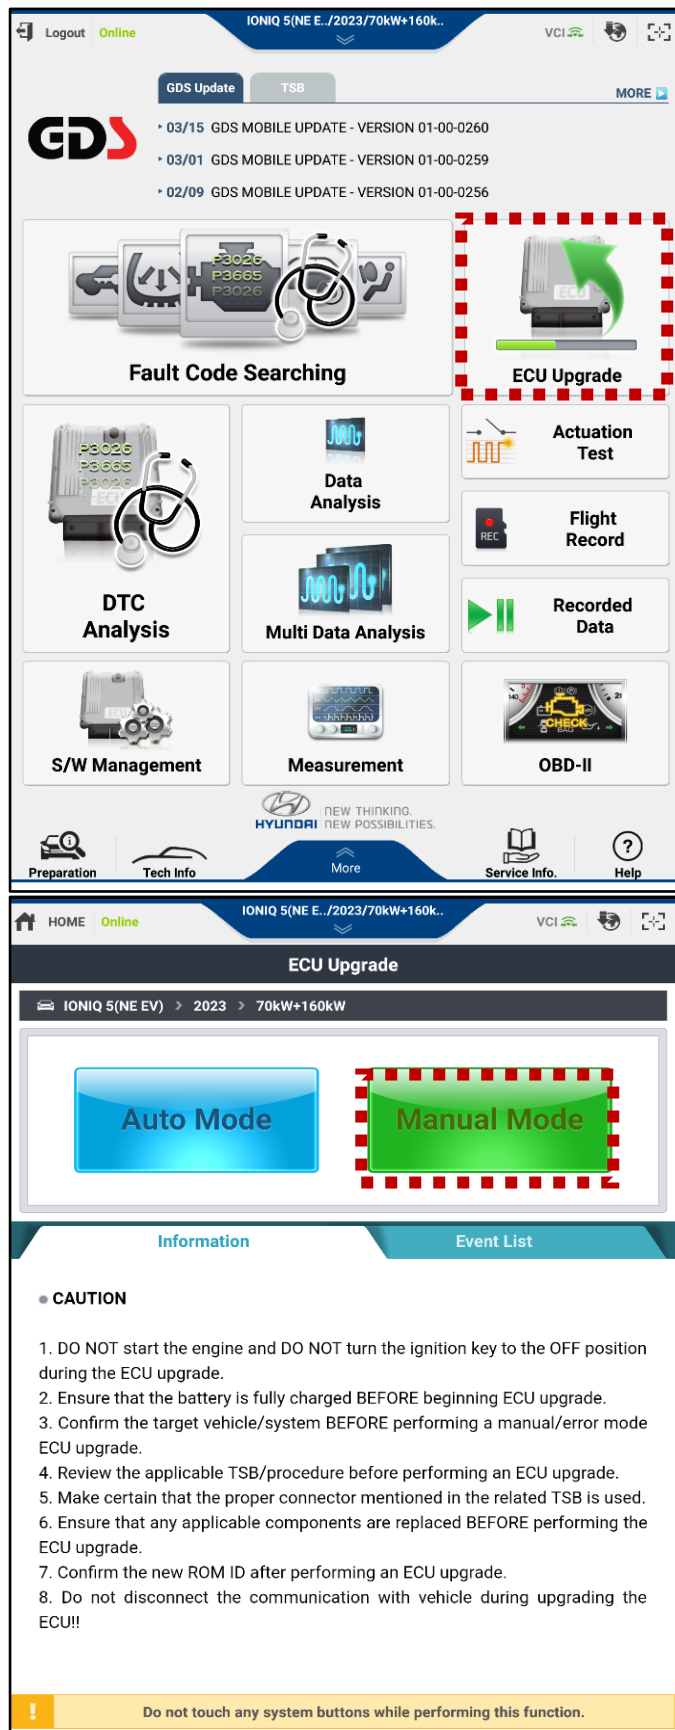
2. Select ECU Upgrade on the initial screen after entering the vehicle information and select Manual Mode.

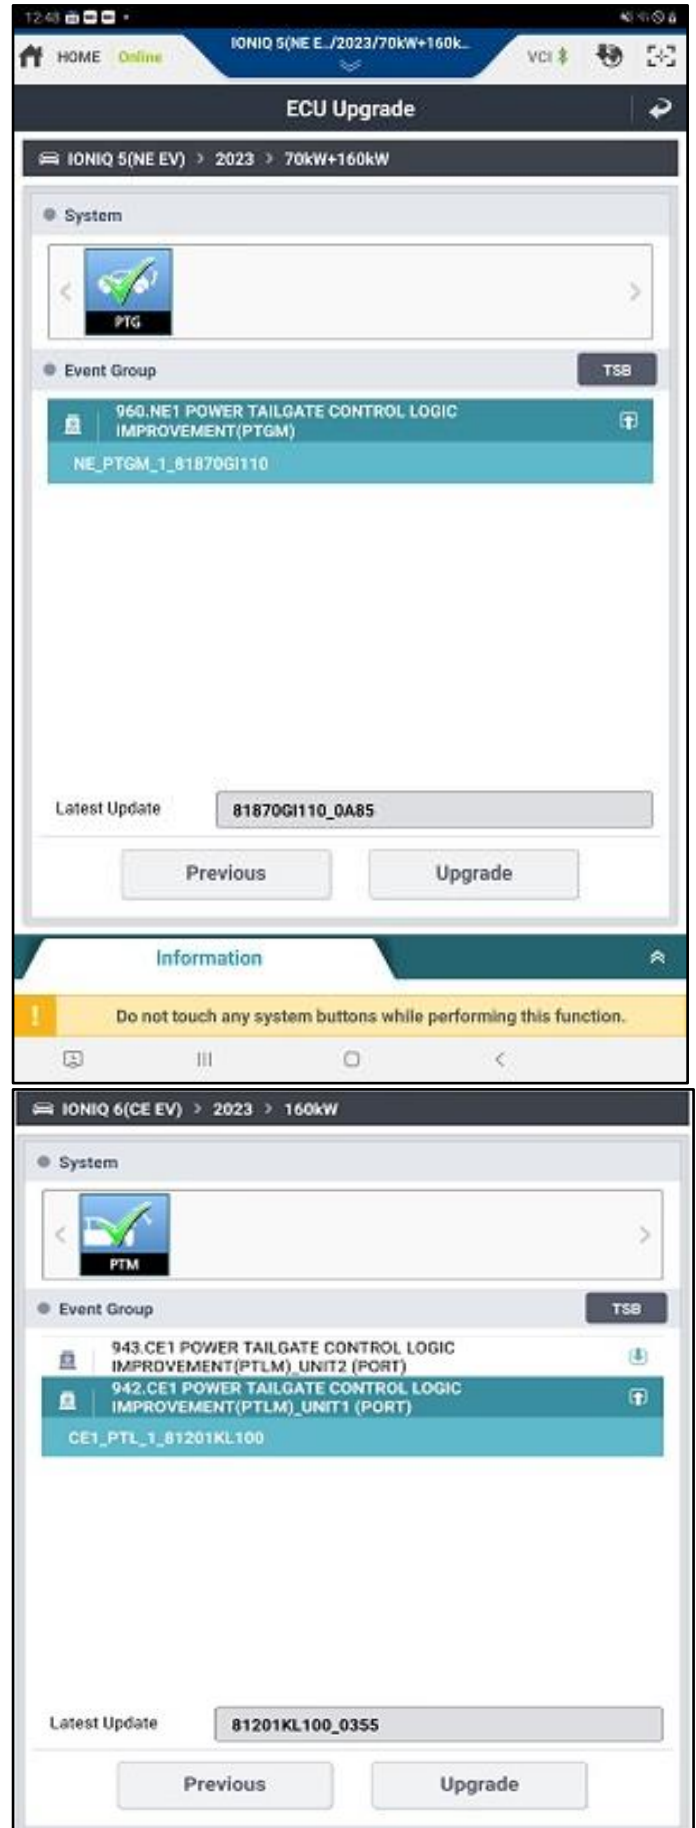
3. Select the control unit part number with reference to the above ROM ID Information Table and tab Upgrade.

- If **IONIQ 5 (NE1)** Select:
#960.NE1 POWER TAILGATE CONTROL LOGIC IMPROVEMENT(PTGM)

NOTICE

Ioniq 6 (CE1) will require two upgrades. Please select **#942** first and once upgrade is complete repeat the steps selecting **#943**.

- If **IONIQ 6 (CE1)** Select:
2-1) #942.CE1 POWER TAILGATE CONTROL LOGIC IMPROVEMENT(PTLM)_UNIT1 (PORT)
2-2) #943.CE1 POWER TAILGATE CONTROL LOGIC IMPROVEMENT(PTLM)_UNIT2 (PORT)

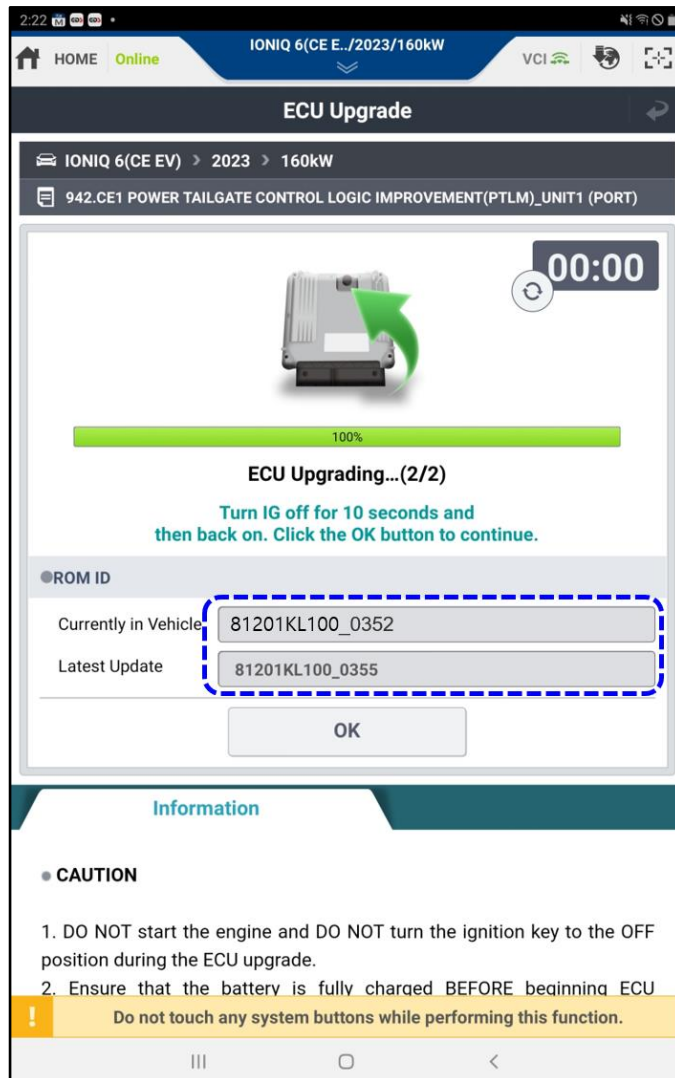
4. When upgrading, check the part number and software version as shown in the picture.

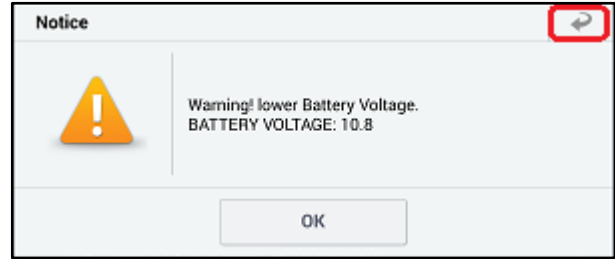
- 6. The vehicle battery voltage is checked to make sure it is at least 12 volts to ensure reliable upgrade results. Click OK if the results indicate voltage is OK.

NOTICE

If battery voltage is below 12 voltages as below, click BACK and then run the engine to assure an adequate battery charge state for reliable upgrade results.

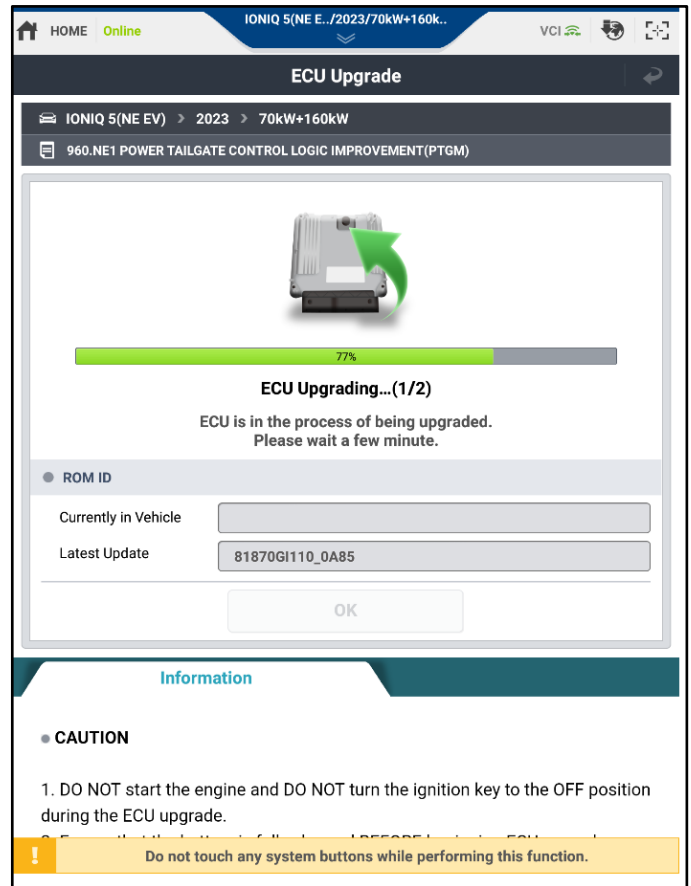
- 7. Upgrade (1/2) will begin, and the progress of the upgrade will appear on the bar graph.

Upgrade (1/2) will occur until 100% is reached on the bar graph.
