Service Bulletin

Bulletin No.: 21-NA-293

Subject: Poor Engine Performance in Extremely Cold Weather Conditions, Charge Air Cooler Icing - Malfunction Indicator Lamp (MIL) Illuminated, DTC P0299, P0234, P0236, P00C7 Set

Brand:	Model:	Model Year:		VIN:		Engine:	Transmission:
		from	to	from	to		
Buick	Encore GX	2020	2023				
Chevrolet	Trailblazer	2021

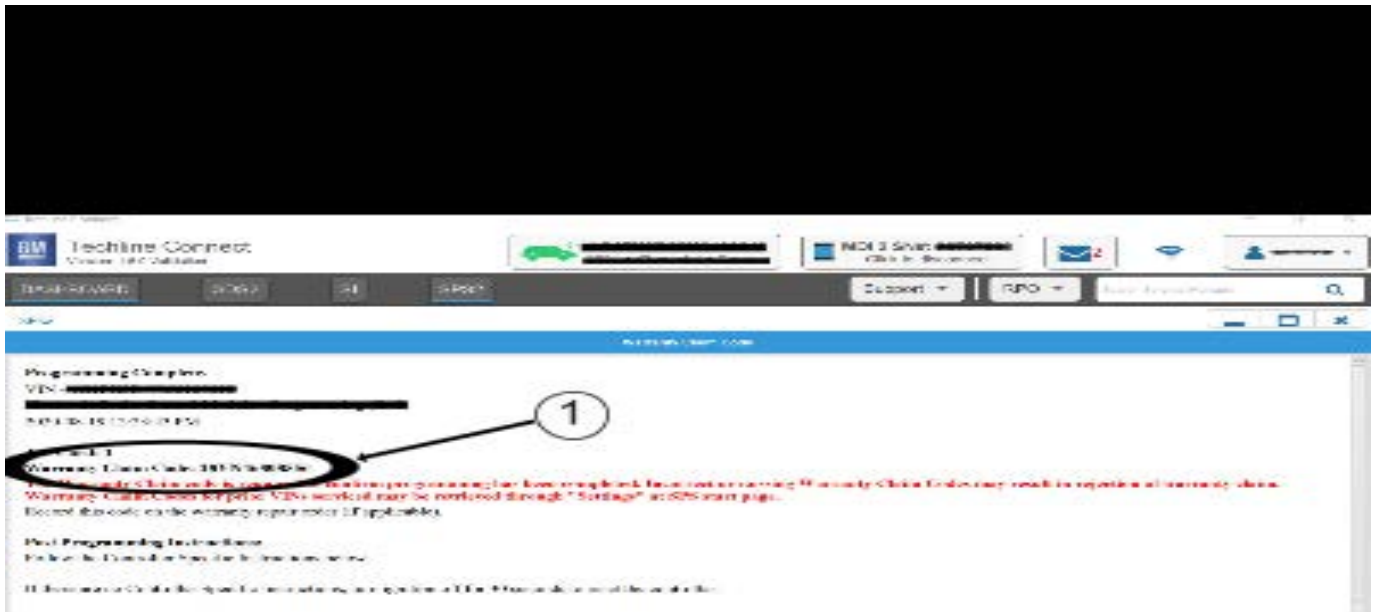
5644478

Note: Select this calibration **ONLY** to address issues related to charge air cooler icing occurring on vehicles operated in cold climates.

Note: The screenshots above are an example of module programming and may not be indicative of the specific module that is being programmed. Module selection and VIN information have been blacked out.

1. Reprogram the Engine Control Module. Refer to *K20 Engine Control Module: Programming and Setup* in SI.
