GROUP	MODEL
Service Campaign	2022-2023MY EV6 (CV) All except GT model
NUMBER	DATE
SC273	July 2023

VCU SOFTWARE LOGIC UPGRADE (SC273)

This bulletin provides information to upgrade the software logic of the Vehicle Control Unit (VCU) on certain 2022-2023MY EV6 (CV) vehicles produced from November 17, 2021 through May 30, 2023, in order to enhance the following two (2) functions:

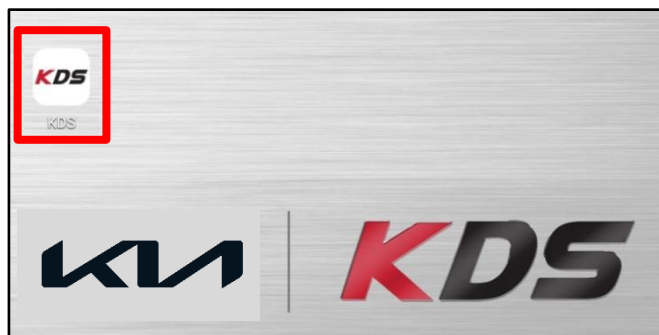
2. With the ignition ON, turn ON the KDS tablet. Select 'KDS' from the home screen.

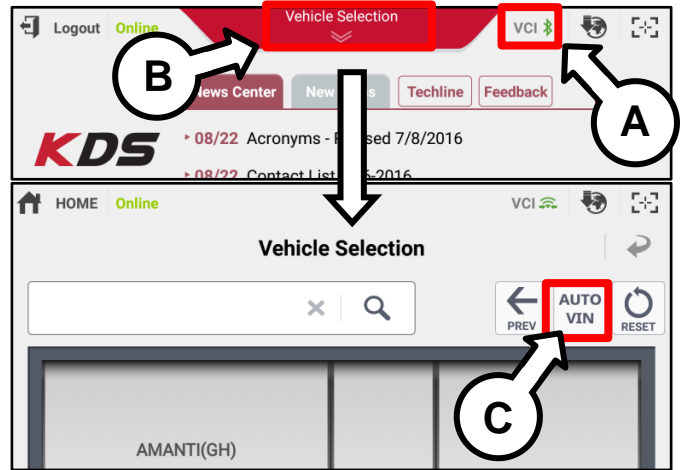
3. Confirm communication with VCI (A) and then configure the vehicle (B) using the 'AUTO VIN' (C) feature.

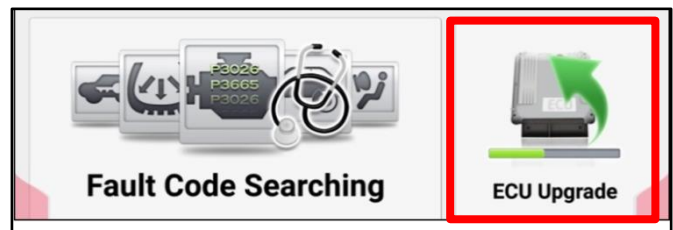
4. Select 'ECU Upgrade'.

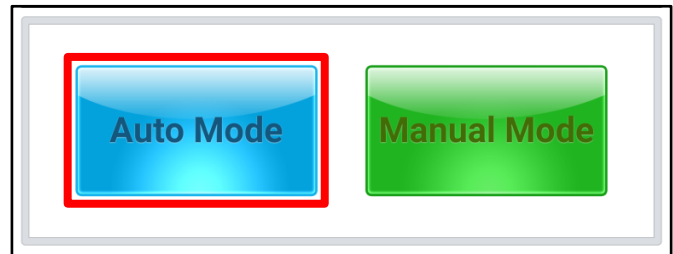
6. Select Auto Mode.

Do NOT attempt to perform a Manual Mode upgrade UNLESS Auto Mode fails. Always follow the instructions given on the KDS in either Auto or Manual mode.

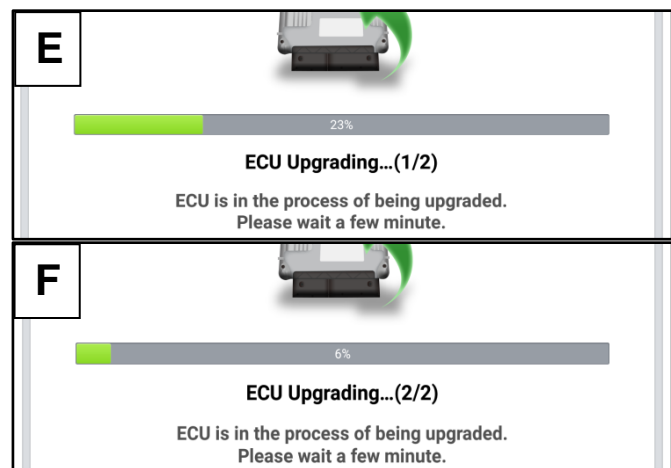
8. The ECU upgrade will begin and the progress of the upgrade will appear on the bar graph. Upgrade part (1/2) (E) will download the upgrade event to the VCI-II. Upgrade part (2/2) (F) will upgrade the ECU.
