GROUP	MODEL
Service Campaign	2022-2023MY EV6 (CV) All except GT model <u>and</u> 2023-2024MY Niro EV (SG2 EV)
NUMBER	DATE
SC273 (Rev 1, 08/17/2023)	July 2023

VCU SOFTWARE LOGIC UPGRADE (SC273)

This bulletin provides information to upgrade the software logic of the Vehicle Control Unit (VCU) on certain 2022-2023MY EV6 (CV) vehicles produced from November 17, 2021 through May 30, 2023, and 2023-2024MY Niro EV (SG2 EV) vehicles produced from July 11, 2022 through June 30, 2023, in order to enhance the following two (2) functions:

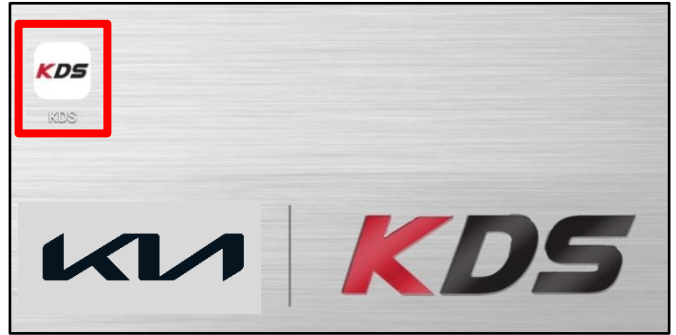
- With the ignition **ON**, turn **ON** the KDS tablet.
Select '**KDS**' from the home screen.

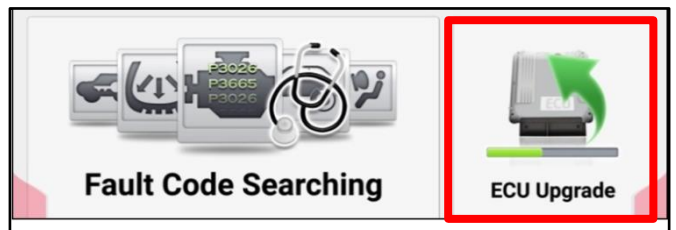
- Select '**ECU Upgrade**'.

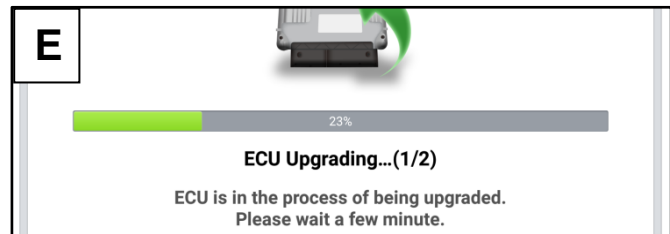
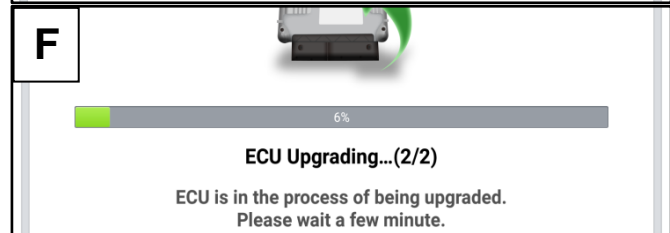
8. The ECU upgrade will begin and the progress of the upgrade will appear on the bar graph. Upgrade part (1/2) (E) will download the upgrade event to the VCI-II. Upgrade part (2/2) (F) will upgrade the ECU.

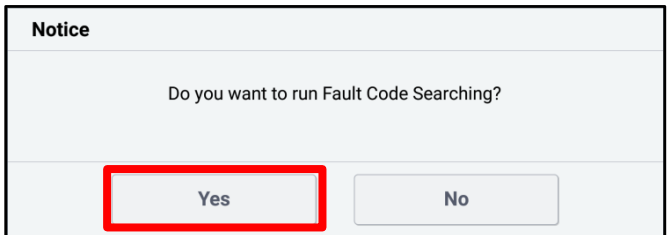
- 12. When prompted, select **'YES'** to check for Diagnostic Trouble Codes (DTC) and erase any DTCs stored such as EPS, ESC, and TPMS that may have been set during the upgrade.
