Service Action

Code: 93P7

Subject HV Battery Cell Module(s)

Evaluate and, if necessary, replace the affected battery cell module(s).

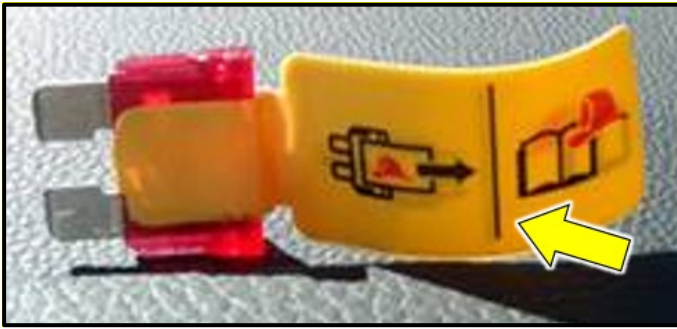
RISK OF REPEAT REPAIR!
 The battery regulation control unit must be reset after de-energizing the vehicle!
 This will prevent a potentially false DTC after the repair.

- Switch on the ignition.
- Remove fuse SC28 <arrow> for a few seconds.
- Reinstall fuse SC28.
- Switch the ignition off.
- Continue to the next step.

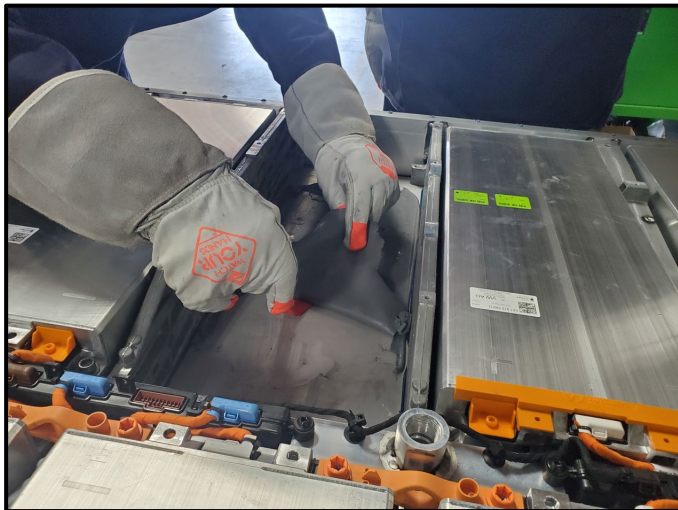
Remove the cell module:

- See ELSA Repair manual: *Repair Manual > Motor > Electric Drive Rear Wheel Drive EIP220 and All Wheel Drive EIA200, EIP220 > 93 Electric drive > High-Voltage Battery Components > Battery Module, Removing*
- Ensure the shock protection is installed on ALL open high-voltage connections.

The cell module can be freed from the adhesive bond from either end of the cell module.
