| <br><b>Technical Service Bulletin</b> | <b>GROUP</b> | <b>NUMBER</b> |
| | <b>BODY ELECTRICAL</b> | <b>23-BE-012G</b> |
| | <b>AUGUST 2023</b> | <b>G90 (HI)</b> |
| <b>SUBJECT:</b> | <b>SOFTWARE UPDATE FOR DIS2.0 HEAD UNITS</b> | |

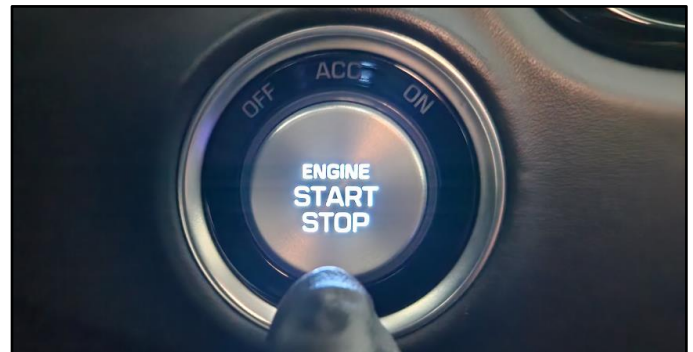
1. Turn the IGN on.

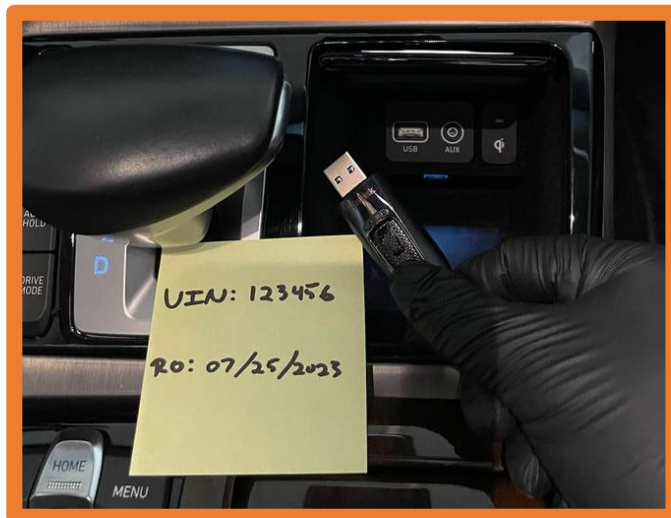
Using STUI, take a picture of the USB stick near the USB Port with the last six digits of the VIN and date of the inspection included. Upload the photo to STUI.

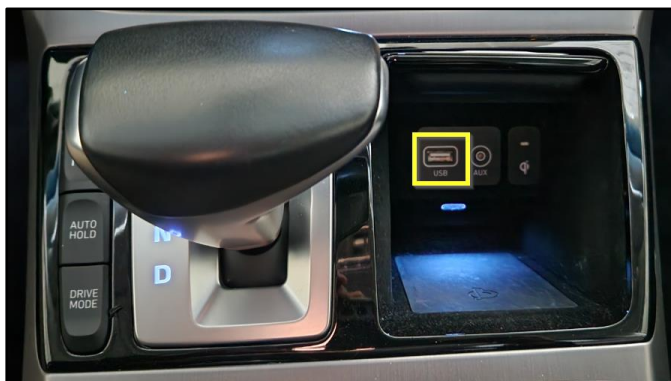
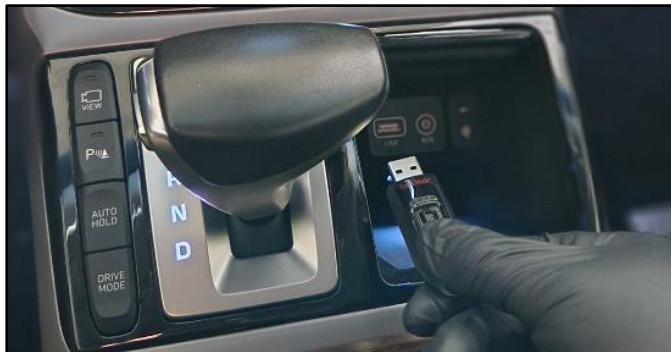
3. Insert the USB into the front multi jack.

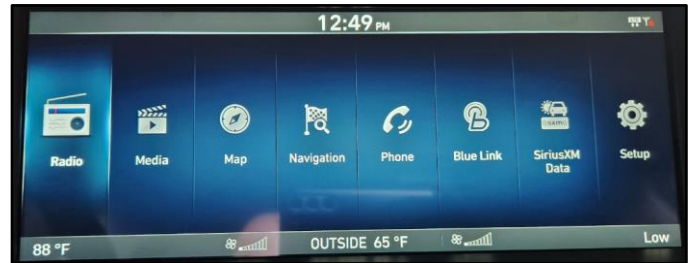
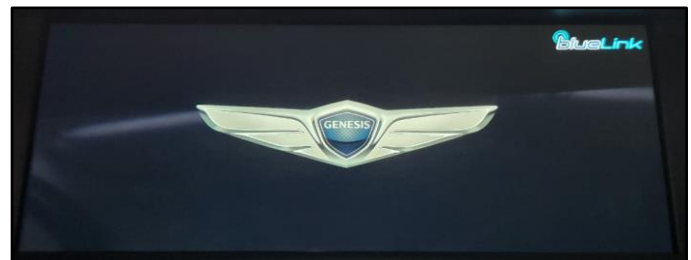
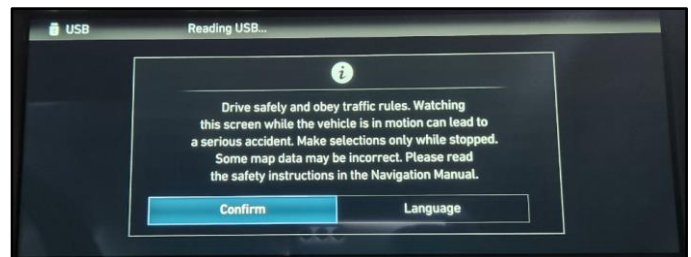
4. In approximately 2~4 minutes, the AVN will be rebooted and go blank as demonstrated in the example photos.

The Genesis Logo will return and request the user to **Confirm** the safety message.

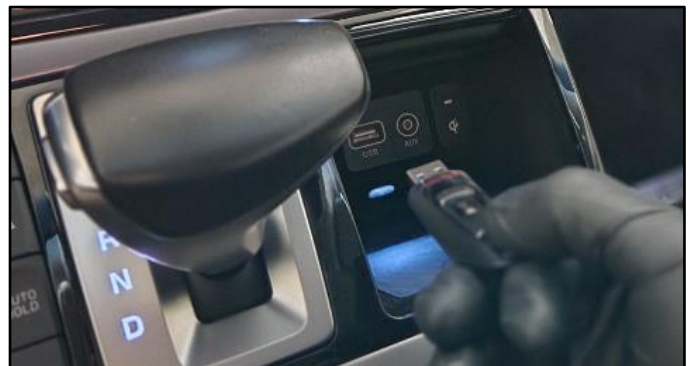
5. Remove the USB immediately after reboot.

If USB is not removed, the reset process will be repeated.
