HYUNDAI

Technical Service Bulletin

GROUP	NUMBER
HYBRID CONTROL	23-HC-002H
DATE	MODEL(S)
AUGUST 2023	SONATA HYBRID (DN8 HEV)

SUBJECT: ECU UPDATE AND GDS-M 'INTEGRATED THERMAL MODULE COOLANT FILLING MODE'

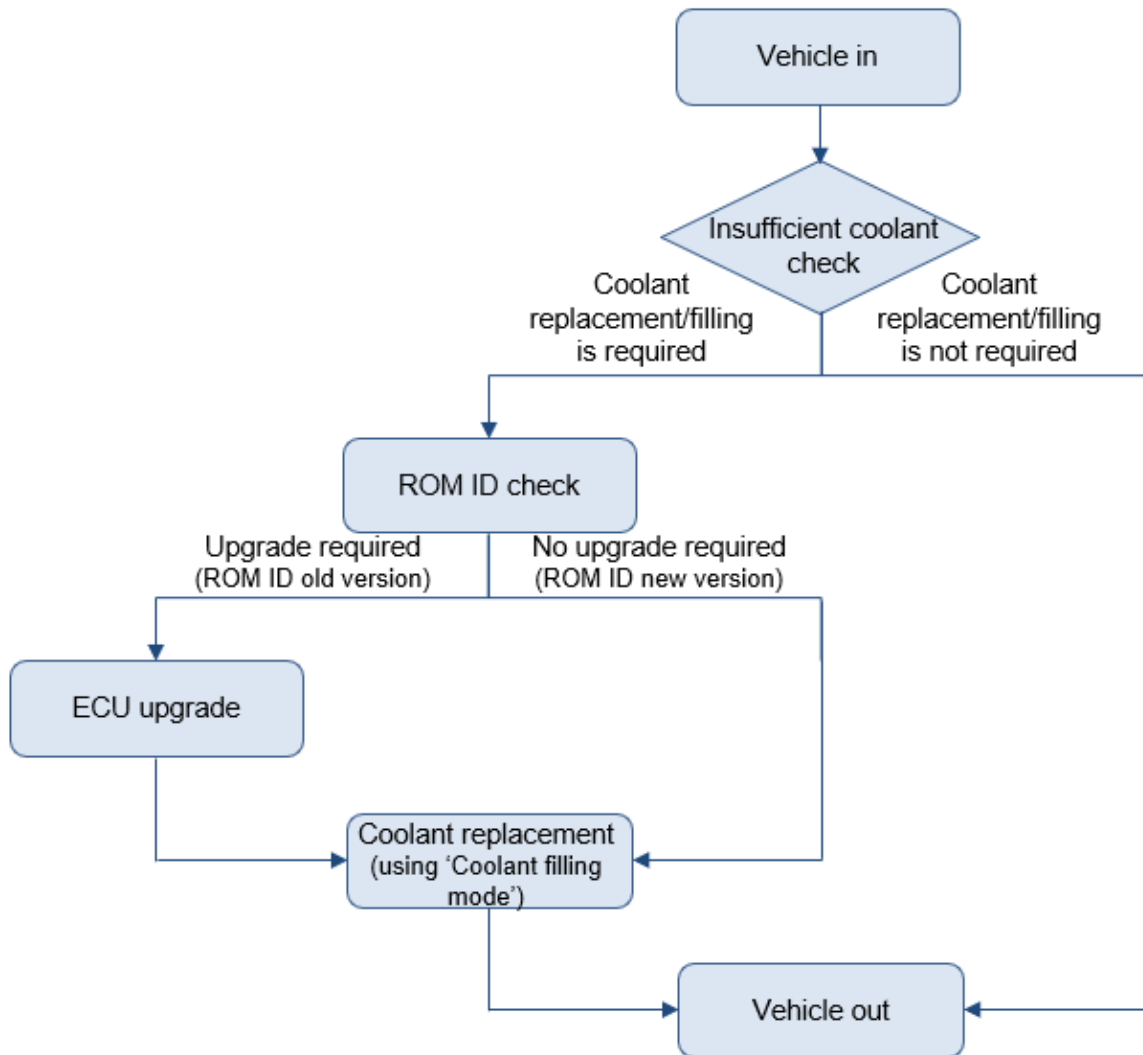
Perform the service procedure referring to the flow chart below.

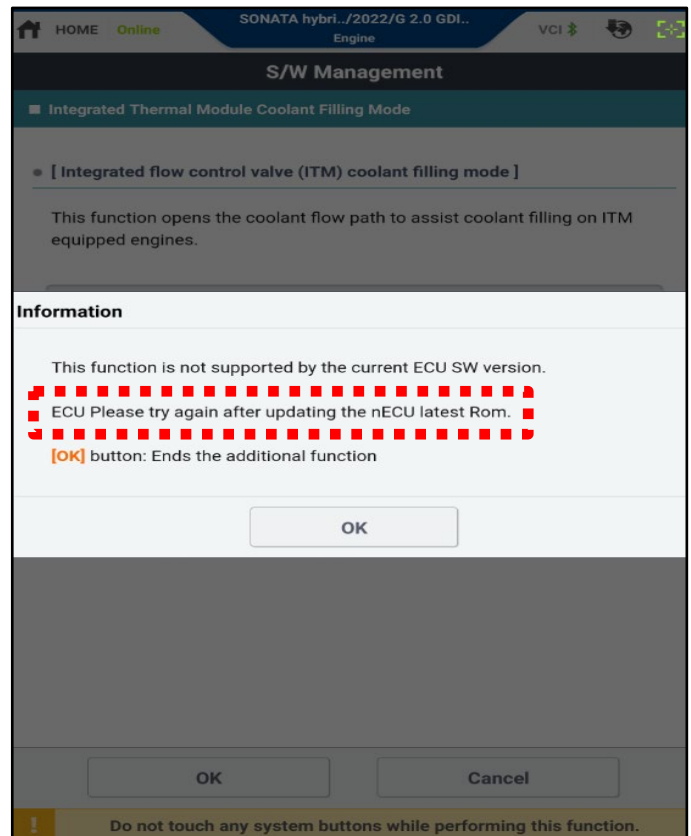
9. If the phrase "ECU please try again after updating the nECU latest Rom" appears, then the ECU version must be updated to V80 or higher (current version: V70).

If ECU Update is not required, skip to step 11.

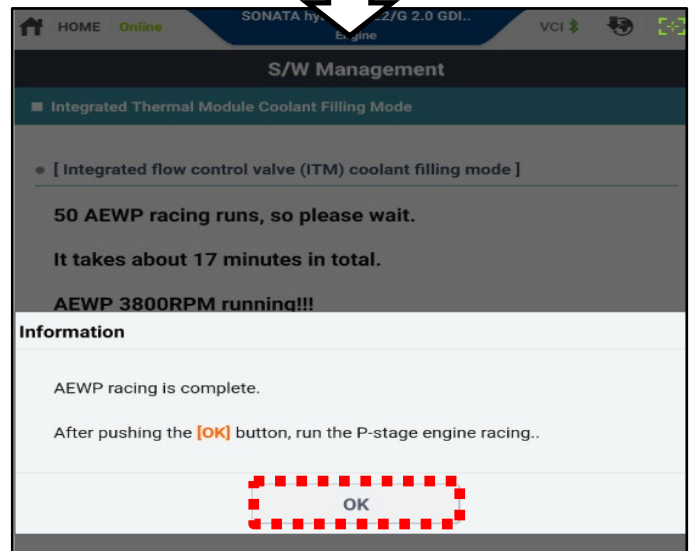
13. Wait until AEWP racing is automatically performed 50 times.

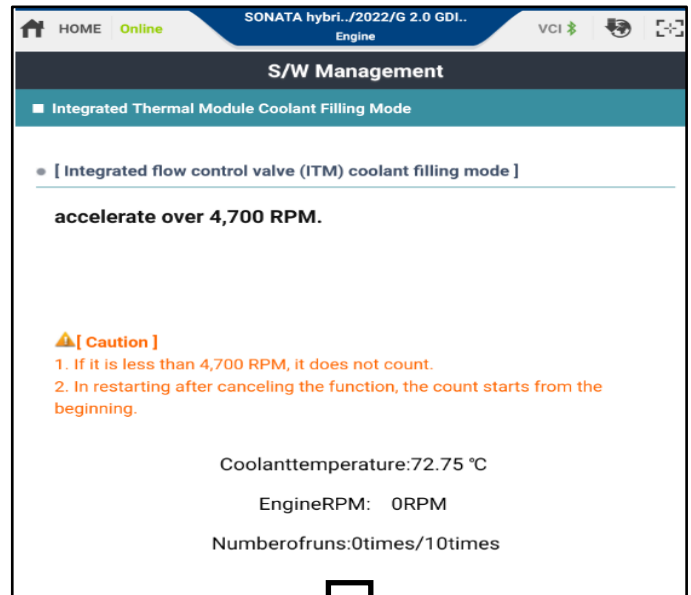
- 16. With transmission in P (Park), step on the accelerator pedal and raise it to 4,700 rpm or more, then lower it to 1,500 rpm or less.

Repeat 10 times and check the amount of coolant in the expansion bottle before replenishing. (Follow instructions on GDS as shown at right.)
