Technical Service Bulletin

GROUP CAMPAIGN	NUMBER 23-01-073H
DATE AUGUST 2023	MODEL(S) KONA ELECTRIC (OS EV)

SUBJECT: KONA EV DTC INSPECTION AND BMS UPDATE (SERVICE CAMPAIGN 9A4)

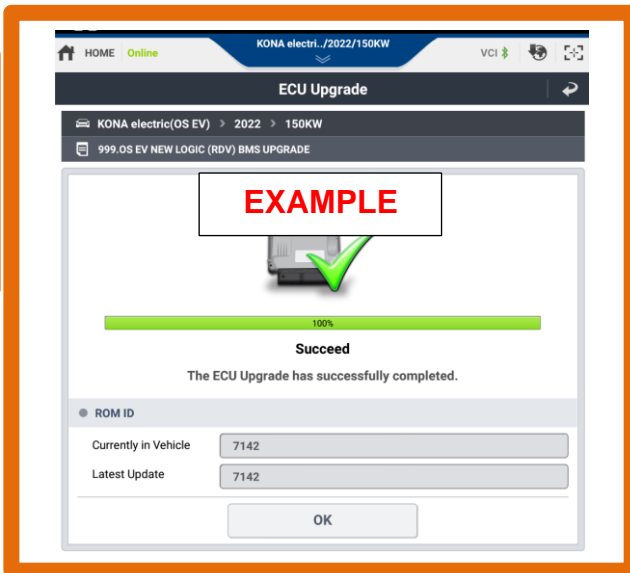
Take a screenshot of the ECU Update Complete screen using your particular tablet's screenshot save method and upload to STUI.

- B3. After the ECU Upgrade process shows 100% complete, cycle the ignition key to OFF for at least 10 seconds to reset the control unit.
- B4. Take a screenshot of the ECU Update complete screen and upload to STUI.

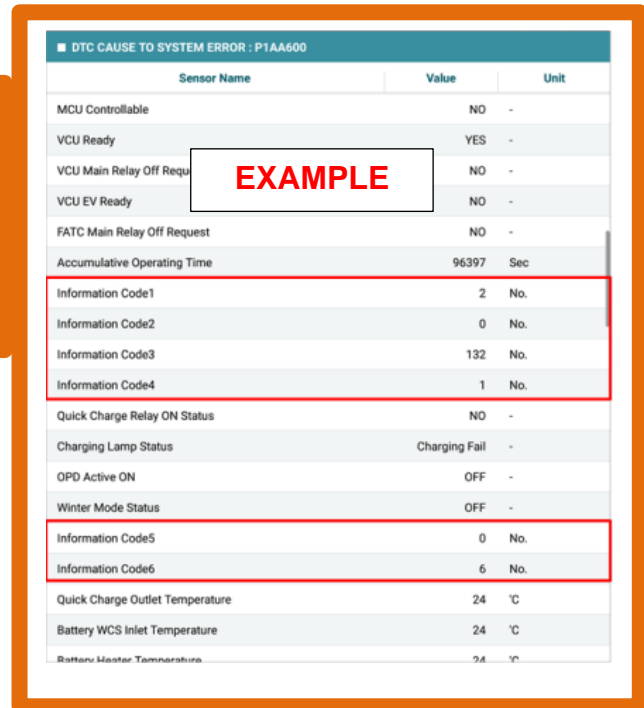
Take a screenshot of the **DTC Freeze Frame Data showing Information Codes 1-5** using your particular tablet's screenshot save method and upload to STUI.

- **No – (None of the above listed DTC are found stored):**
Go to section B - Perform BMS Software Update.
- **Yes – (DTC P1AA6 is found stored):**
Go to next step A3. - Check the DTC P1AA6 Freeze Frame Information Code 1-2 values to determine next steps.
- **Yes – (Any of DTC P1AA7, P1AA8, P1AA9, P1AAA, P1AAB, P1AAC, P1AAD, P1AAE or P1AAF are found stored):**
Go to section C. - Take STUI photo of Freeze Frame Data, Replace BSA and perform BMS Update if needed.
