Technical Service Bulletin

SUBJECT: CHECK ENGINE LIGHT ILLUMINATES WITH DTC P0401/P0400		No: TSB-23-13-004	
		DATE: August 2023	
		MODEL: Outlander Sport	
CIRCULATE TO:	<input type="checkbox"/> GENERAL MANAGER	<input checked="" type="checkbox"/> PARTS MANAGER	<input checked="" type="checkbox"/> TECHNICIAN
<input checked="" type="checkbox"/> SERVICE ADVISOR	<input checked="" type="checkbox"/> SERVICE MANAGER	<input checked="" type="checkbox"/> WARRANTY PROCESSOR	<input checked="" type="checkbox"/> SALES MANAGER

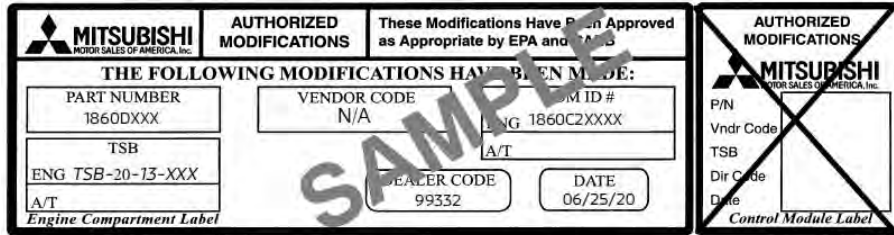
7. Using a ball-point pen, enter the appropriate ECU part number, Software Part Number (ROM ID#), this Technical Service Bulletin number, your dealer code, and the current date on the Engine Compartment/Control Module Label (p/n MSSF024G00). The Vendor Code is not applicable. The label is available from your facing PDC.
