# TECHNICAL SERVICE BULLETIN

Classification: AN23-006C	Reference: ITB23-010C	Date: August 16, 2023
------------------------------	--------------------------	--------------------------

## SOFTWARE UPDATE FOR INFOTAINMENT ISSUES

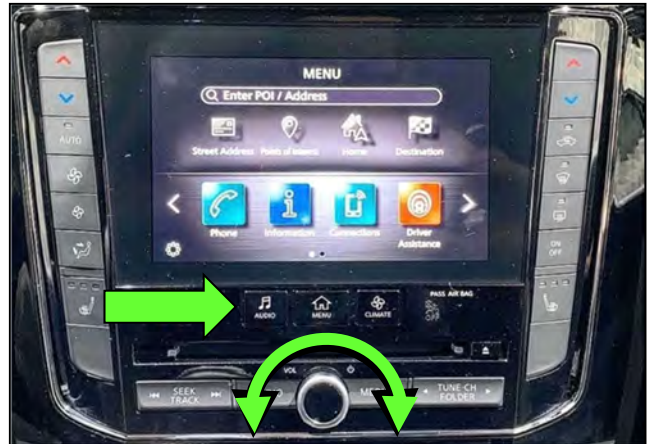
Figure 2

1. Press and hold the **AUDIO** button while, at the same time, rotating the volume knob left-right-left.

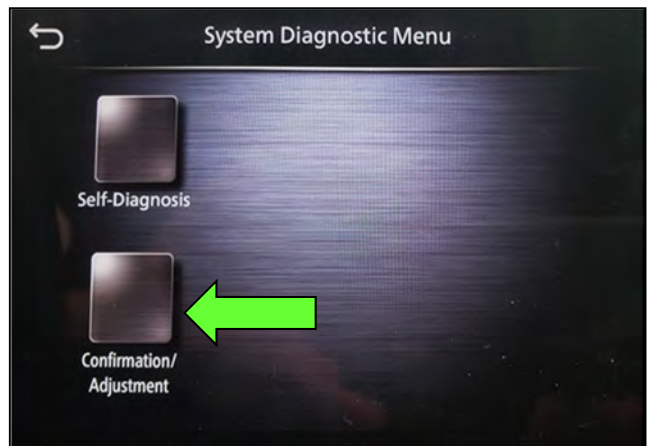
Figure 3

2. Select **Confirmation/Adjustment**.

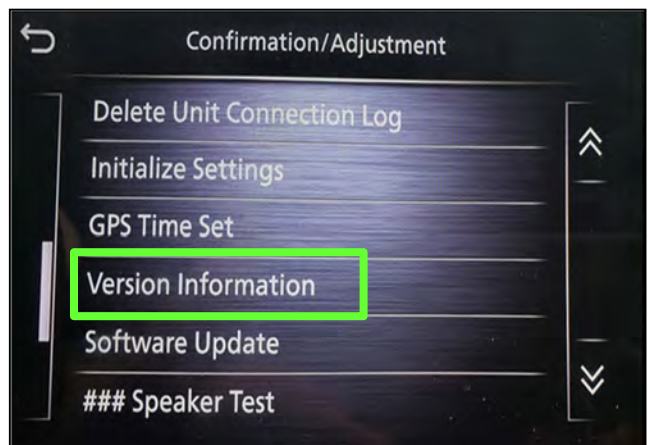
Figure 4

3. Select **Version Information**.

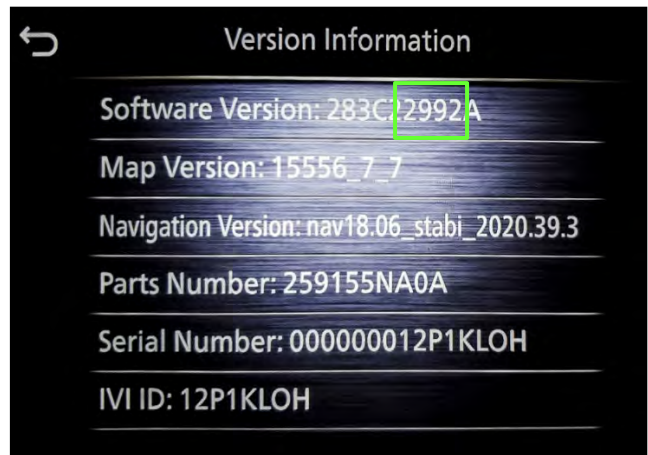
Figure 5

- If the **Software Version** (characters 6-9, as shown in Figure 5) is not the latest software version listed in the vehicle table, select the back icon and continue to step 5.
- If the **Software Version** is the latest software version listed in the vehicle table, an update is not available. Select the back icon and skip to **CLAIMS INFORMATION** on the last page.

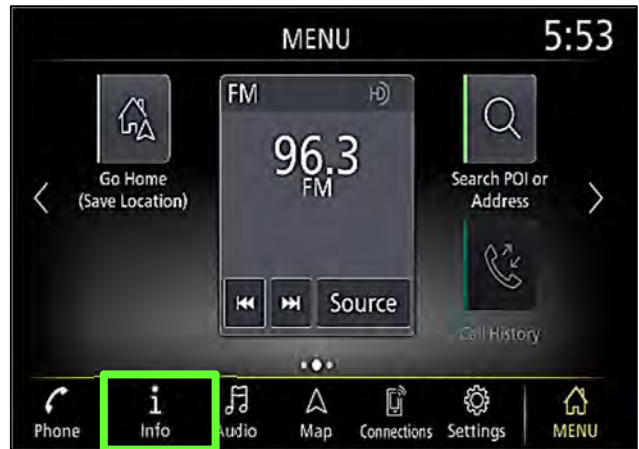
Figure 6

- Starting from the HOME screen (Figure 6), select **Info**.

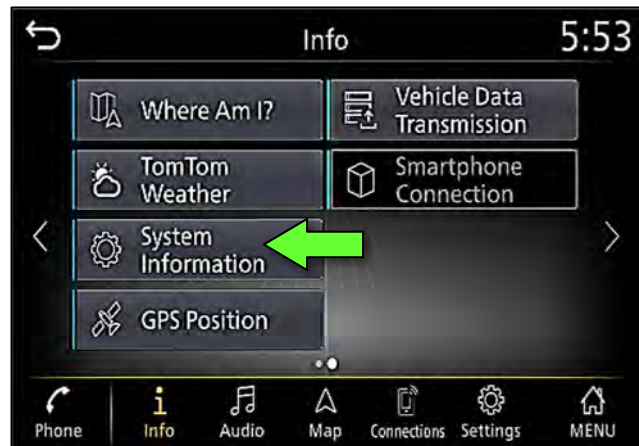
Figure 7

- Select **System Information**.

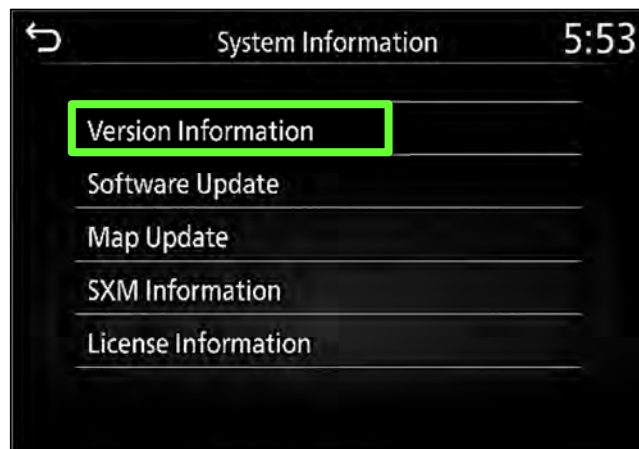
Figure 8

- Select **Version Information**.

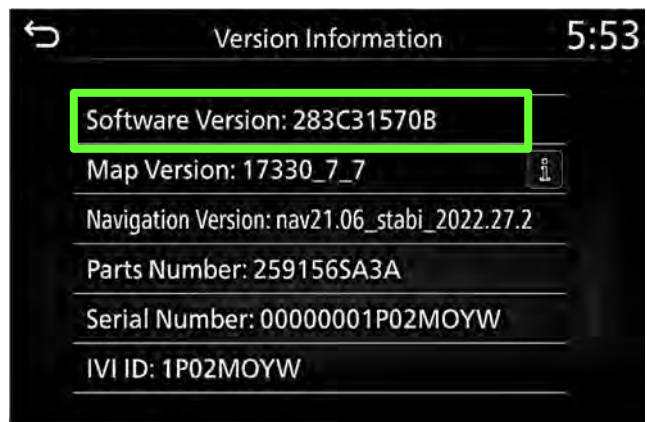
Figure 9

9. Confirm the **Software Version**.
  - If the **Software Version** is not the latest software version listed in the vehicle table, select the back icon and continue to step 10.
  - If the **Software Version** is the latest software version listed in the vehicle table, an update is not available. Select the back icon and skip to **CLAIMS INFORMATION** on the last page.

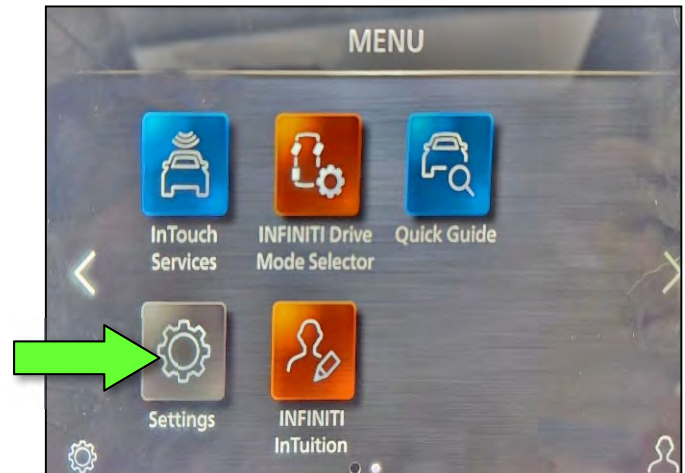
Figure 10

- a. From the **MENU** screen, select **Settings**.

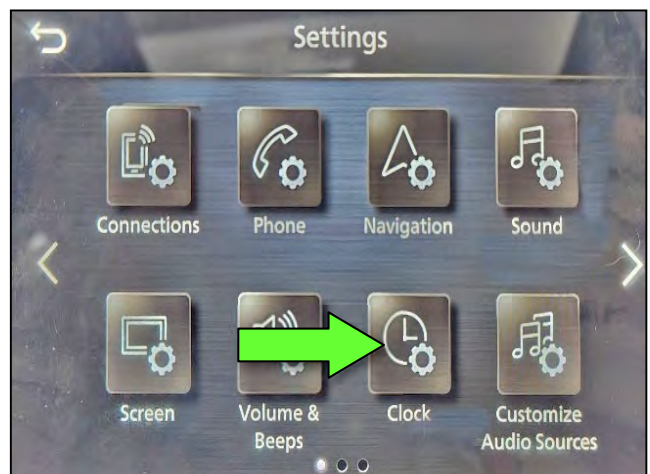
Figure 11

- b. Select **Clock**.

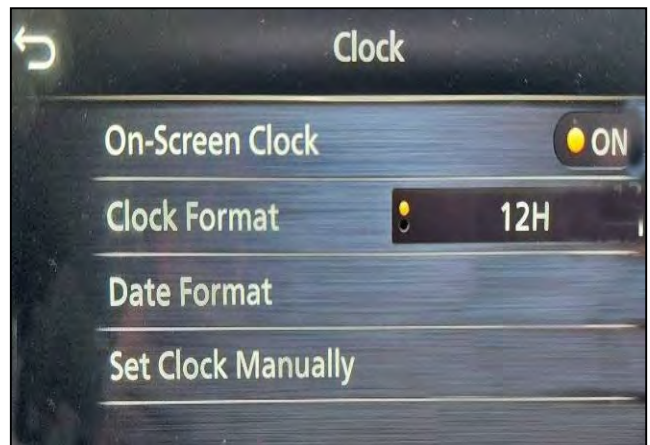
Figure 12

- c. Record all the clock settings.
  - o For vehicles without navigation:
    - **On-Screen Clock**
      - ON/OFF
    - **Clock Format**
      - 12H/24H
    - **Date Format**
      - Select **Date Format** to view and record settings.
    - **Set Clock Manually**
      - Select **Set Clock Manually** to view and record settings.

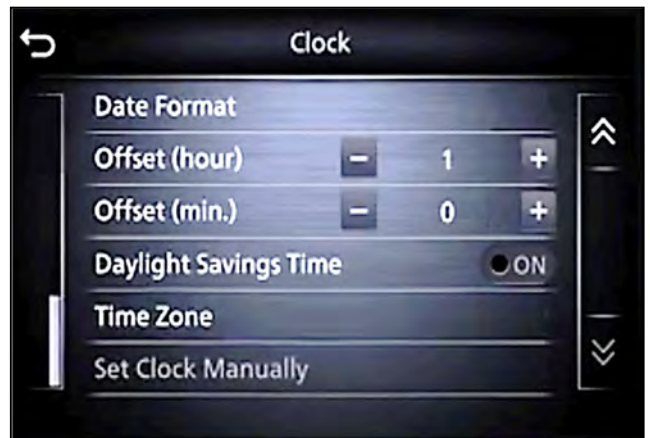
Figure 13

- o For vehicles with navigation:
  - **On-Screen Clock** (not shown)
    - ON/OFF
  - **Clock Mode** (not shown)
    - Auto/Manual/Time Zone
  - **Clock Format** (not shown)
    - 12H/24H
  - **Date Format**
    - Select **Date Format** to view and record settings.
  - **Offset (hour)**
  - **Offset (min.)**
  - **Daylight Savings Time**
    - ON/OFF
  - **Time Zone**
    - Select **Time Zone** to view and record settings.
  - **Set Clock Manually**
    - Select **Set Clock Manually** to view and record settings.

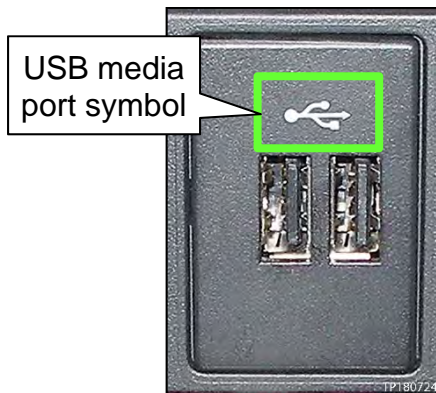
Figure 14

14. Insert the USB drive with the infotainment update-software into the vehicle's USB media port (Figure 14).

Do not insert the USB drive into a charging port. If used, the update-software and/or USB drive may become damaged. Only insert the USB drive in a USB media port.

**HINT:** Charging ports are marked in the vehicle with a “lightning bolt” symbol.

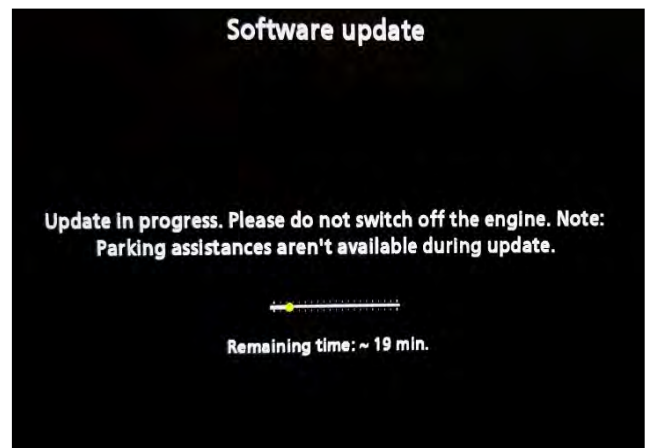
Figure 16

15. Wait for the update to complete.

**HINT:** The update lasts 15-25 minutes.

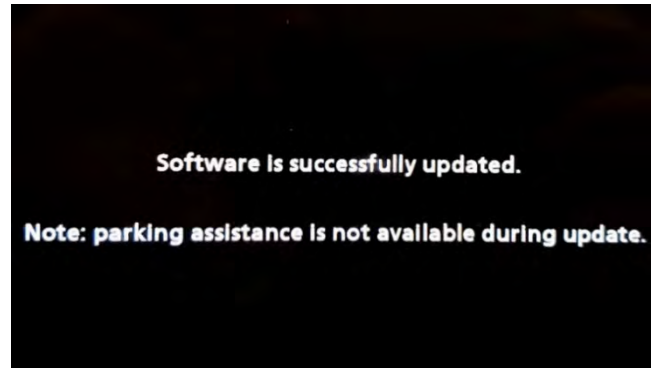
Figure 17

16. Once the update is complete (Figure 17), remove the USB drive; the system will reboot (restart).

**HINT:** The system will not reboot until the USB drive is removed.

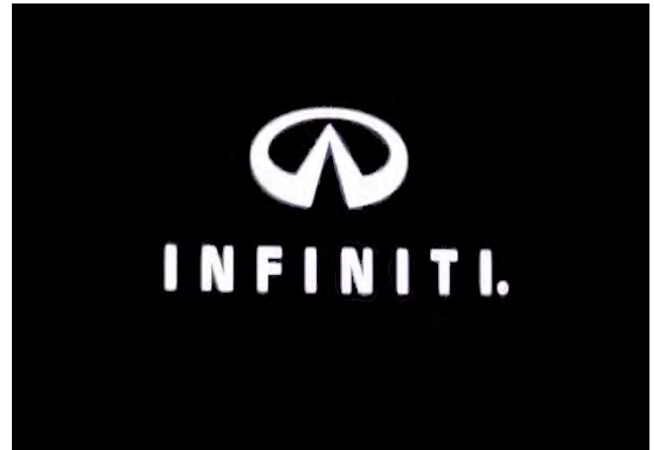
Figure 18

17. Allow the reboot to complete (approximately 30 seconds).
  - The Infiniti logo will be displayed during the reboot.

21. Turn the ignition ON (engine OFF) and wait for the Infiniti logo to appear (Figure 18).
  - If the Infiniti logo does not appear (this might take up to 30 seconds), start over from step 18.

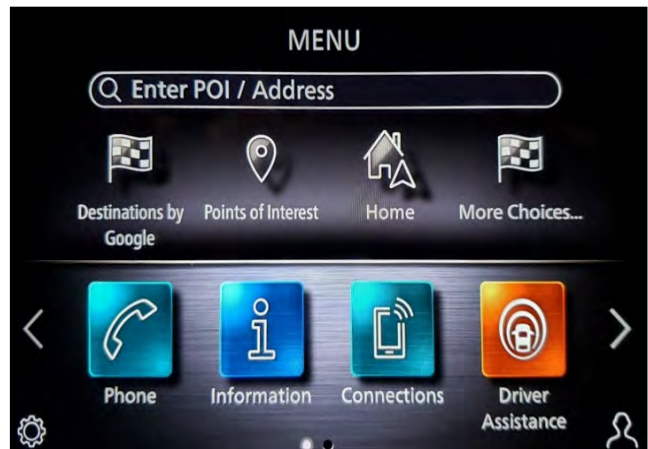
- The MENU (Home) screen in Figure 19 will be displayed.

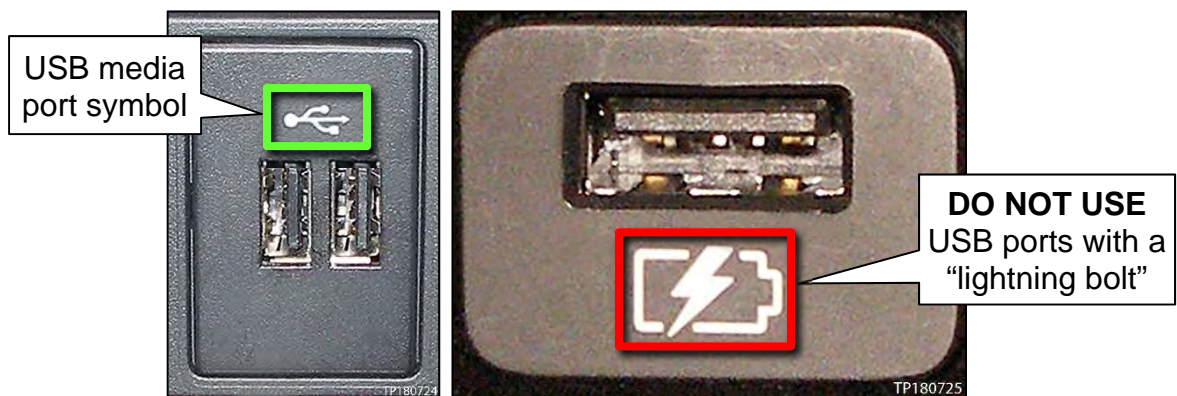
Figure 20

30. Insert the USB drive with the infotainment update-software into the vehicle's USB media port (Figure 20).

Do not insert the USB drive into a charging port. If used, the update-software and/or USB drive may become damaged. Only insert the USB drive in a USB media port.

**HINT:** Charging ports are marked in the vehicle with a “lightning bolt” symbol.

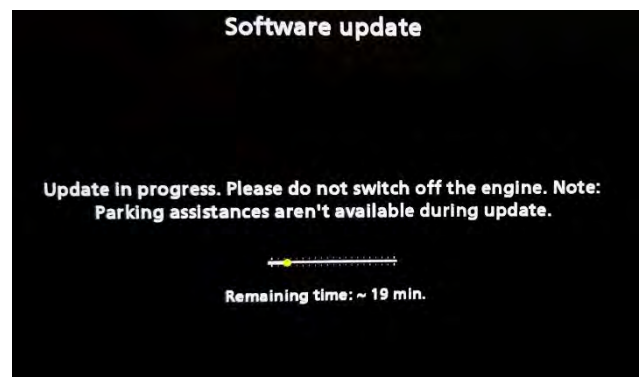
Figure 22

31. Wait for the update to complete.

**HINT:** The update lasts 20-30 minutes.

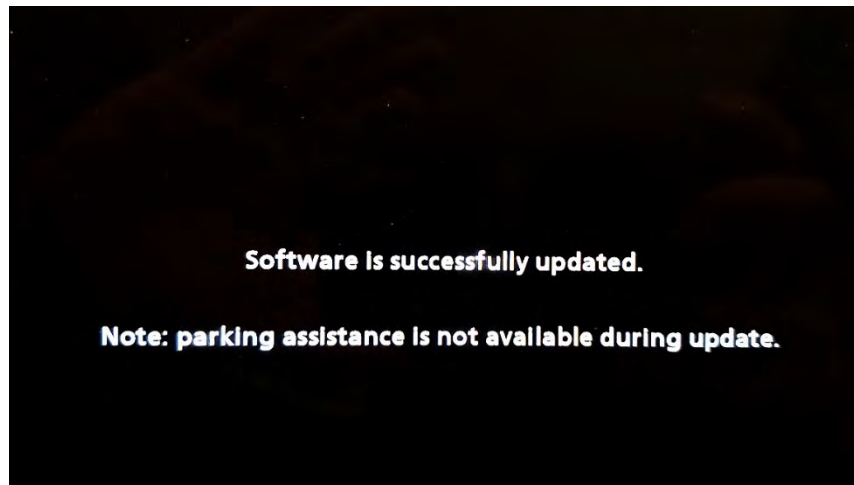
Figure 23

32. Once the update is complete (Figure 23), remove the USB drive; the system will reboot (restart).

**HINT:** The system will not reboot until the USB drive is removed.

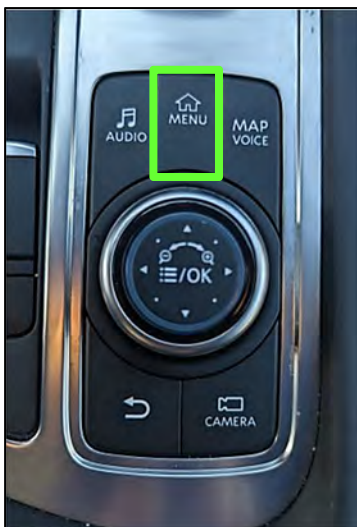
Figure 24

33. Press and hold the **MENU** button on the IT Commander (Figure 24) and turn the AV Control Unit volume knob (Figure 25) left-right-left at the same time.

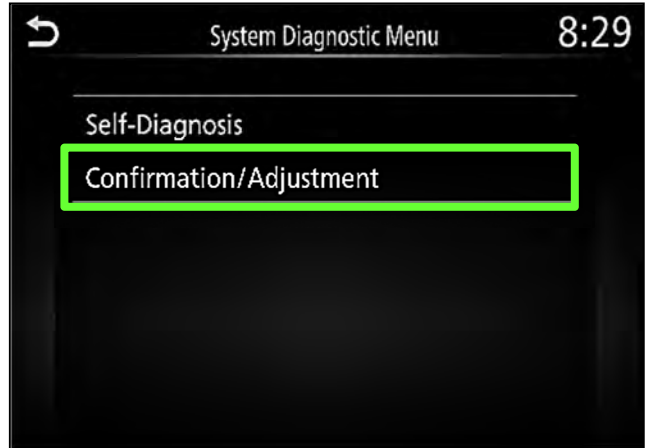
Figure 26

34. Select **Confirmation/Adjustment**.

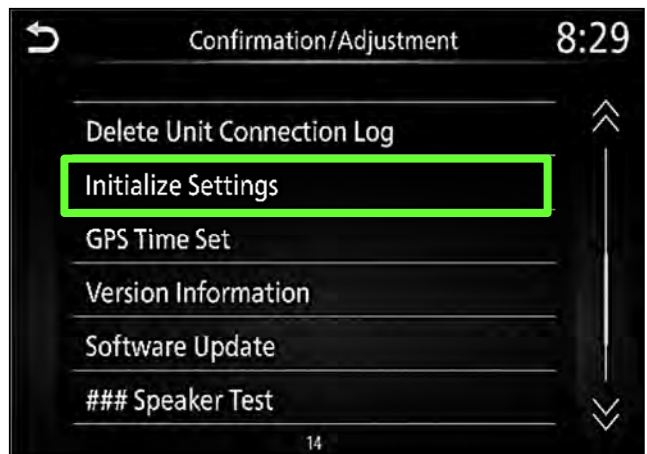
Figure 27

35. Select **Initialize Settings**.

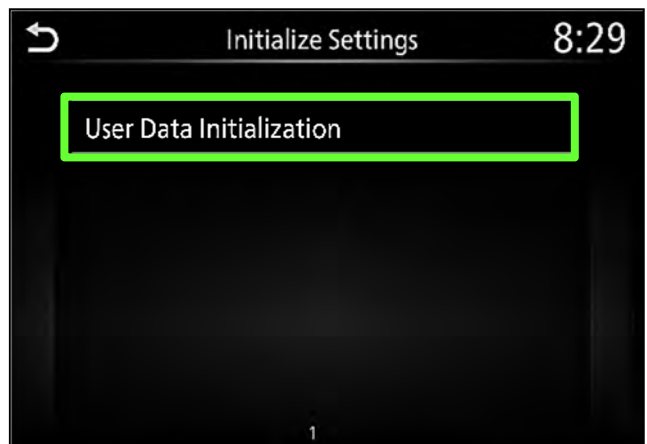
Figure 28

36. Select **User Data Initialization**.

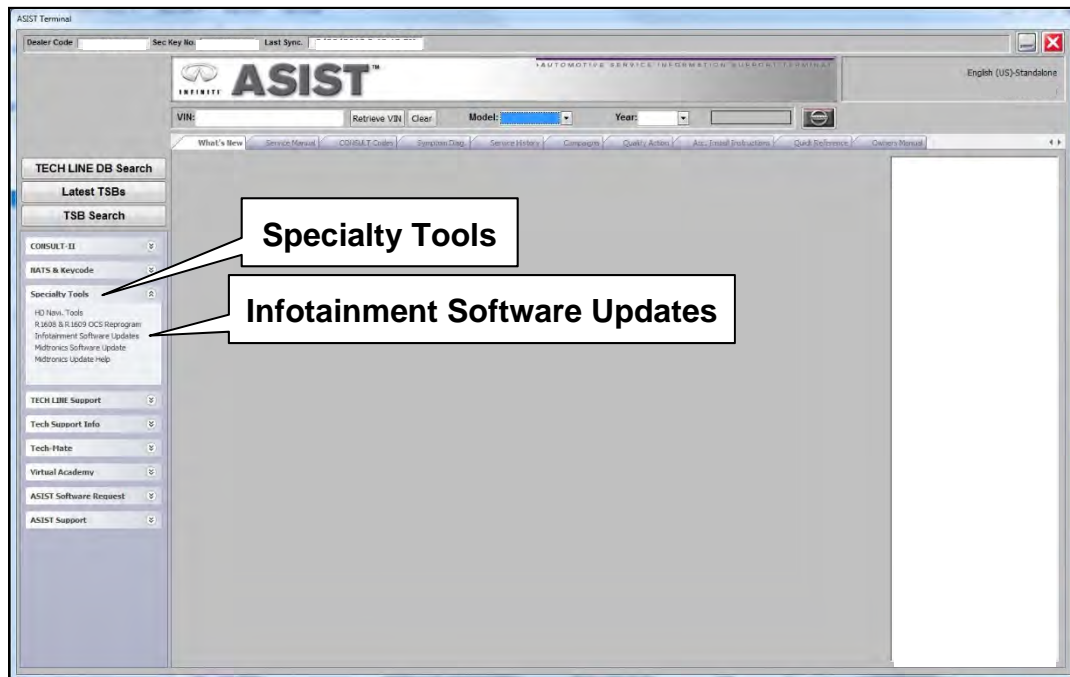
Figure 31

42. Select **Specialty Tools**, and then select **Infotainment Software Updates**.

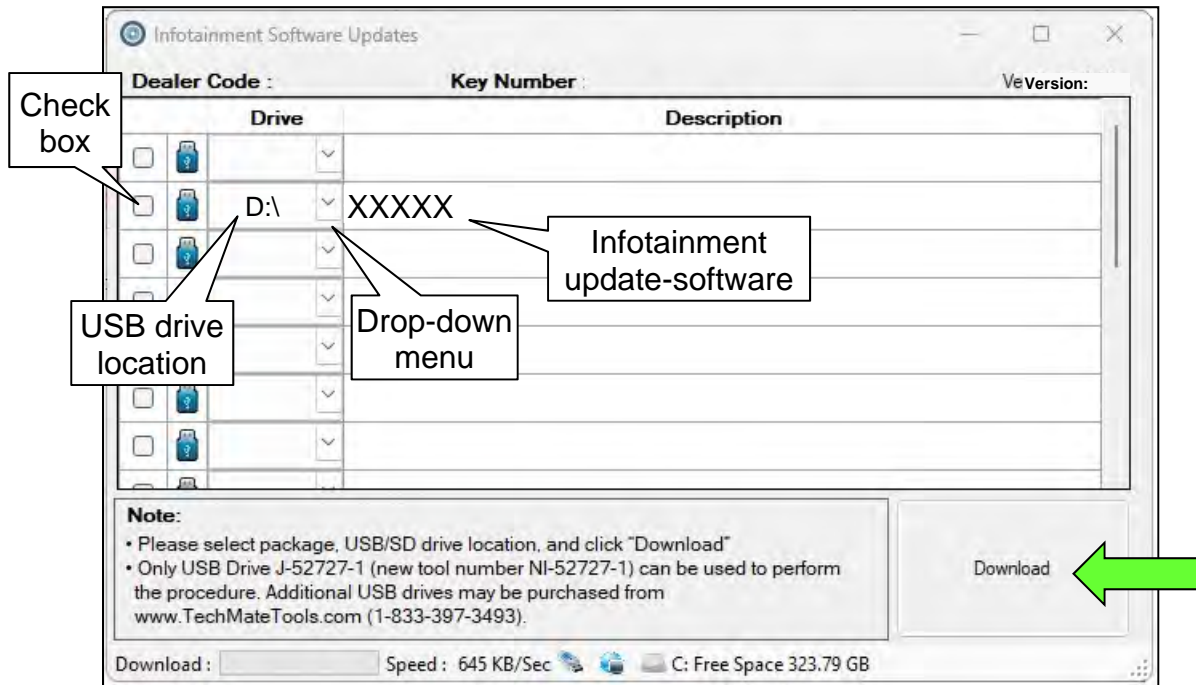
Figure 32

43. Select the check box next to the infotainment update-software (Figure 32).
  - Refer to the appropriate vehicle table to determine the correct infotainment update-software for your vehicle.
44. Use the drop-down menu and select the location of the USB drive that was inserted in step 40 on page 28.

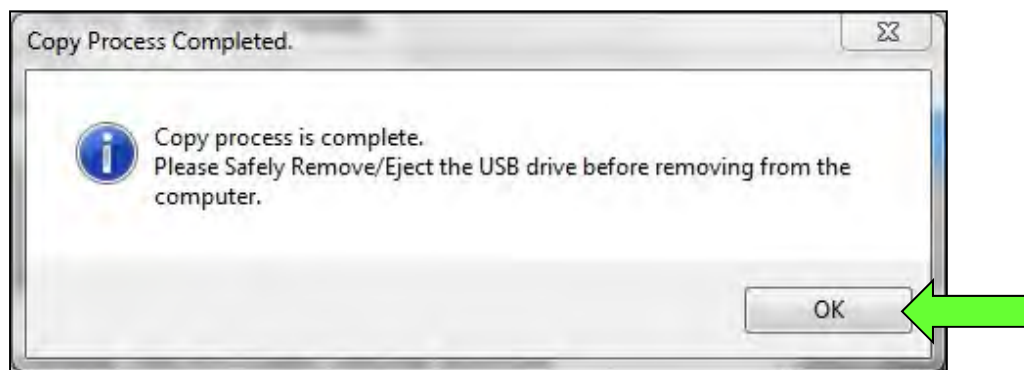
**HINT:** The update-software is estimated to take 10-15 minutes to download to the USB drive.
46. Select **OK** when the message in Figure 33 is displayed.

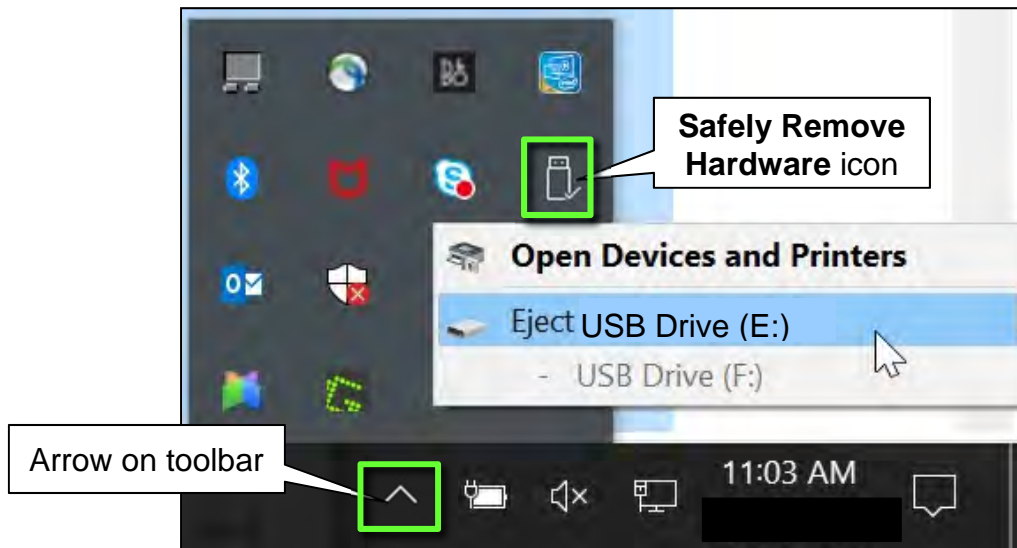
Figure 34

47. Once the transfer is complete, safely remove the USB drive from the CONSULT PC.
  - a. From the PC toolbar, select the **Safely Remove Hardware** icon.
    - o The icon is on the toolbar, or can be found after selecting the arrow.
  - b. Select the USB drive to be removed, and then remove the USB drive from the CONSULT PC.
