# Service Bulletin

Bulletin No.: 23-NA-124

**Subject: Dead Battery Resulting from Communication Gateway Module Activity**

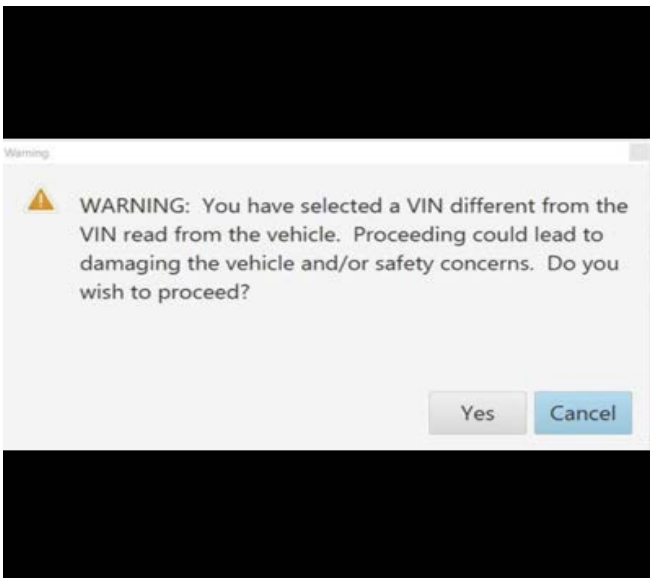
5877000

**Important:** If the vehicle VIN DOES NOT match, the message below will be shown.
