**TECHNICAL INSTRUCTIONS**  
**FOR**  
**23TC01**  
**TOYOTA SAFETY SENSE INOPERATIVE INTERMITTENTLY**  
**CERTAIN**  
**2023 MODEL YEAR bZ4X**  
**2023 MODEL COROLLA**  
**2023 MODEL COROLLA HATCHBACK**  
**2023 MODEL COROLLA HYBRID**  
**2023 MODEL COROLLA CROSS**

**I. OPERATION FLOW CHART**

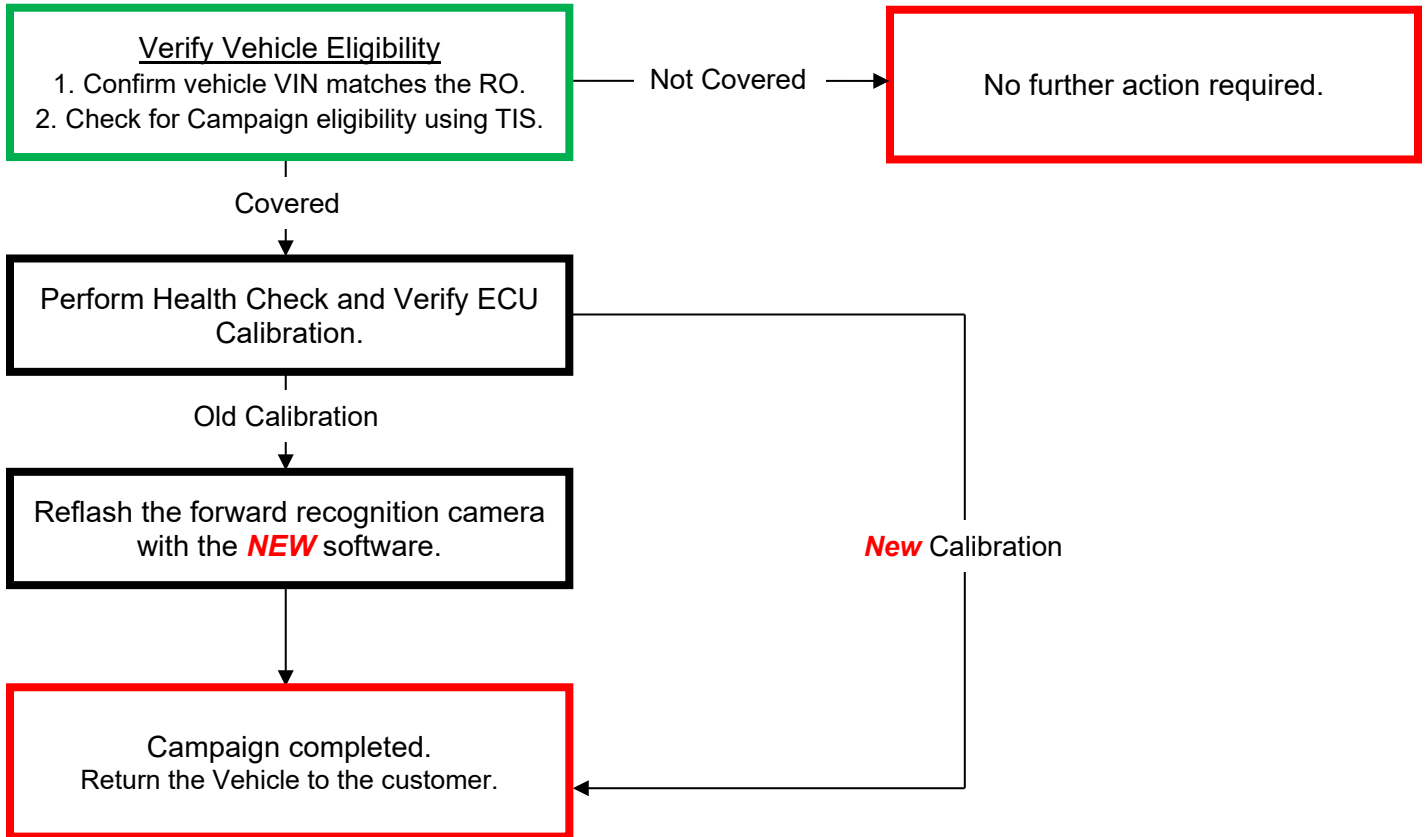
The flow chart is for reference only. **DO NOT** use it in place of the full technical instructions. Follow **ALL** steps as outlined in the full technical instructions to confirm the campaign is completed correctly.

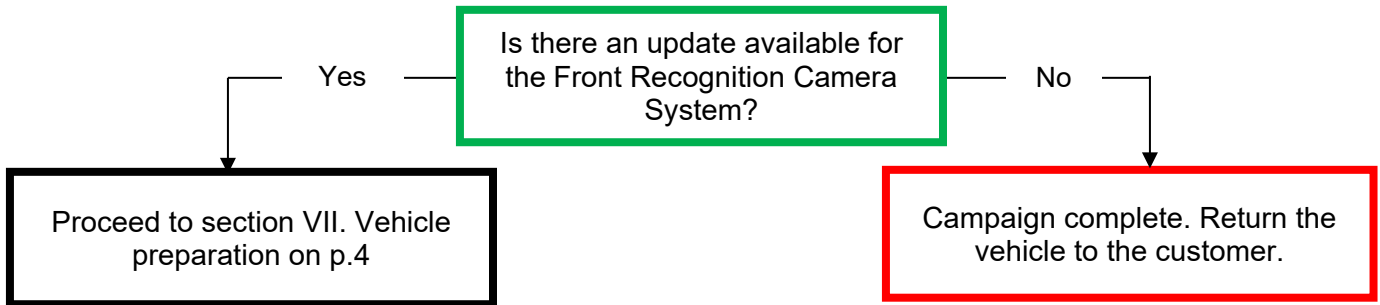
S221101206004aS

## 2. CHECK CURRENT CALIBRATION

- a) Locate the Update column for the Front Recognition Camera System in the Stored Data tab for this vehicle.
- b) Determine the status of an available update; indicated by a YES or NO.

### HINT:

If the CID's indicate 'Yes', proceed with the update procedure.

System	RoB	Calibration	Update	Configure
Circumference Monitoring Camera Control Module	●	8679F7820011 8679F7816021	No No	No
<b>Front Recognition Camera</b>	●	*****	<b>Yes</b>	No
Cleanance Camera	●	8934F7817020	No	No
Smart Access	●	021210040002	No	No
SRS Airbag	●	8917F7822000	No	No
Main Body	●	8AA117814000	No	No
Power Source Control	●	8922F7806003 02221C030002	No No	No

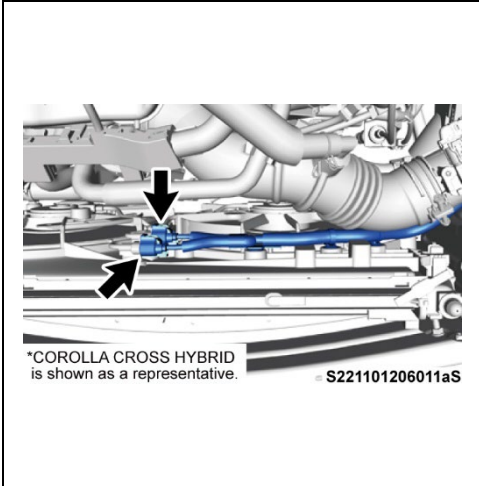
### 2. RECONNECT COOLING FAN (For COROLLA HYBRID and COROLLA CROSS HYBRID)

- Peel off the covering tape, etc.
- Reconnect the 2 connectors to the cooling fan on the radiator fan shroud.

**If you fail to reconnect fans a DTC may not set, ensure this is performed prior to the vehicle leaving.**

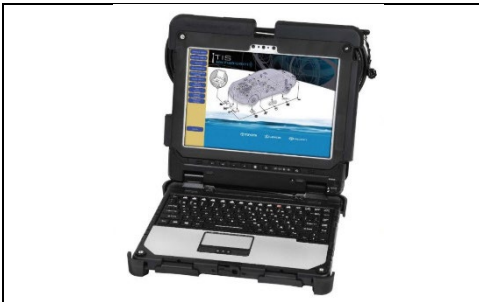
**THIS VERIFICATION HEALTH CHECK IS NECESSARY to update the results and CID's to the National database.**
