Service Action

Code: 97HB

Subject ID.4 Software Update

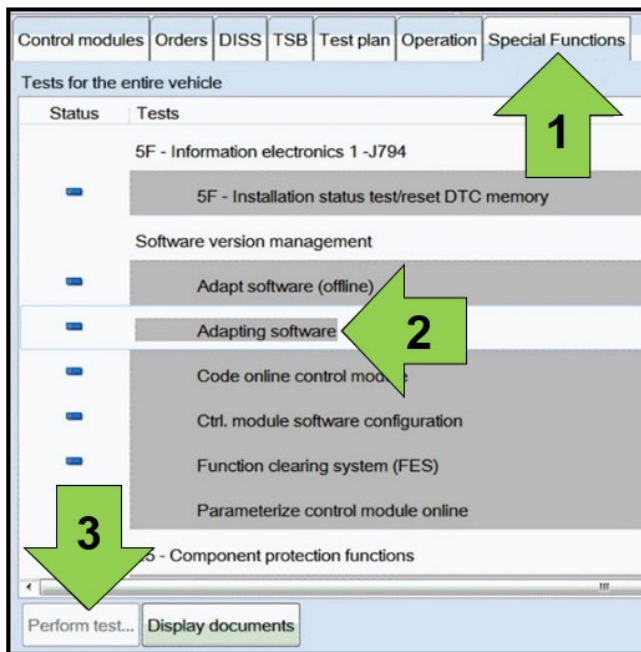
- Once the GFF scan is complete, select “Special functions” <arrow 1>, then “Adapting software” <arrow 2>, then select “Perform test” <arrow 3>.

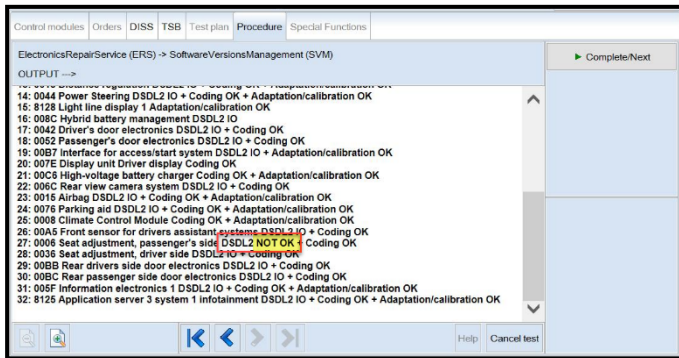
- Pay attention to the status report of the control module updates.
- Any module stating NOT OK will have to be updated again.
- Selecting “Complete/Next” will begin another attempt to update the control module.
- It may take more than one attempt to update every control module.

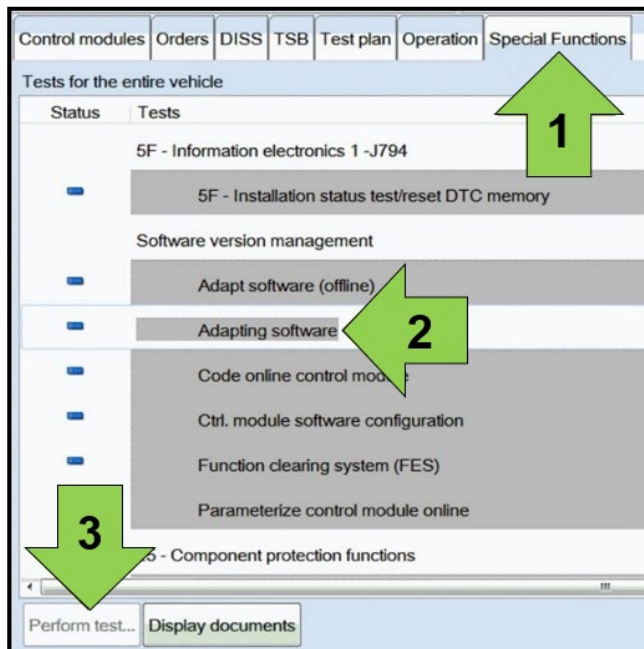
- Turn battery charger OFF, then back ON.
- Connect battery charger.
- Turn the hazards on.
- Confirm that scan tool is communicating with the diagnostic head by USB <Green Arrow>.
 - If the Bluetooth symbol is shown <Red Arrow> then disconnect the diagnostic head from the vehicle and reconnect the USB cable to the diagnostic head and then reattach to the vehicle.
- Upon ODIS startup, verify the “Diagnosis” operating mode is selected <as shown>.
- Once the GFF scan is complete, select “Special functions” <arrow 1>, then “Adapting software” <arrow 2>, then select “Perform test” <arrow 3>.

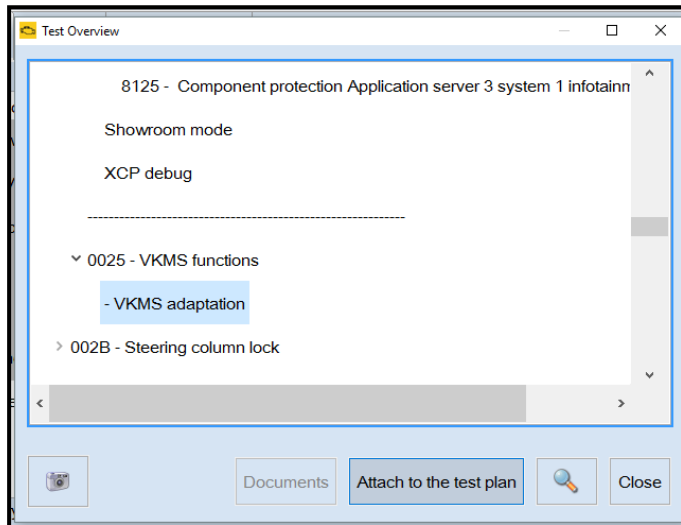
- Perform 0025 Immobilizer “VKMS Adaptation” test plan.

After selecting “Self Test,” use the search function and enter “VKMS” to aid in finding the test plan.

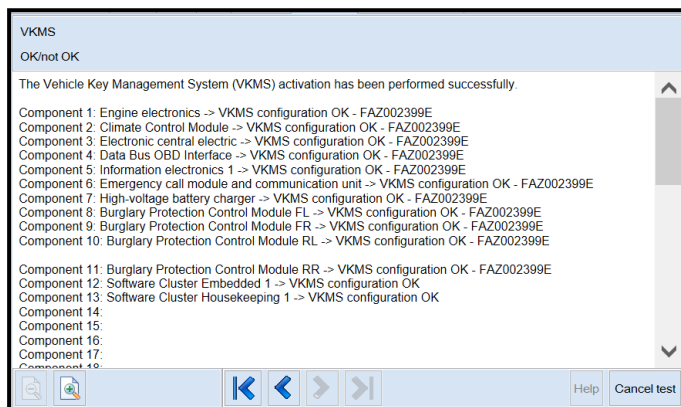
- Ensure each component shows the VKMS configuration is OK.
- If any component does not complete the VKMS adaptation, repeat the test plan.

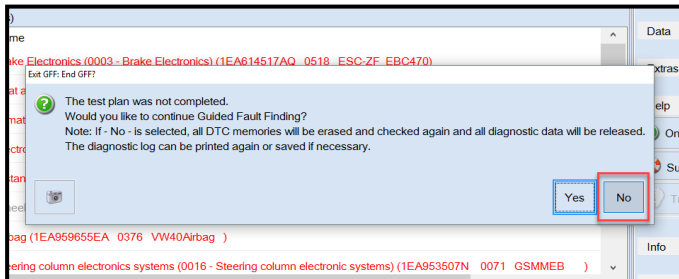
- When prompted to continue Guided Fault Finding, select “NO”.
- GFF will be exited and faults will be erased.

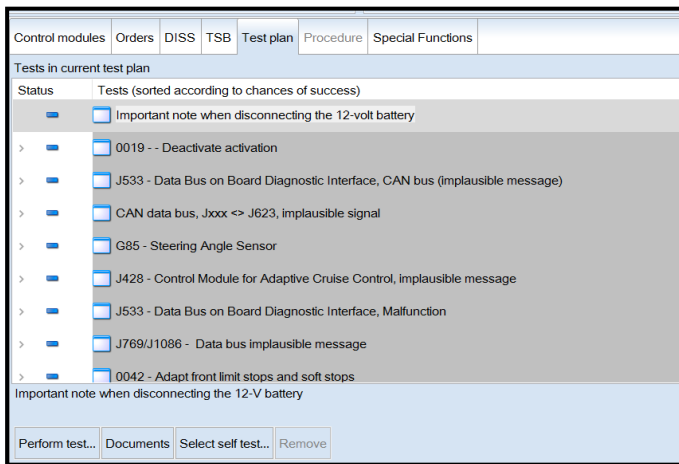
- Work through all test plans for faults created by the flash process.
- Reference any applicable TSBs that address “ghost” faults.
- Pay close attention to all steps outlined in the test plans and follow them exactly as described.
- Exit GFF and send diagnostic protocol online.
