SERVICE PROGRAM BULLETIN

APPLICABILITY: 2023 MY Solterra

NUMBER: WRG-23

SUBJECT: Reprogramming of the Forward Recognition Camera

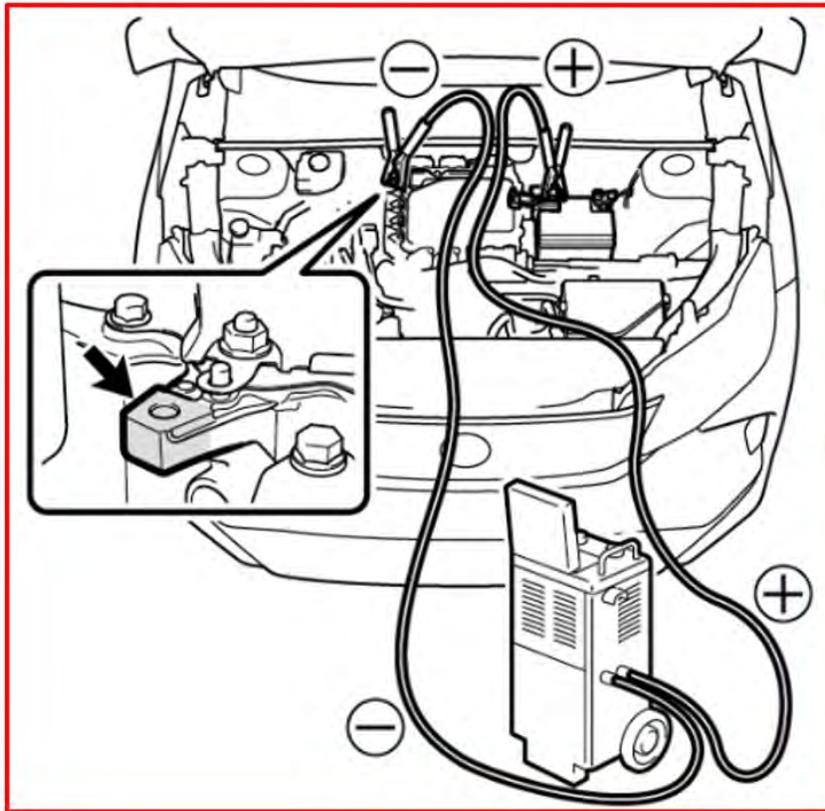
BATTERY CHARGER NOTES:

- For instructions on using the Power Supply Mode, reference the applicable User Manual for the Midtronics DCA-8000 Dynamic Diagnostic Charging on STIS.

- Select the correct battery type (Enhanced Flooded, Flooded, Gel, AGM, or AGM Spiral).
- Input the CCA which matches the vehicle's battery.
- If using a DCA-8000 Dynamic Diagnostic Charging System, set the power supply voltage to 13.5 Volts.

- DO NOT connect the GTS+ until the Power Supply mode function has completed its battery test mode and the Charging Voltage has dropped to and shows a steady 13.5 Volts on the display.

- Once Power Supply Mode reaches a steady 13.5 Volts, connect the GTS+ to the OBD connector and proceed with initiating the normal reprogramming process.

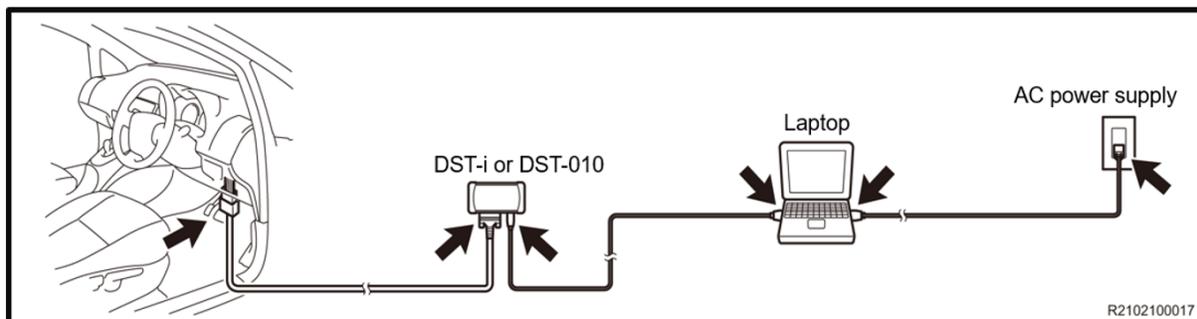
STEP 4: Secure the connection of the cables.

Confirm the power switch

is in the OFF position and connect the laptop to the vehicle.

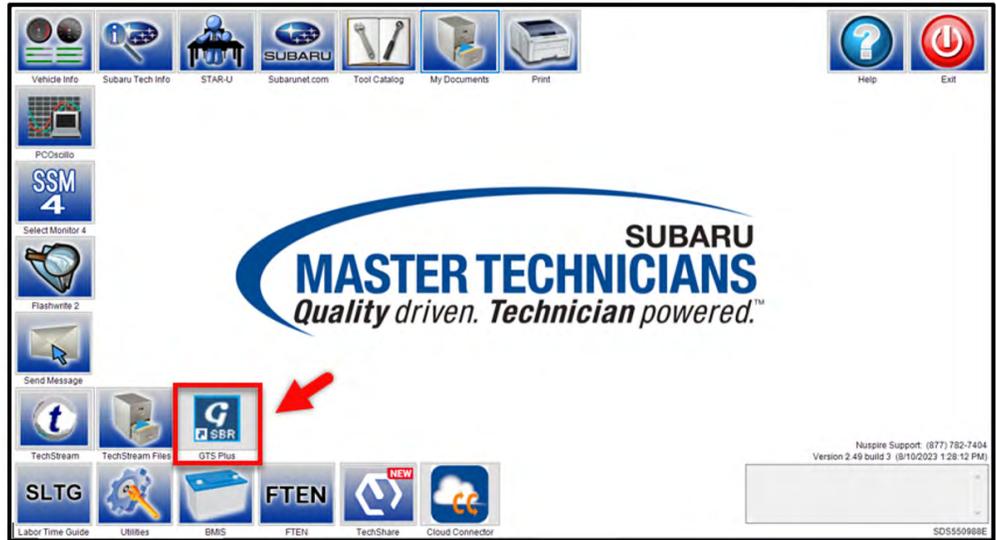
- A. Click the GTS+ icon to start the GTS+ application.

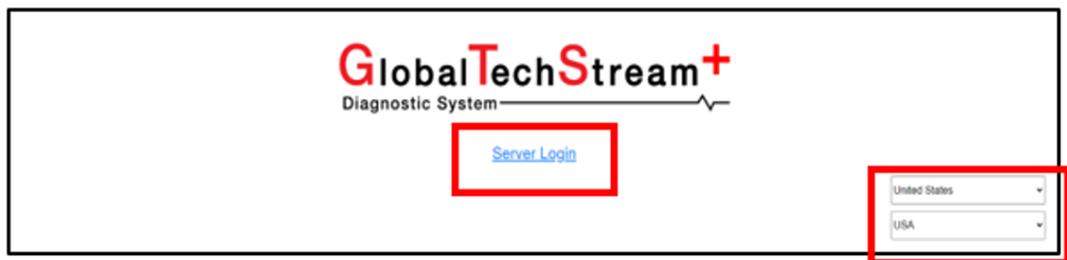
- B. SSM will automatically close and the GTS+ browser will open. Set the GTS+ application region to “United States” and set the lower box to “USA” then click the Server Login link.

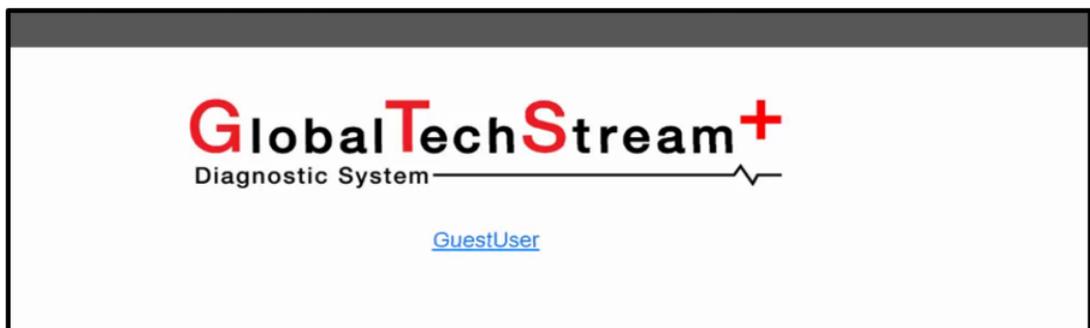
NOTE: In some instances, a user may have logged in previously. In these cases, if the PC has not been restarted, the screen bellow my appear when clicking on the GTS+ icon (Step 5-A). This is normal operation. Click the “GuestUser” link to directly login to GTS+.

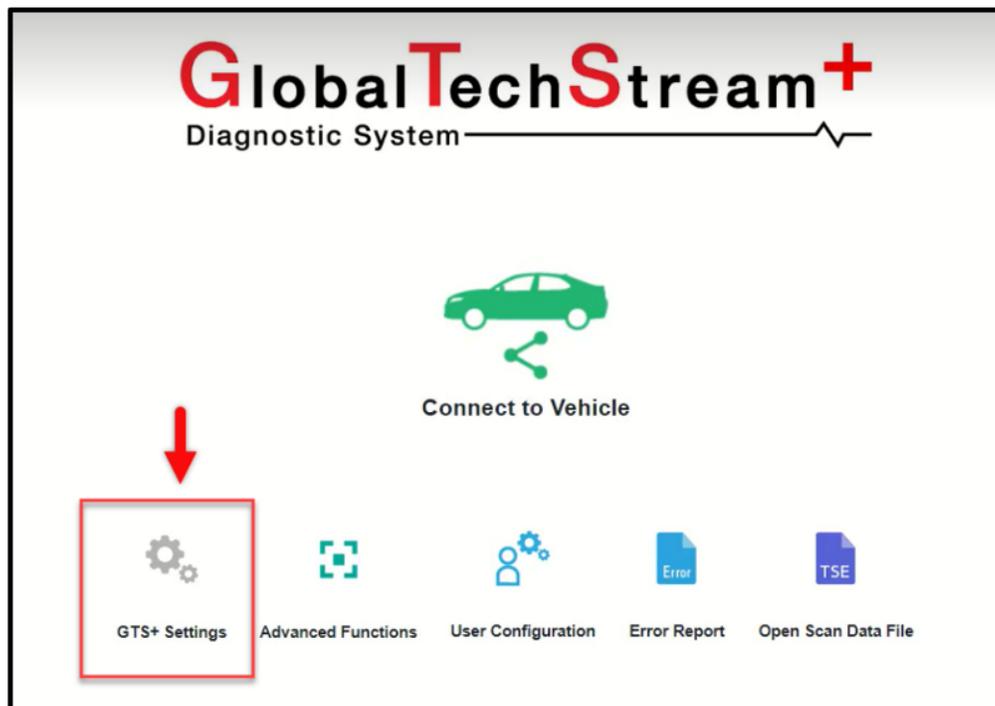
- D. Turn the power switch

to the ON position **WITHOUT** depressing the brake pedal. Click the “GTS+ Settings” button.

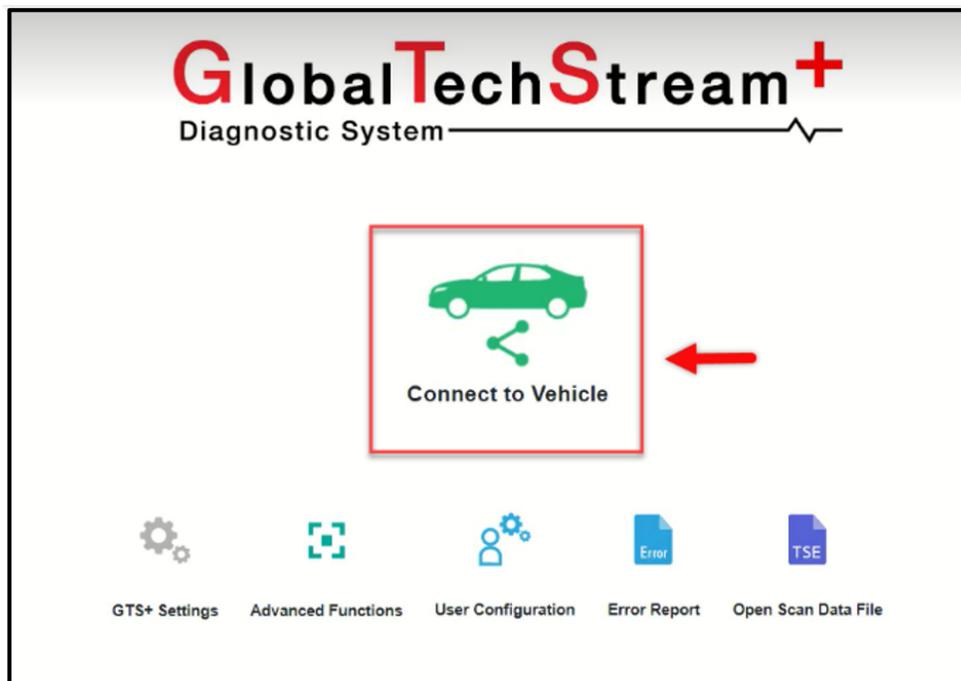
- F. Click the “Connect to Vehicle” button. Confirm the target VIN information and continue by clicking the “Next” button.

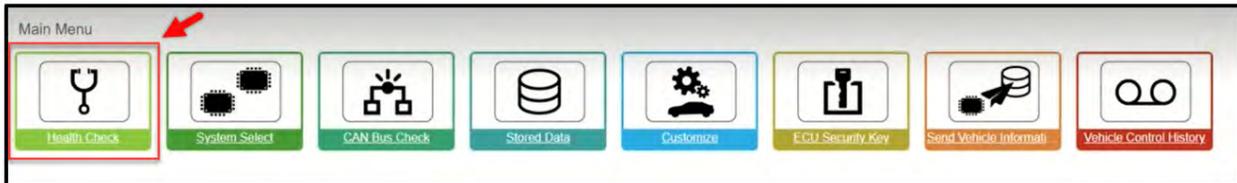
STEP 6: Click “Health Check” button located in the Main Menu.

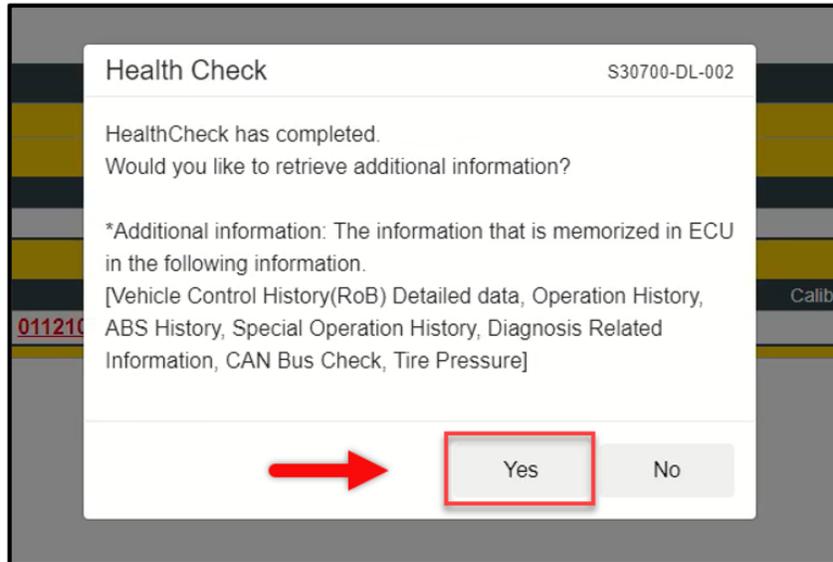
STEP 8: While the Health Check is being performed, a pop-up will be displayed asking if you would like additional information retrieved. Click the “Yes” button to continue.

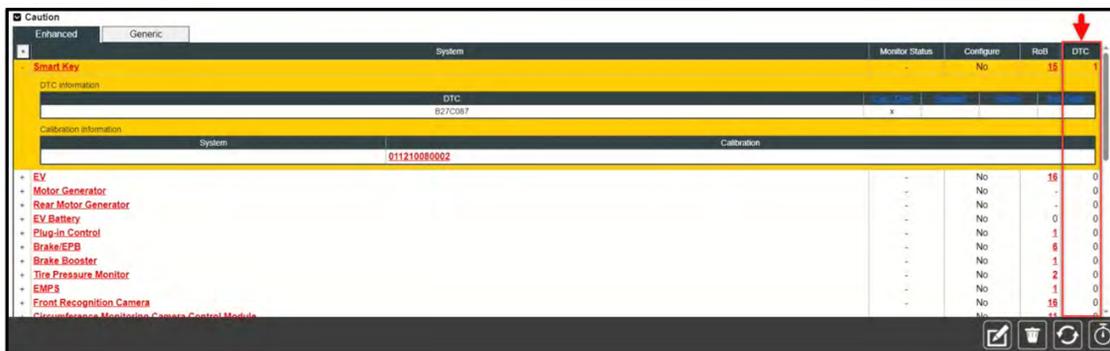
STEP 9: Once the Health Check is completed, check the results for any stored DTC(s).

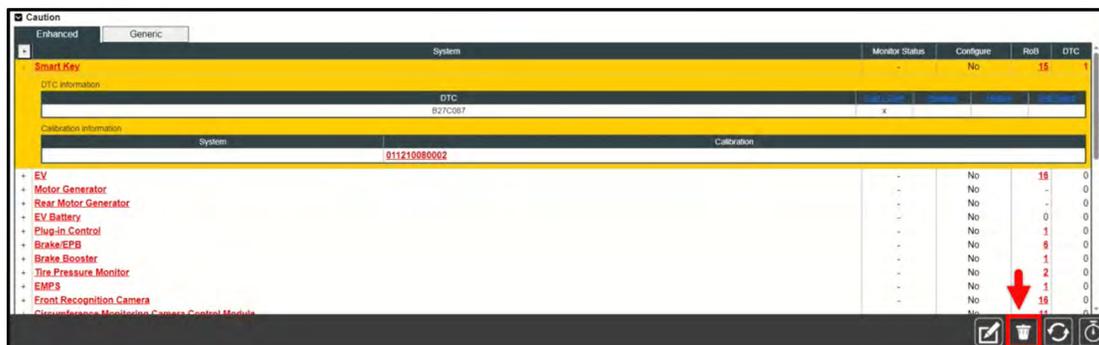
STEP 10: Clear all DTC(s) by clicking the “Erase” button.

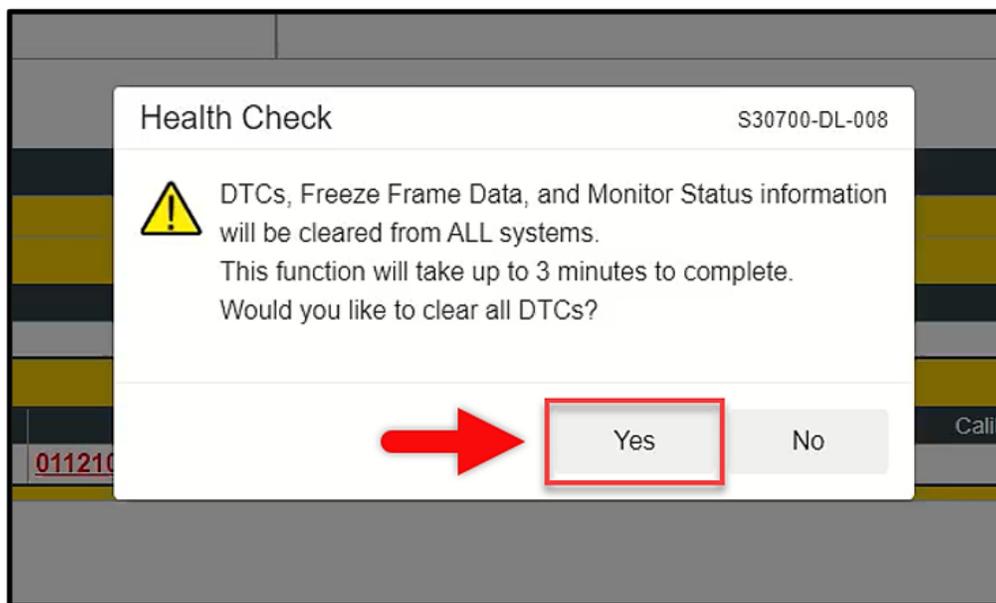
A pop-up will display reminding all Freeze Frame and Monitor Data will be cleared. Click the “Yes” button to continue.

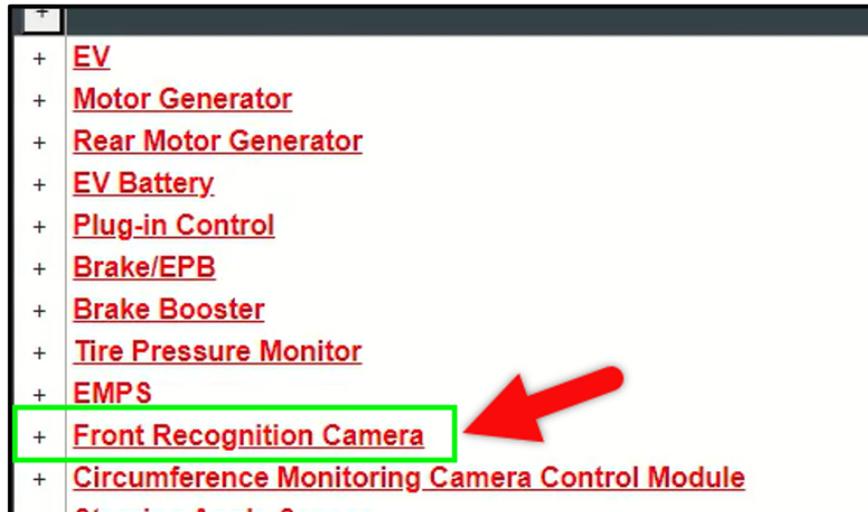
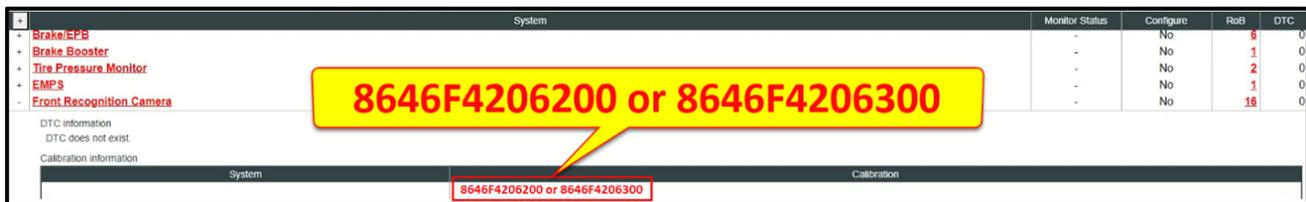
STEP 11: Click on the “Plus” symbol next to Front Recognition Camera to expand the system information. Confirm the Forward Recognition Camera calibration ID displayed is 8648F4206200 or 8646F4206300. In a rare case of 8646F4206400 being displayed, there would be no need for further action.

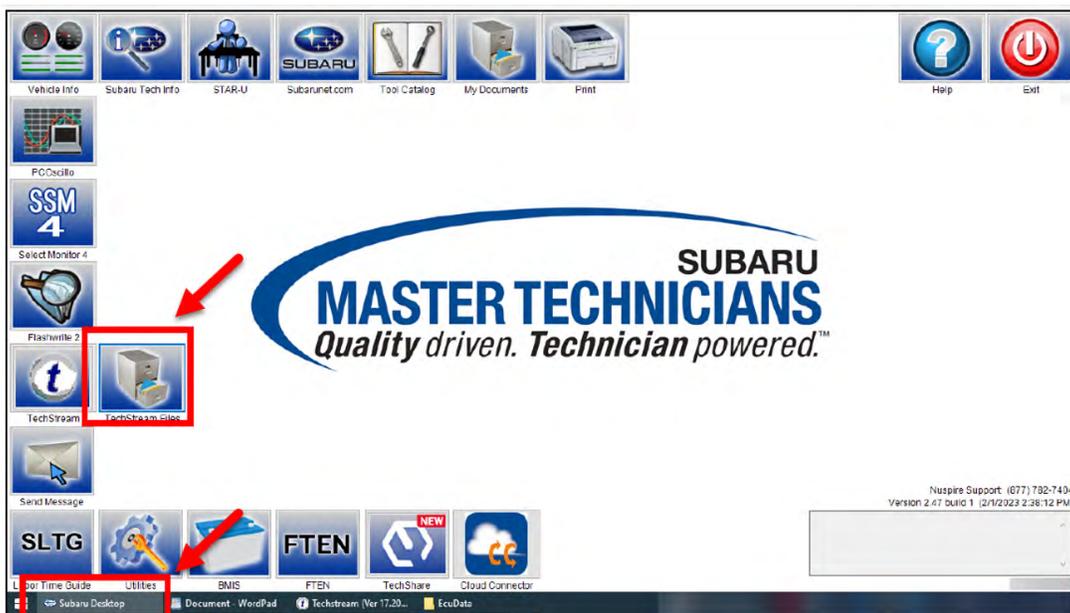
STEP 12: Prepare the Forward Recognition Camera CUW file. Select the Subaru Desktop from the lower taskbar. Select The TechStream Files icon. Open the ECU Data folder.

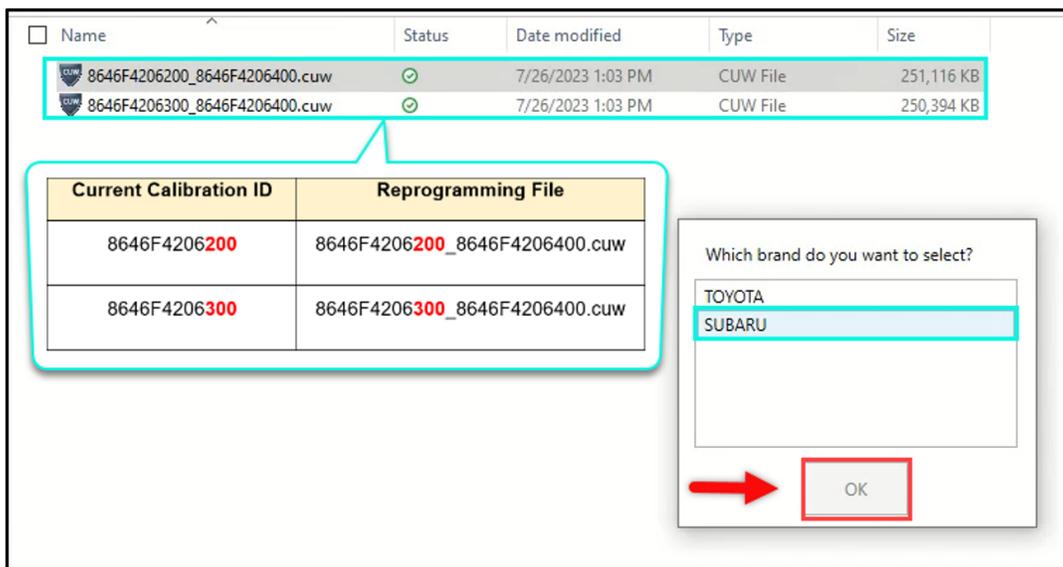
STEP 13: Double-click the applicable CUW file icon. A pop-up will display requesting a manufacturer to be selected. Select “Subaru” and click the “OK” button to continue.

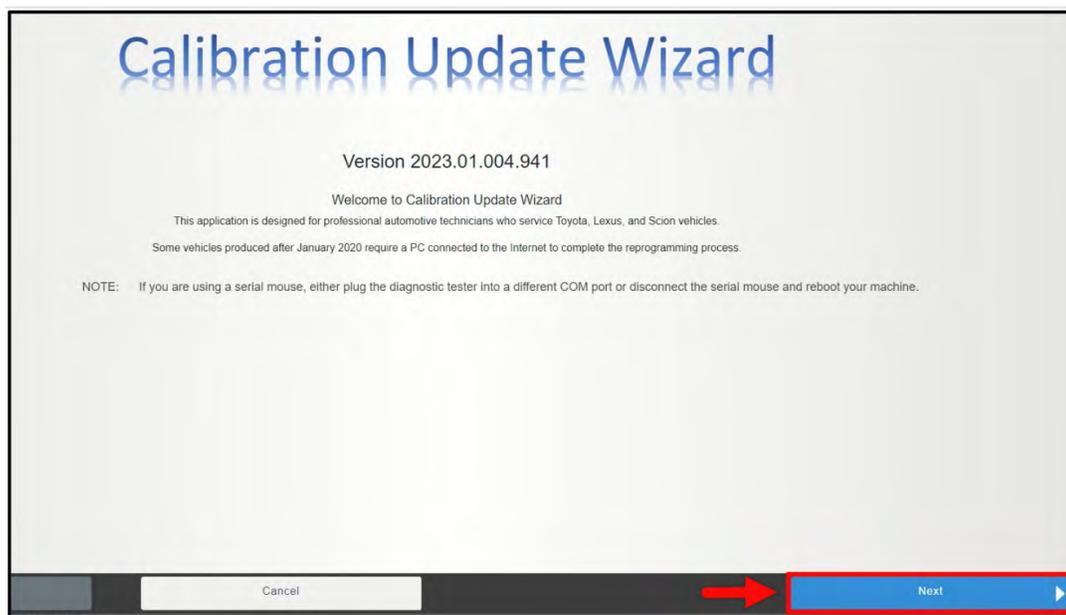
STEP 14: After double-clicking the file icon, the Calibration Update Wizard program is launched, and a new window will appear. Select the “Next” button to continue.

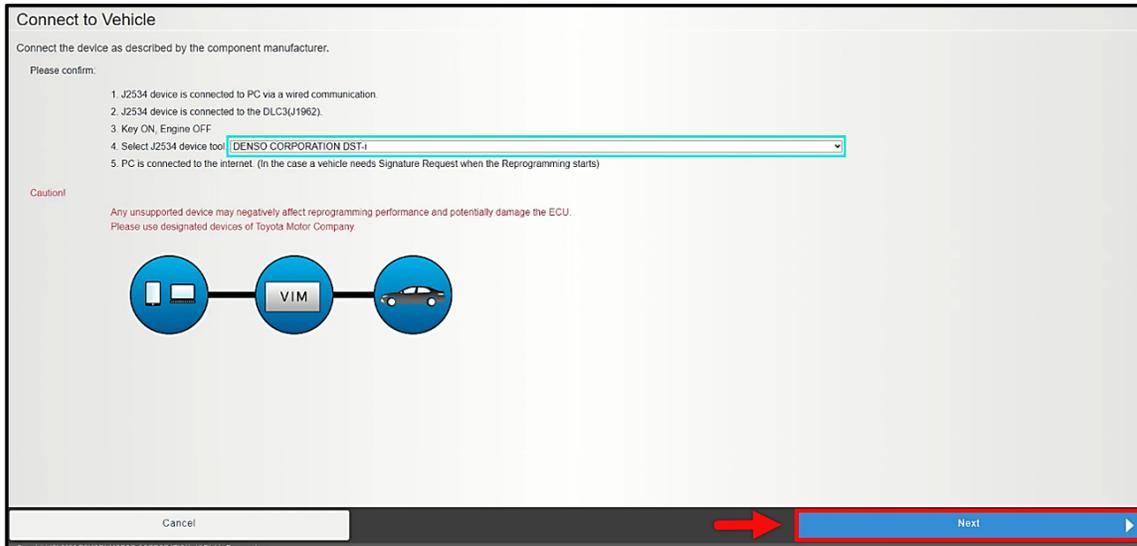
STEP 15: Confirm the pass-through device currently being used. Select the “Next” button to continue.

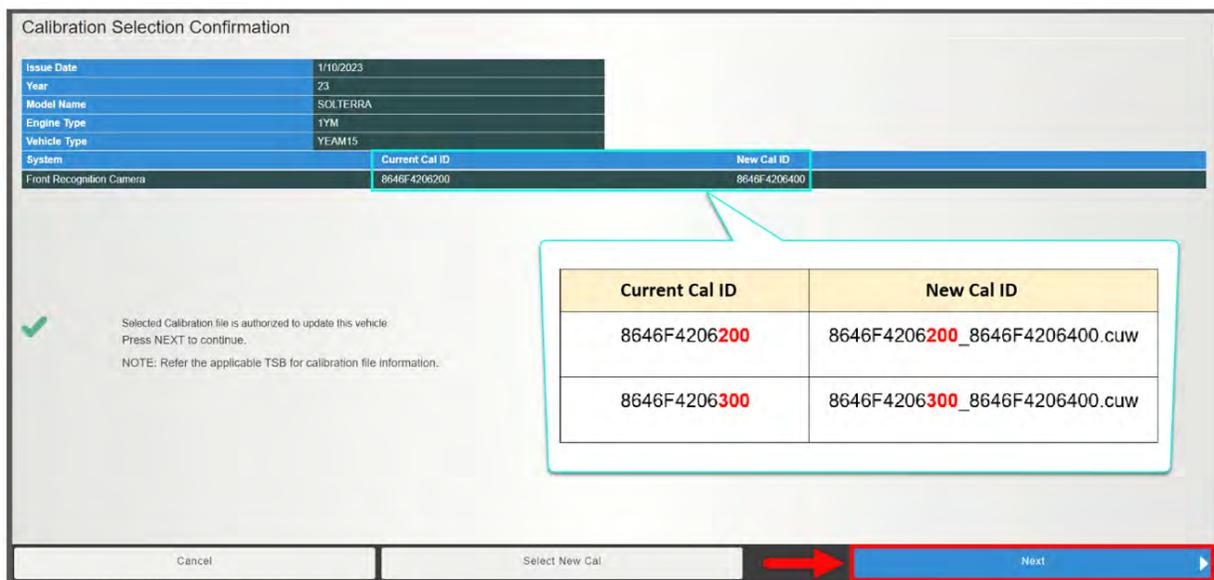
STEP 17: The Calibration Selection Confirmation window will appear. Confirm the applicable Current Cal ID and the New Cal ID. Click the “Next” button to continue.

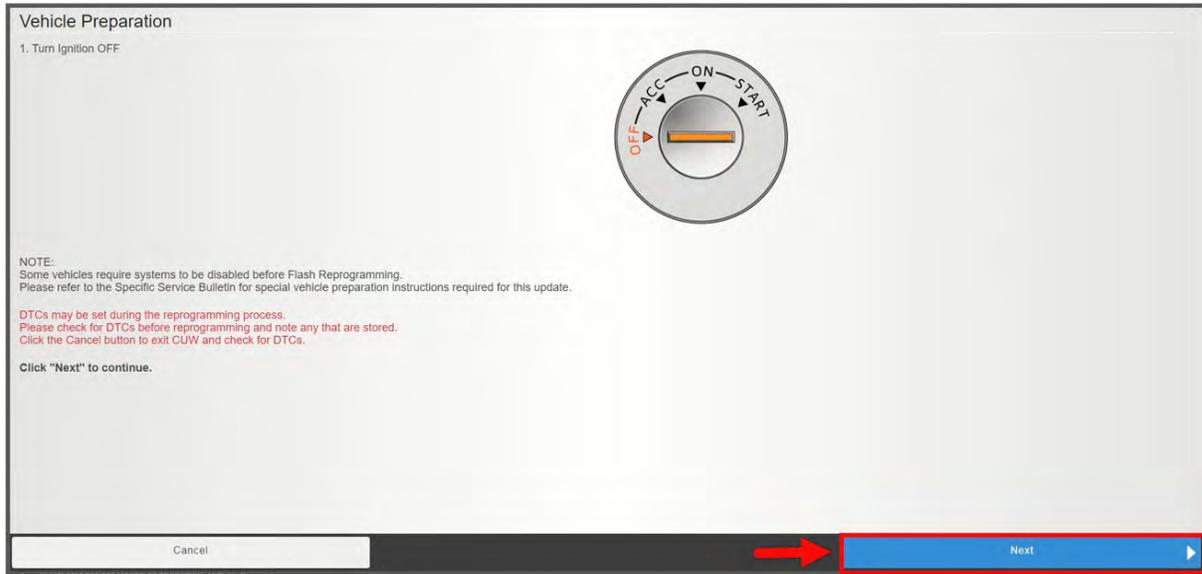
STEP 18: Review the CAUTIONS listed. Follow the on-screen instruction, turn the power switch to the OFF position. Select the “Start” to continue.

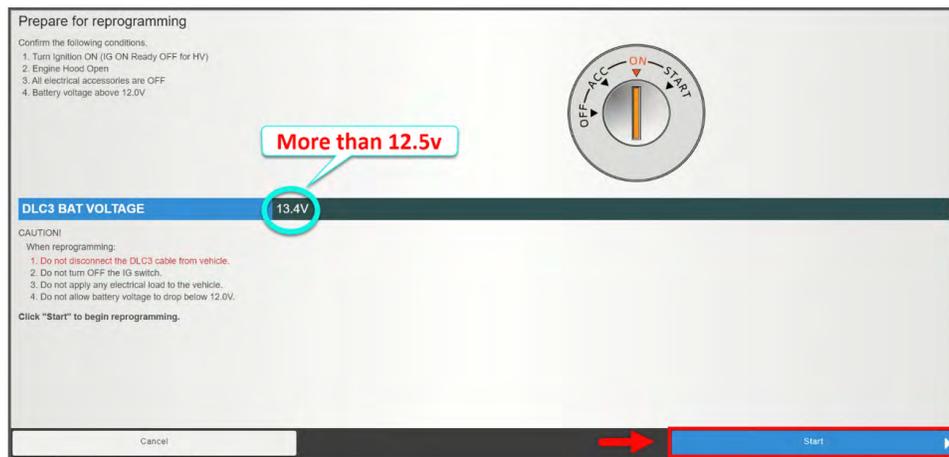
STEP 19: Review the CAUTIONS listed. Follow the on-screen instruction, turn the power switch to the ON position **WITHOUT** depressing the brake pedal. Confirm the 12v auxiliary battery voltage is more than 12.5 volts. Select the “Start” to begin the reprogramming process.

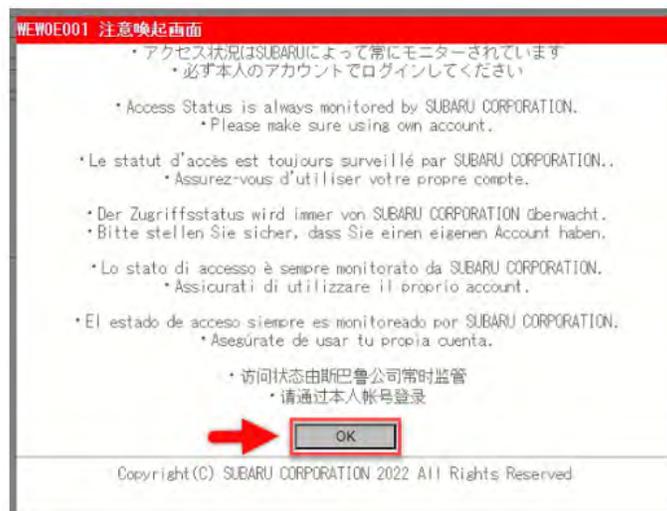
STEP 21: Once the browser is started, a pop-up will display. Click the “OK” button to continue.

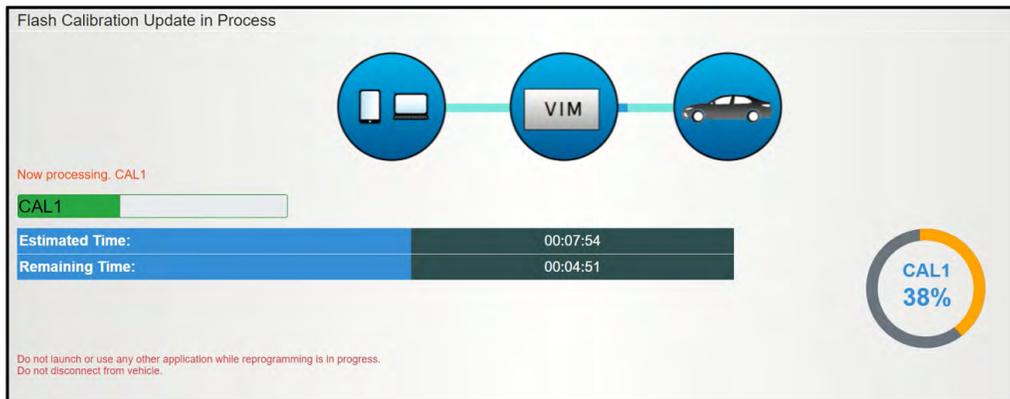
STEP 25: While the vehicle is reprogramming, the progress window is displayed. **ALWAYS** remain near the vehicle during reprogramming in order to monitor the progress.

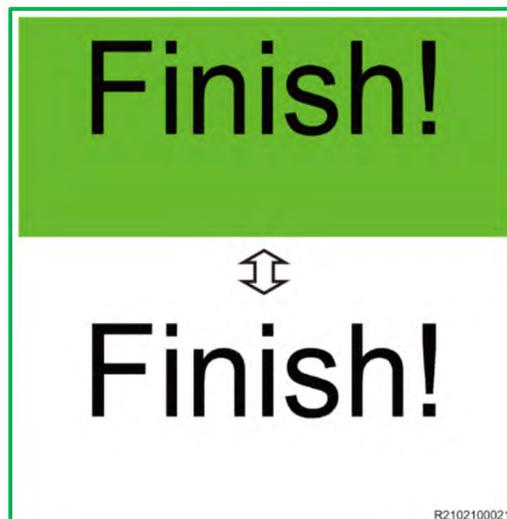
STEP 26: When the reprogramming procedure is successfully completed, the “Finish” window will be displayed. Press any key to continue. **IMPORTANT NOTE:** If the reprogramming procedure is unsuccessful, an error window is displayed. If no error window is displayed, proceed to Step 27.

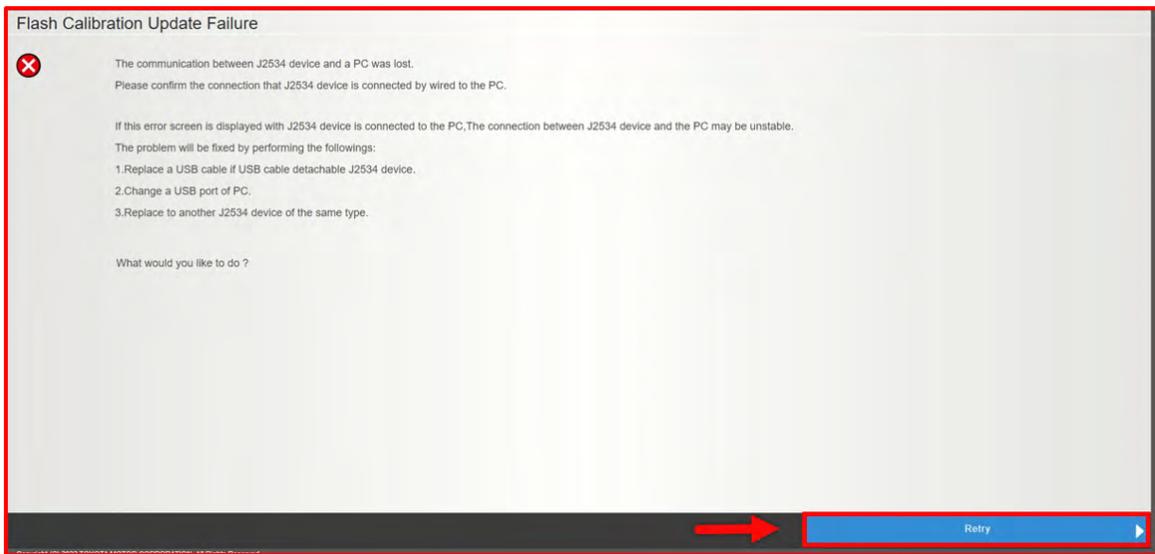
Attempt to restart the reprogramming procedure by clicking the “Retry” button **AFTER** the following prerequisites are met:

- Inspect the USB cables and connections and confirm they are in working condition.
- Confirm the 12V battery has sufficient charge.
- Confirm the battery charger is operating as desired.
- Confirm the battery cables are securely connected.

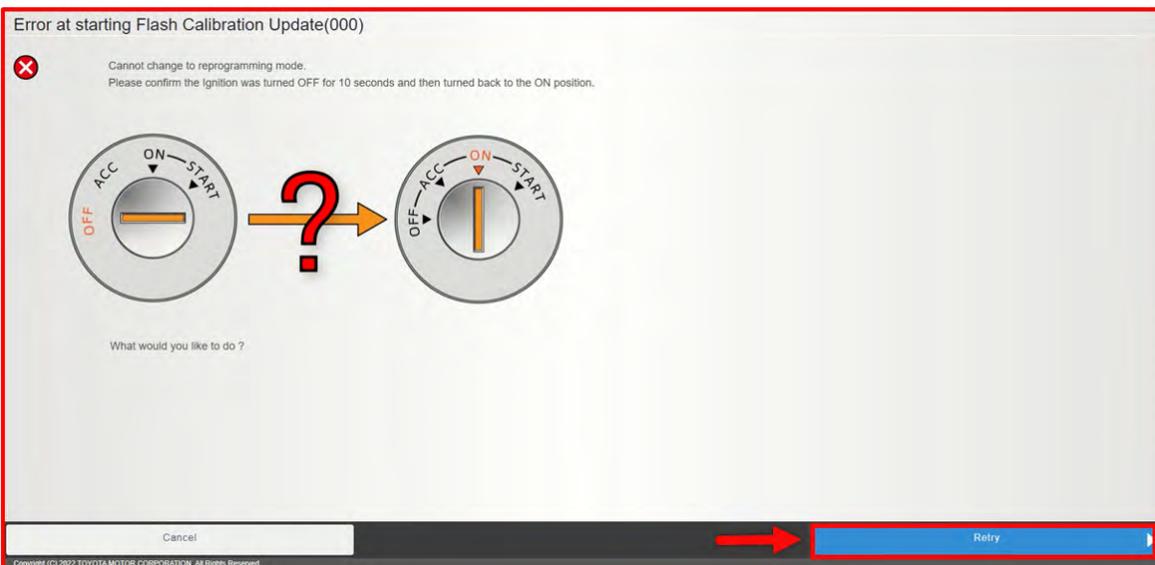
Cycle the power switch

as per the GTS+ and click the “Retry” button to continue.

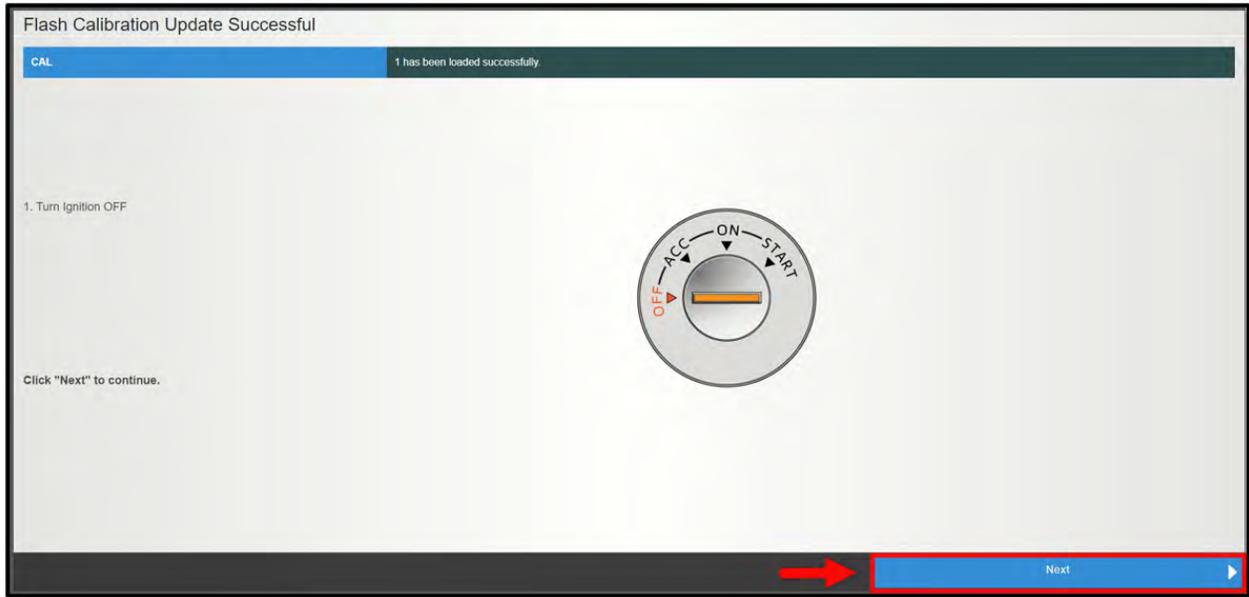
STEP 27: The “Flash Calibration Update Successful” window will display. Turn the power switch to the OFF position. Click the “Next” button to continue.

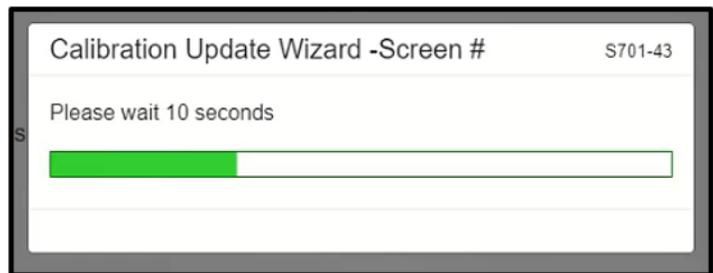
NOTE: A Progress bar will be displayed. **DO NOT** operate the power switch while the bar is shown.

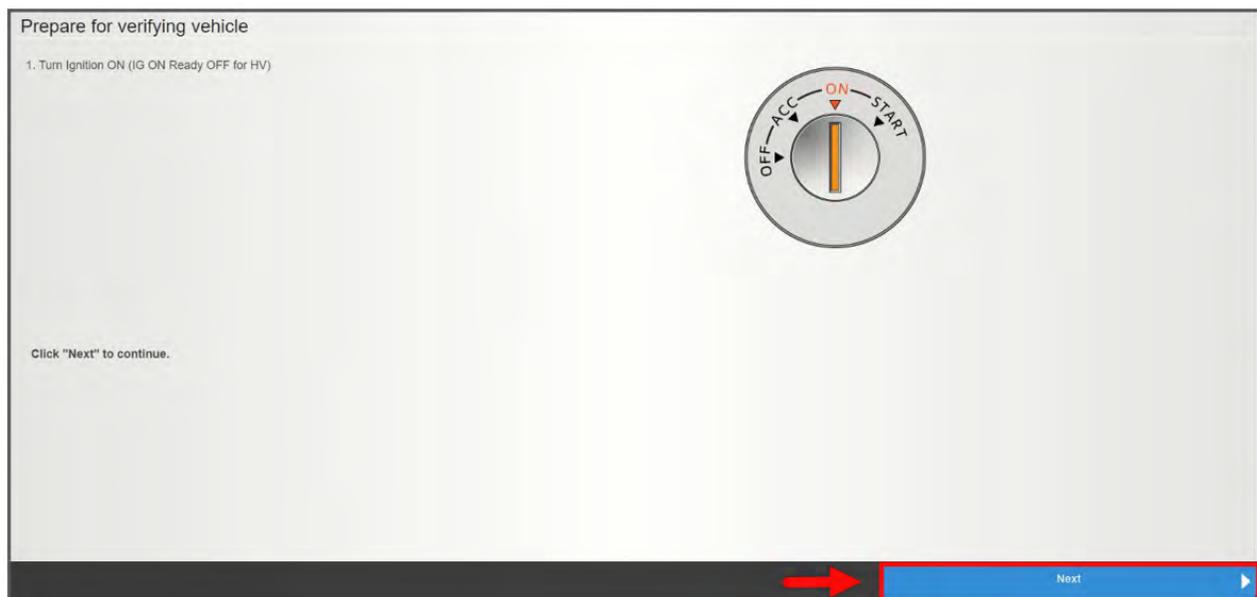
STEP 28: Follow the on-screen instruction. Turn the power switch to the ON position. Select the “Next” button to continue.

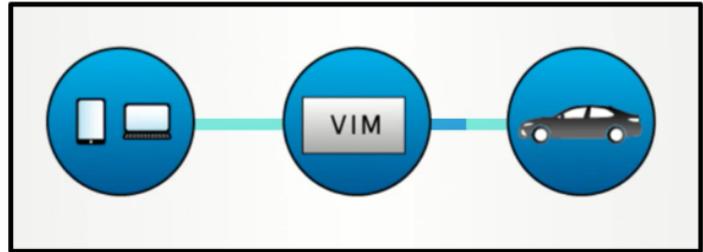
NOTE: A Progress bar will be displayed.
DO NOT operate the power switch while the bar is shown.

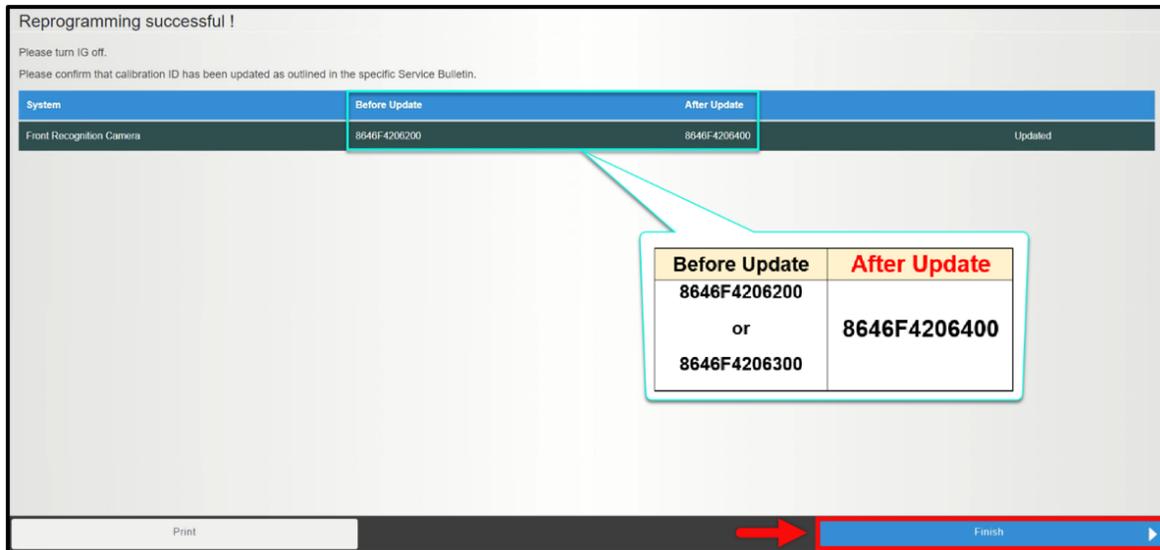
STEP 27: Confirm the “AFTER UPDATE” calibration ID is 8646F4206400. Click the “Finish” button.

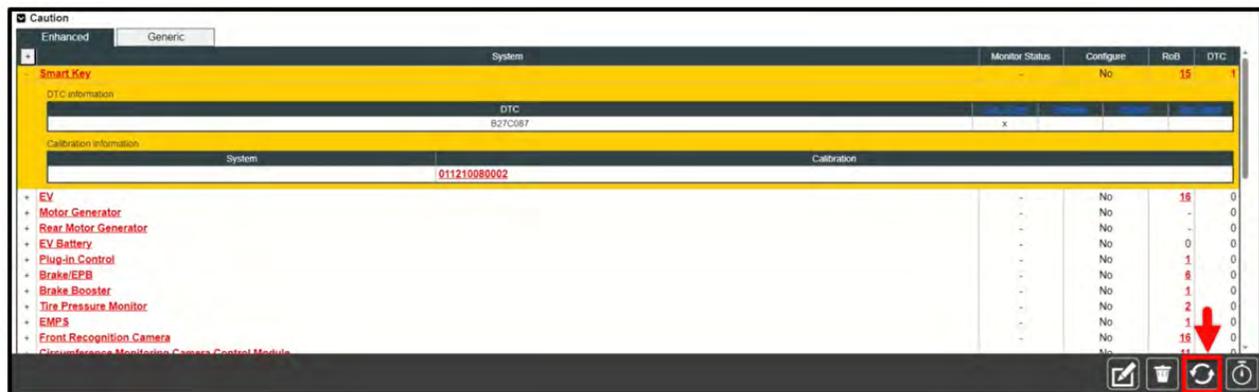
STEP 27: Return to the GTS+ window. Perform the “Health Check” a second time by selecting the button in the lower right corner of the Stared Data tab window.

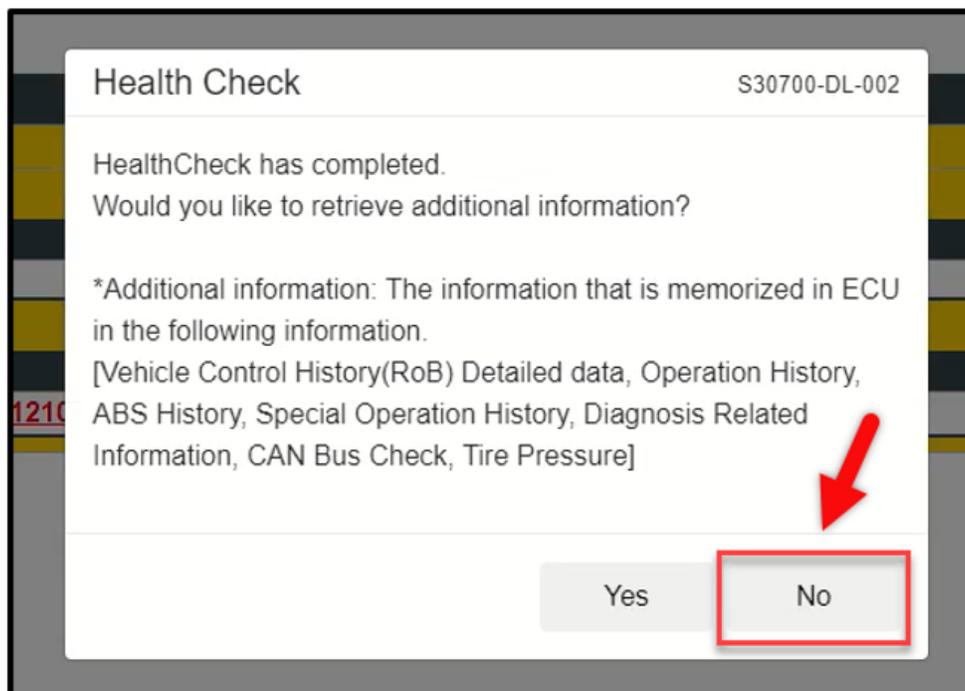
While the Health Check is being performed, a pop-up will be displayed asking if you would like additional information retrieved. Click the “No” button to continue.

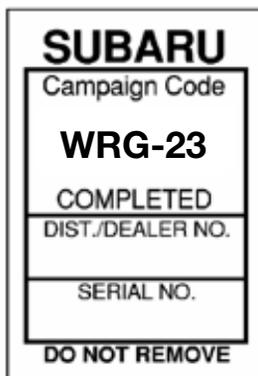
Type or print the necessary information on a Campaign Identification Label. The completed label should be attached to the vehicle’s left side radiator support bracket located behind the driver side headlamp. Additional labels are available through normal parts ordering channels. The part number is MSA6P1302, which comes as one sheet of 20 labels.
