# 36-008: T680 Next Gen Lane Keep Assist Retrofit

T680 Next Gen Lane Keep Assist Retrofit

Certain T680 Next Gen pre-production chassis are eligible to receive production-level software, dash switches, and driver information displays.

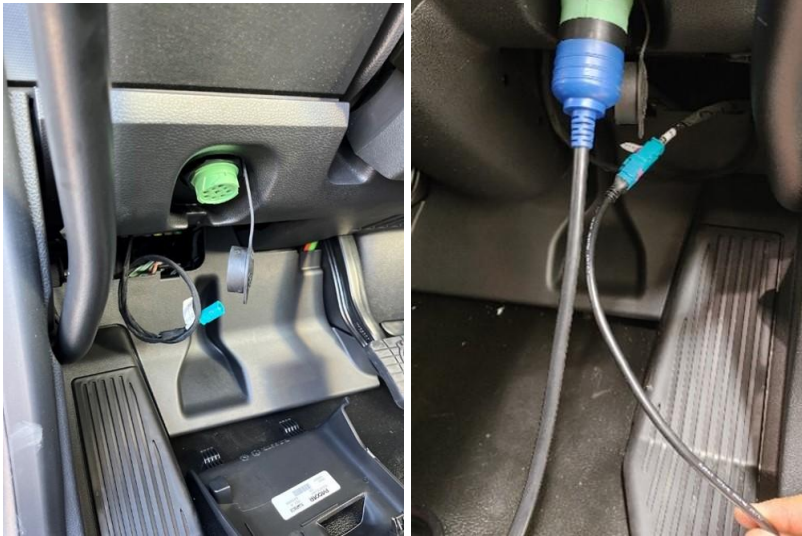
1. Hook-up battery charger to the vehicle during programming.
2. Connect DAVIE4.
  - Hook-up Nexiq to 9-pin diagnostic connector.
  - Hook-up Ethernet cable.

3. Download software for each module to be updated.
  - Digital Display
  - VECU
  - EPAS
4. Upload software to individual modules following DAVIE4 prompts.
  - Digital Display
  - VECU
  - EPAS
5. Run "relearn switches" following DAVIE4 prompts.
6. Clear codes in all modules and refresh vehicle check.
7. Disconnect DAVIE4 and battery charger.
