# Service Bulletin

Bulletin No.: 23-NA-157

**Subject: HPCM2 Software Update for DTC U3636 Symptom 09**

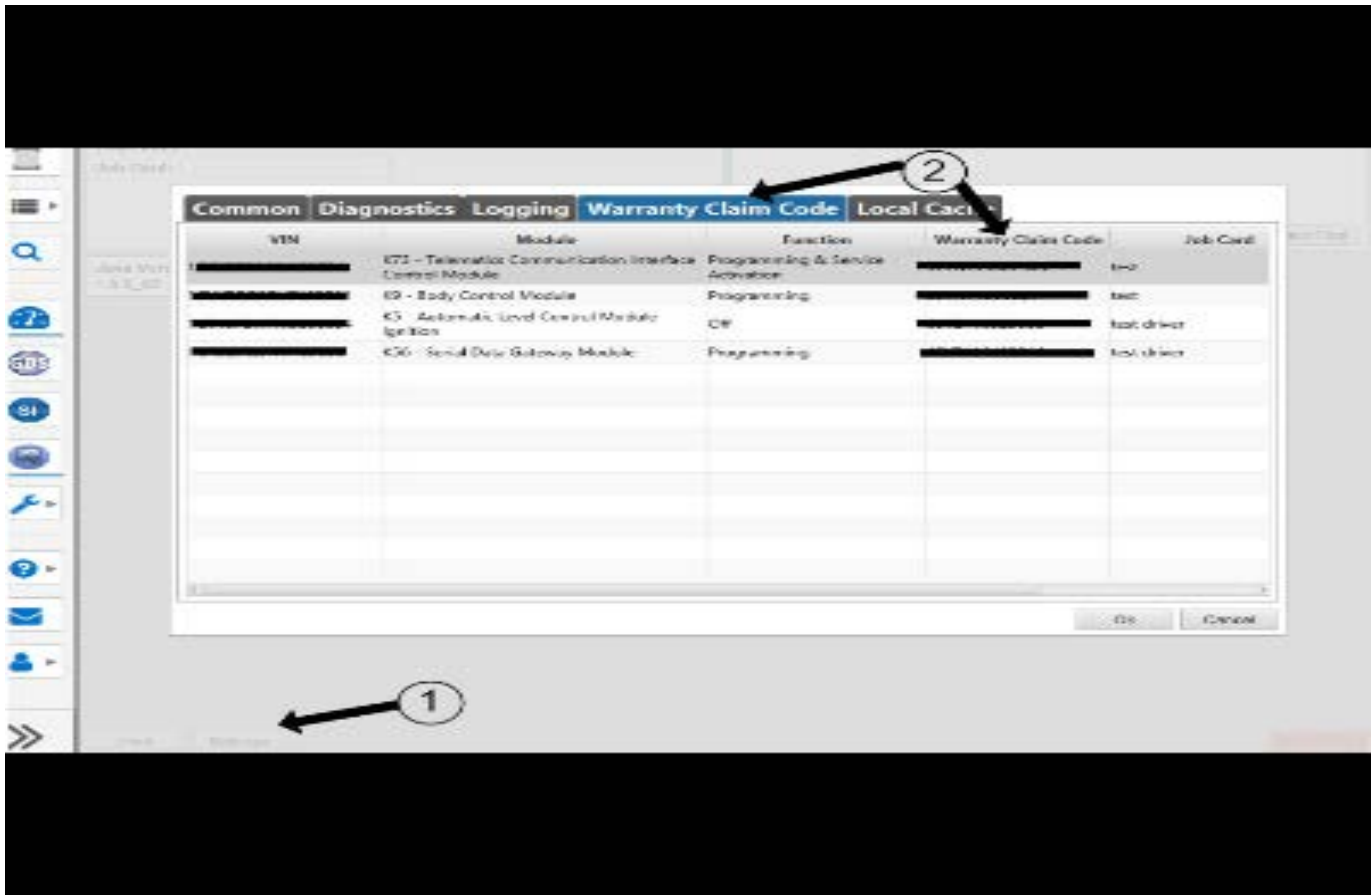
6125774

Warranty Claim Code Information Retrieval

If the Warranty Claim Code was not recorded on the Job Card, the code can be retrieved in the SPS2 system as follows:

The VIN, Warranty Claim Code and Date/Time will be listed on a roster of recent programming events. If the code is retrievable, dealers should resubmit the transaction making sure to include the code in the SPS Warranty Claim Code field.
