**TECHNICAL INSTRUCTIONS**

**23LC01**

**LEXUS SAFETY SENSE+ INOPERATIVE INTERMITTENTLY**

**2022 - 2023 MODEL YEAR NX250**

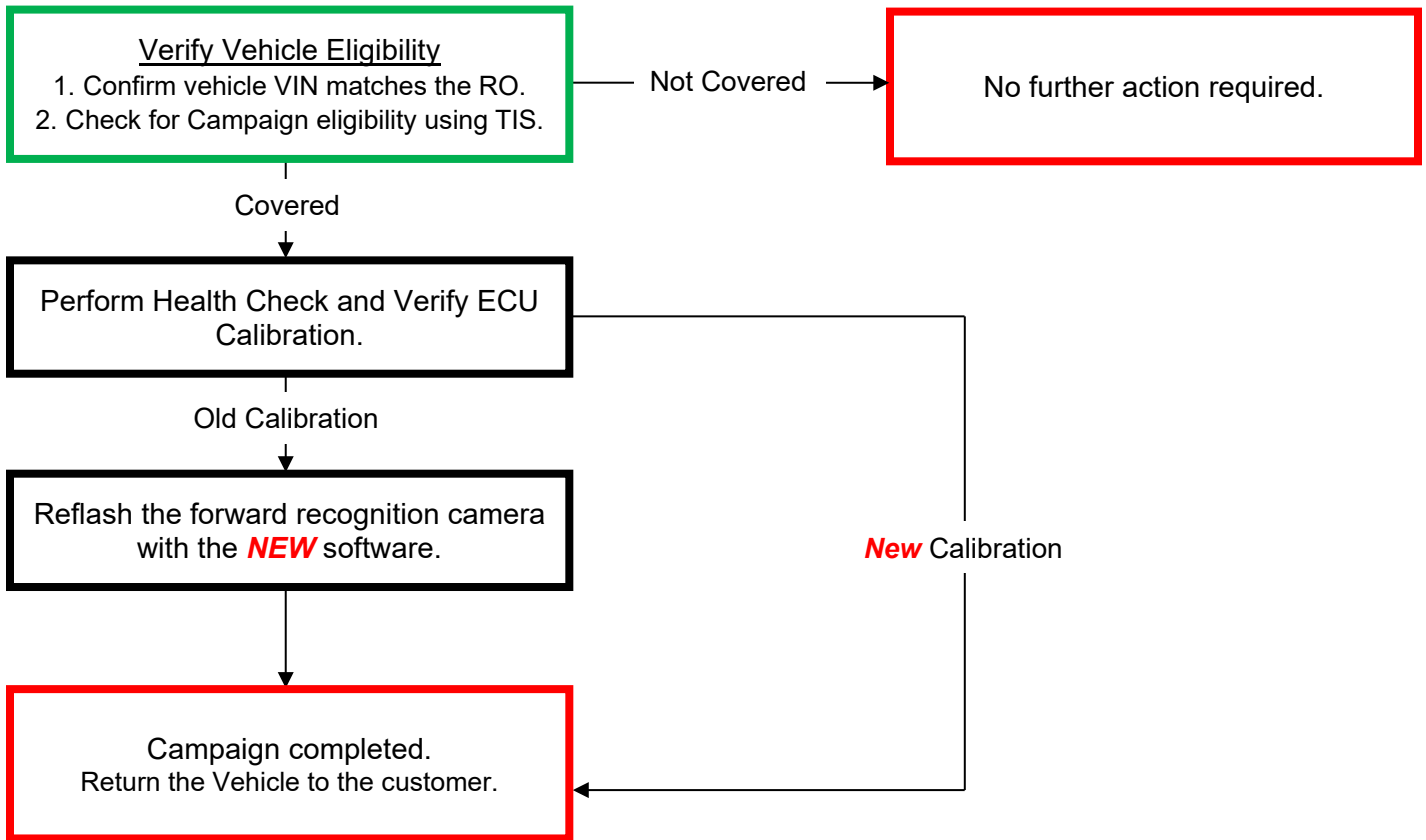
## I. OPERATION FLOW CHART

The flow chart is for reference only. **DO NOT** use it in place of the full technical instructions. Follow **ALL** steps as outlined in the full technical instructions to confirm the campaign is completed correctly.

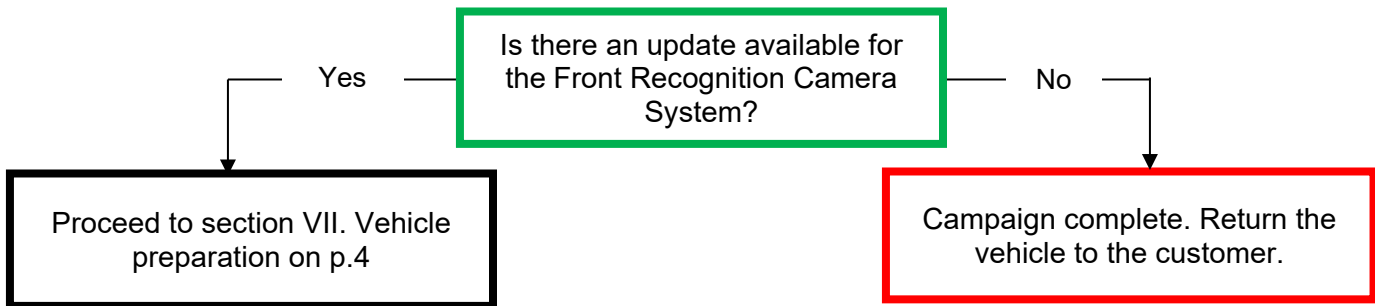
**2. CHECK CURRENT CALIBRATION**

- a) Locate the Update column for the Front Recognition Camera System in the Stored Data tab for this vehicle.
- b) Determine the status of an available update; indicated by a YES or NO.

If the CID's indicate 'Yes', proceed with the update procedure.

System	RoB	Calibration	Update	Configure
Circumference Monitoring Camera Control Module	●	8679F7820011	No	No
Front Recognition Camera	●	*****	Yes	No
Cleanance Learning	●	8934F7817020	No	No
Smart Access	●	021210040002	No	No
SRS Airbag	●	8917F7822000	No	No
Main Body	●	8AA117814000	No	No
Power Source Control	●	8922F7806003	No	No
	●	02221C030002	No	No

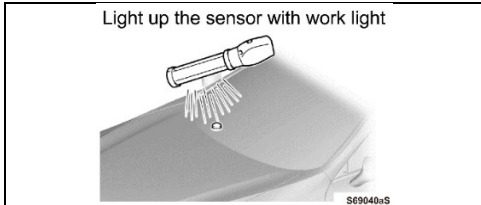
- Vehicle in the IG position (for HEV and PHEV Model: READY OFF, for Gasoline Model: engine OFF).
- Transaxle in Park.
- Parking brake engaged.
- Turn off all electrical accessories (i.e. climate control, audio system, etc.)
- Headlight switch in the DRL OFF position. (w/ DRL OFF position)
- Windshield wiper switch in the OFF position.

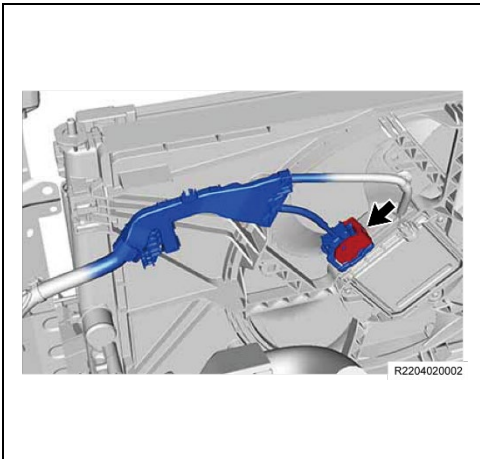
1. **DISCONNECT THE DCA-8000**
2. **RECONNECT COOLING FAN (For NX350h and NX450h+)**
  - a) Peel off the covering tape, etc.
  - b) Reconnect the connector to the cooling fan on the radiator fan shroud.
3. **CHECK THE OPERATION OF THE COOLING FAN (For NX350h and NX450h+)**
  - a) Turn the READY ON.
  - b) Turn the air conditioner ON to check if the cooling fan operates.

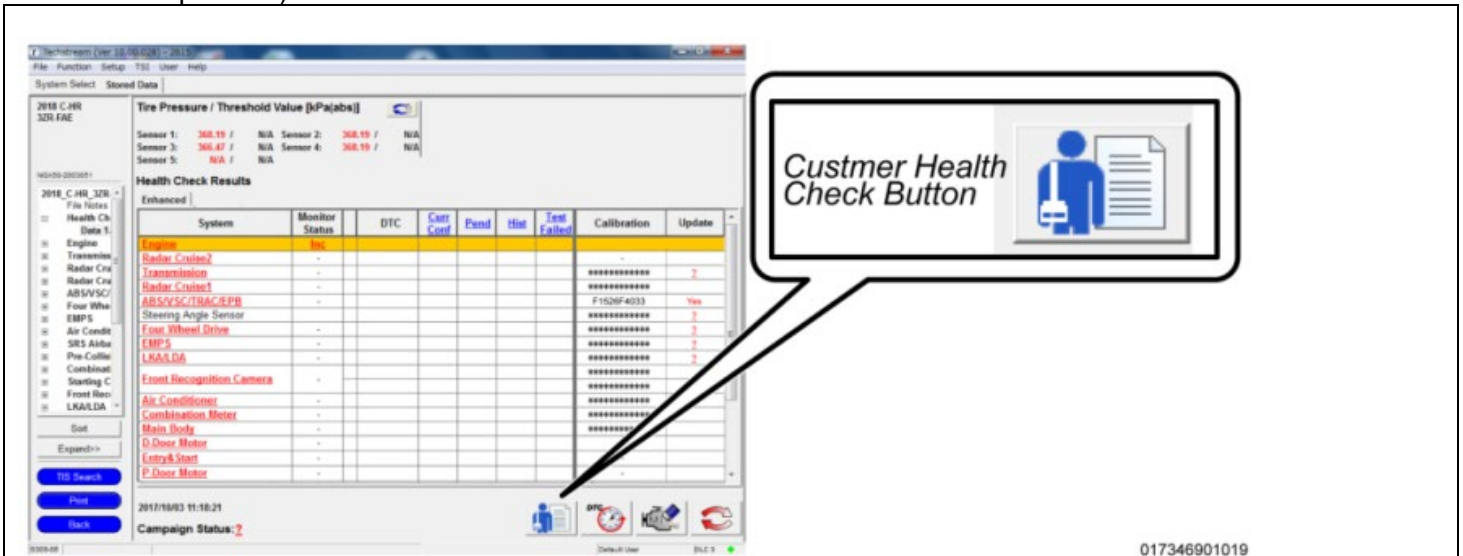
- a) From the Stored Data tab, select the Customer Health Check Report button (TIS will launch when button is pressed).

The screenshot shows the TIS software interface with the 'Health Check Results' table. The table has columns for System, Monitor Status, DTC, Cutt Conf, Panel, Hist, Test Failed, Calibration, and Update. A callout box points to a button labeled 'Customer Health Check Button' with an icon of a person and a document.

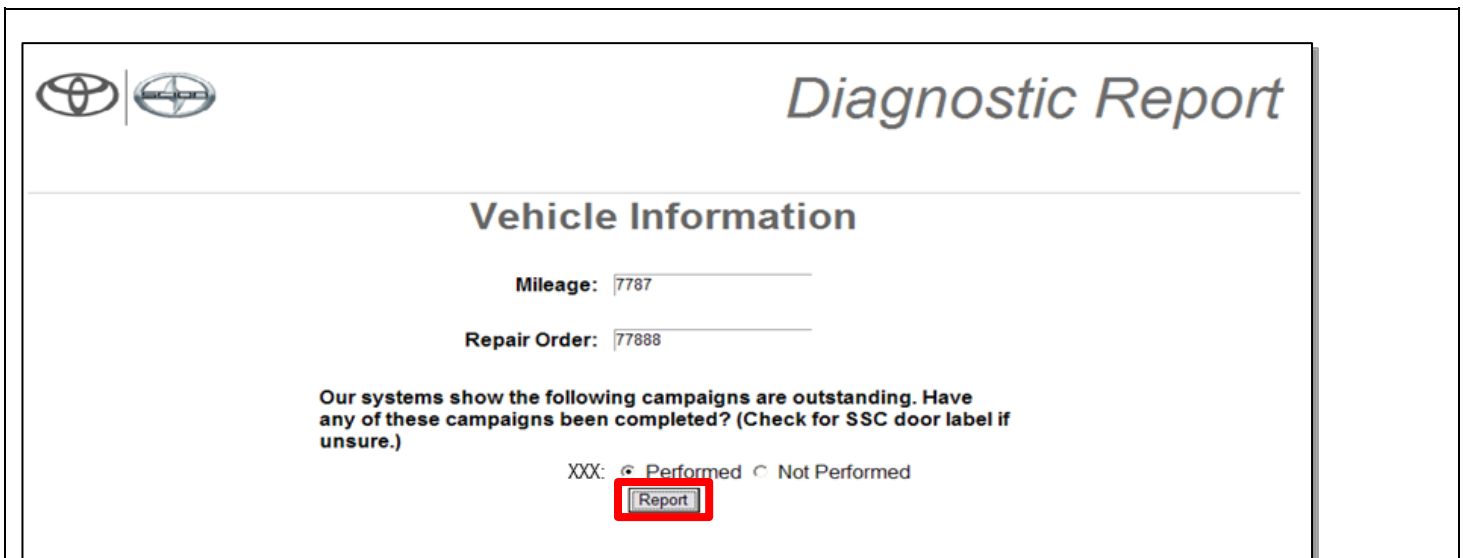
- b) Log in to TIS.  
c) Input Vehicle Mileage and Repair Order number.  
d) Check the "Performed" campaign button for campaign 23LC01.  
e) Select the Report button.

The screenshot shows the Diagnostic Report form. The form has the Toyota and Lexus logos at the top left. The title is 'Diagnostic Report'. Below the title is 'Vehicle Information' with fields for Mileage: 7787 and Repair Order: 77888. Below this is a section for outstanding campaigns with a 'Report' button highlighted in a red box.
