GLOBAL SAFETY FIELD INVESTIGATIONS DCS6695 URGENT - DISTRIBUTE IMMEDIATELY

Subject: N232408230 - Emission Recall

Particulate Matter Sensor OBD

Models: 2019 Chevrolet Express

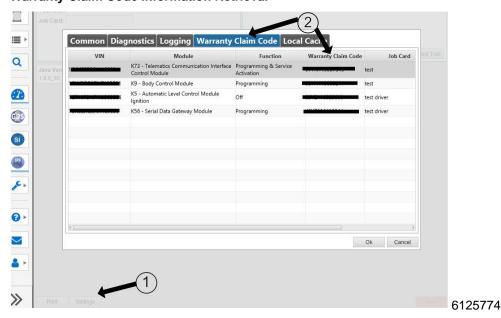
Warranty Claim Code Information Retrieval

If the Warranty Claim Code was not recorded on the Job Card, the code can be retrieved in the SPS2 system as follows:

- 1. Open TLC on the computer used to program the vehicle.
- 2. Select and start SPS2.
- 3. Select Settings (1).

The VIN, Warranty Claim Code and Date/Time will be listed on a roster of recent programming events. If the code is retrievable, dealers should resubmit the transaction making sure to include the code in the SPS Warranty Claim Code field.

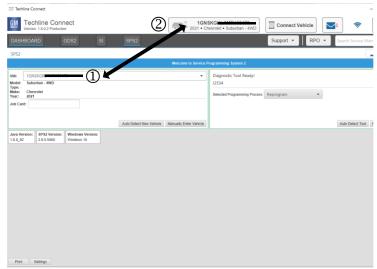
Caution: Be sure the VIN selected in the drop down menu (1) is the same as the vehicle connected (2) before beginning programming.

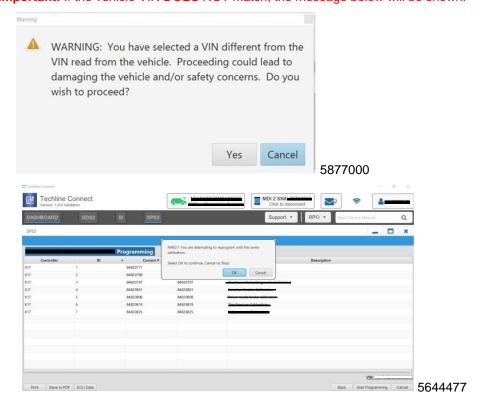
Important: If the vehicle VIN DOES NOT match, the message below will be shown.

Important: Techline Connect screens shown above.
