Technical Service Bulletin

00 Replacement control module is unable to be coded

00 23 77 2071338/2 October 16, 2023. Supersedes Technical Service Bulletin Group 00 number 23-72 dated September 8, 2023, for reasons listed below.

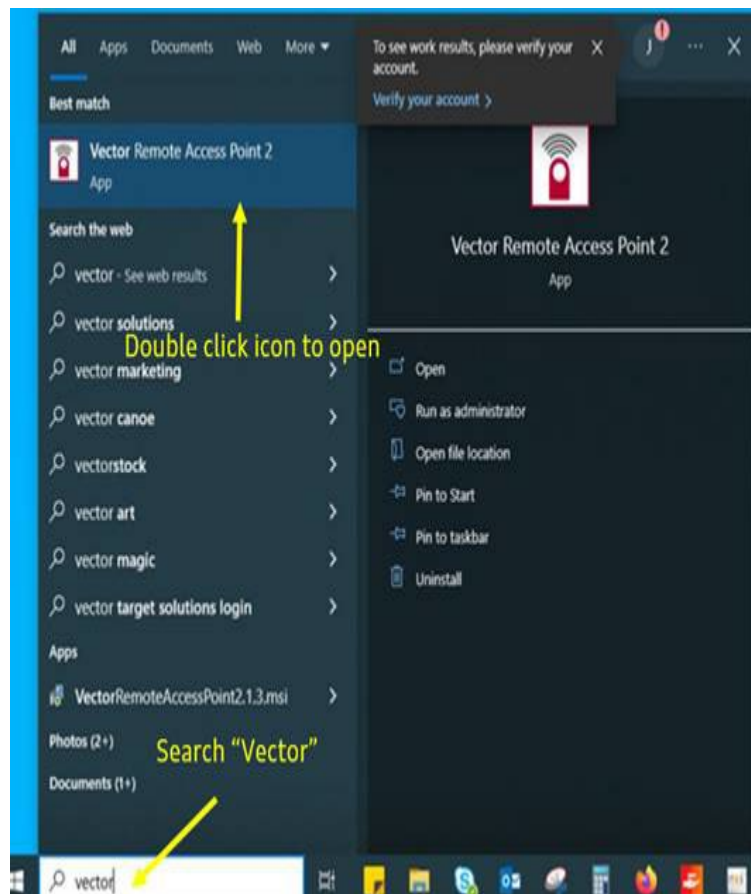
To access the tool during the coding session:

- Search “vector” from the windows desktop search bar.
- Click the Vector icon and accept the prompt when the tool opens.

Figure 2: How to access Vector Remote Access Point.

1. Using the ODIS tester, connect to the Microsoft Teams session using the link from your email.
2. Start the Vector access point (see figure 2 above).
3. Copy/paste the Vector session ID and PW into teams chat window (red arrow figure 4).
4. Audi representative will carry out initial coding of the module using the Vector remote access point.
5. Once instructed, technician will start a new ODIS "Diagnosis" Session.
6. Work with the Audi representative throughout the coding process.
7. Once the remote coding session is complete, carry out any other subsequent work needed.

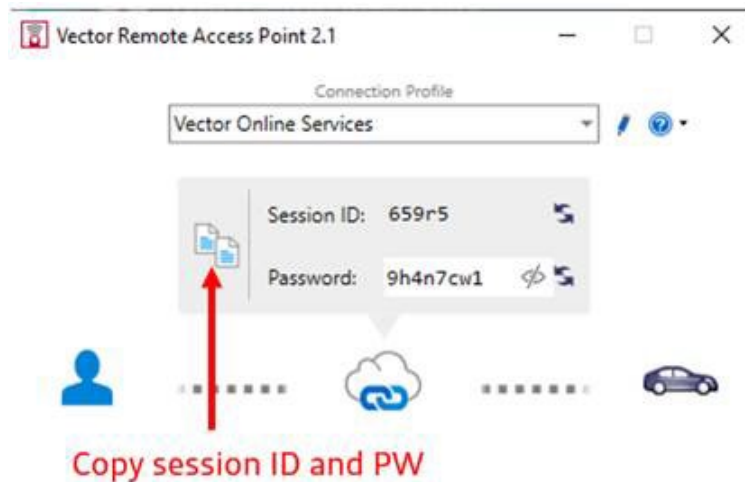
Figure 4: Use the copy button (red arrow) to copy the Session ID and PW.
