June 2023
SF639A

Subject: Bendix SDP5 Software Update

**Models Affected: Specific model year 2022 Freightliner Cascadia;
and Western Star 49X vehicles manufactured January 4, 2021,
through May 16, 2021.**

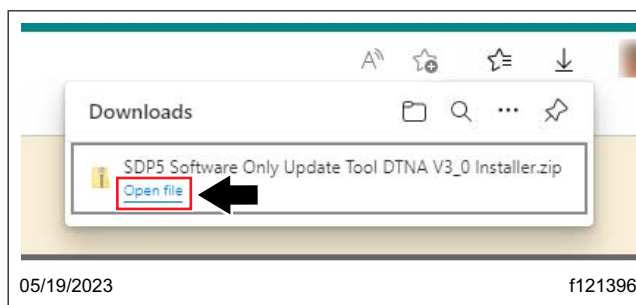
Fig. 3, Opening the Downloaded File

5. A 'Downloads' box will appear in the upper-right corner of the browser window. Once the download is complete, select 'Open file' to see the contents of the downloaded zip file within the file explorer. See [Fig. 3](#).

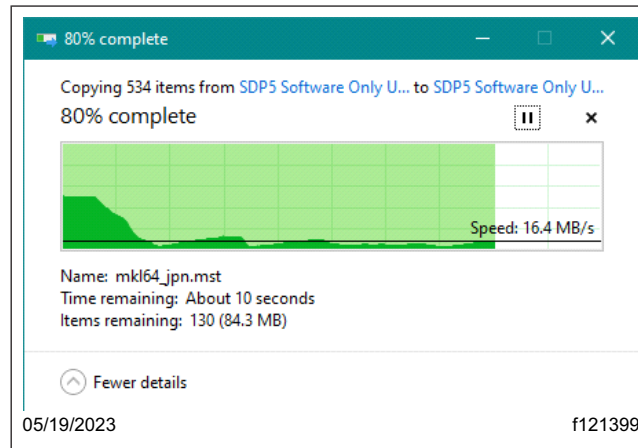
Fig. 6, Extracting the Files

8. The files are extracted to the destination folder. See [Fig. 6](#).

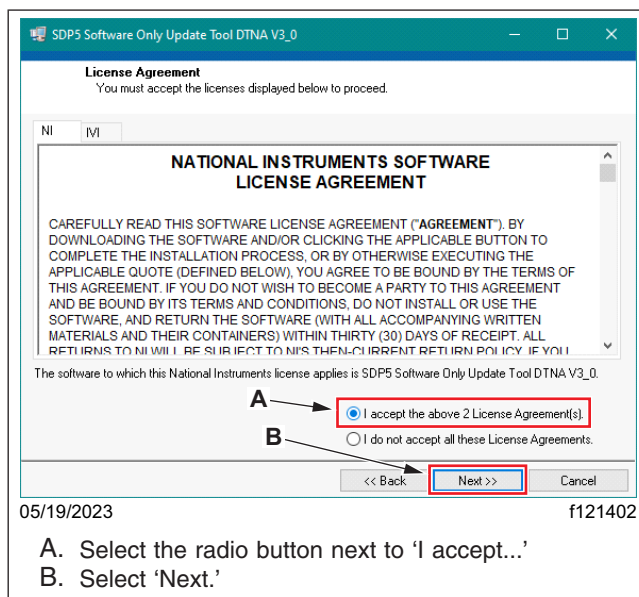
Fig. 9, Accepting the License Agreements

11. Select the radio button next to 'I accept the above 2 License Agreement(s).' Select 'Next.' See [Fig. 9](#).

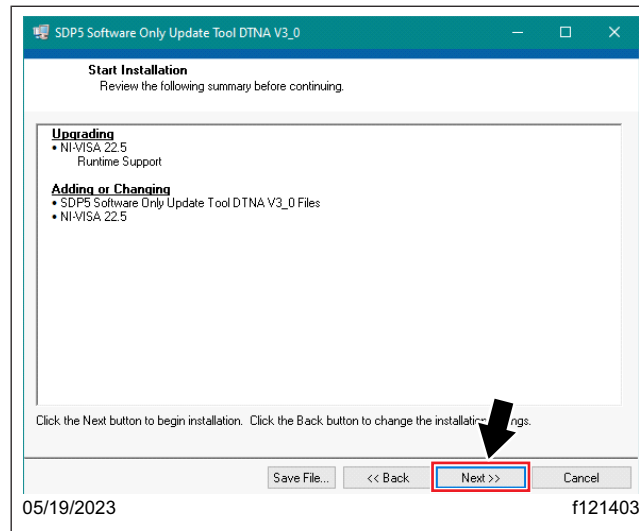
Fig. 10, Beginning the Installation Process

12. Select 'Next' to begin the installation. See [Fig. 10](#).

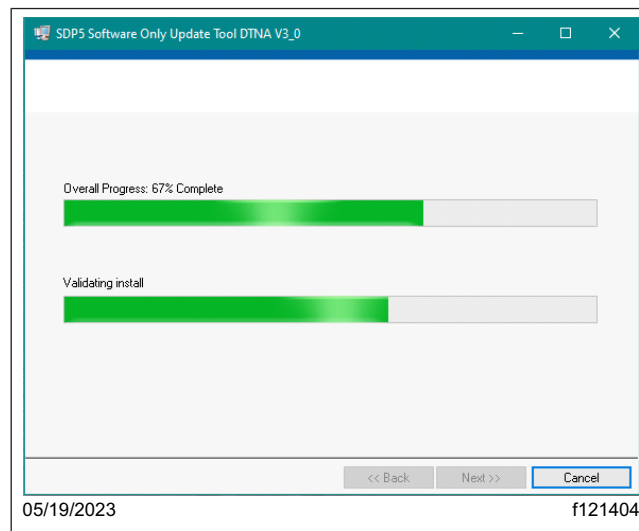
Fig. 11, Software Installation in Progress

13. The software installation begins. See [Fig. 11](#).

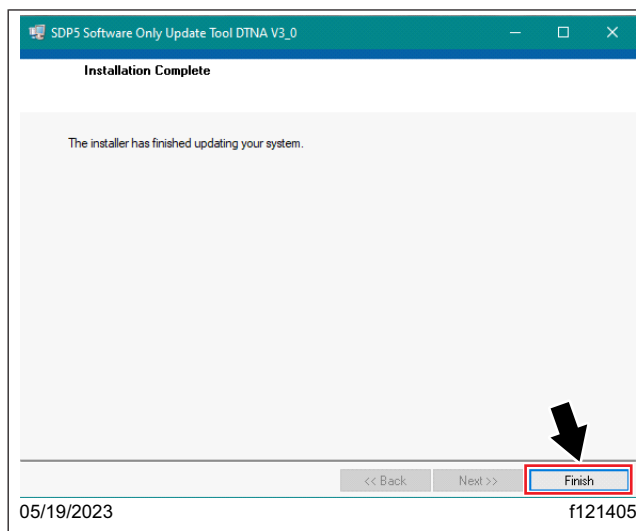
Fig. 12, Installation Completed

14. Once the installation is complete, select 'Finish.' See [Fig. 12](#).

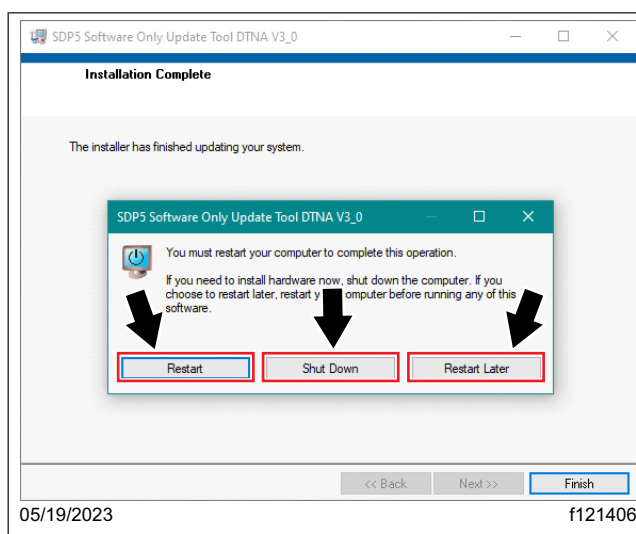
Fig. 13, Restarting the Computer

15. Select 'Restart' or 'Shut Down' to complete the installation process. See [Fig. 13](#).

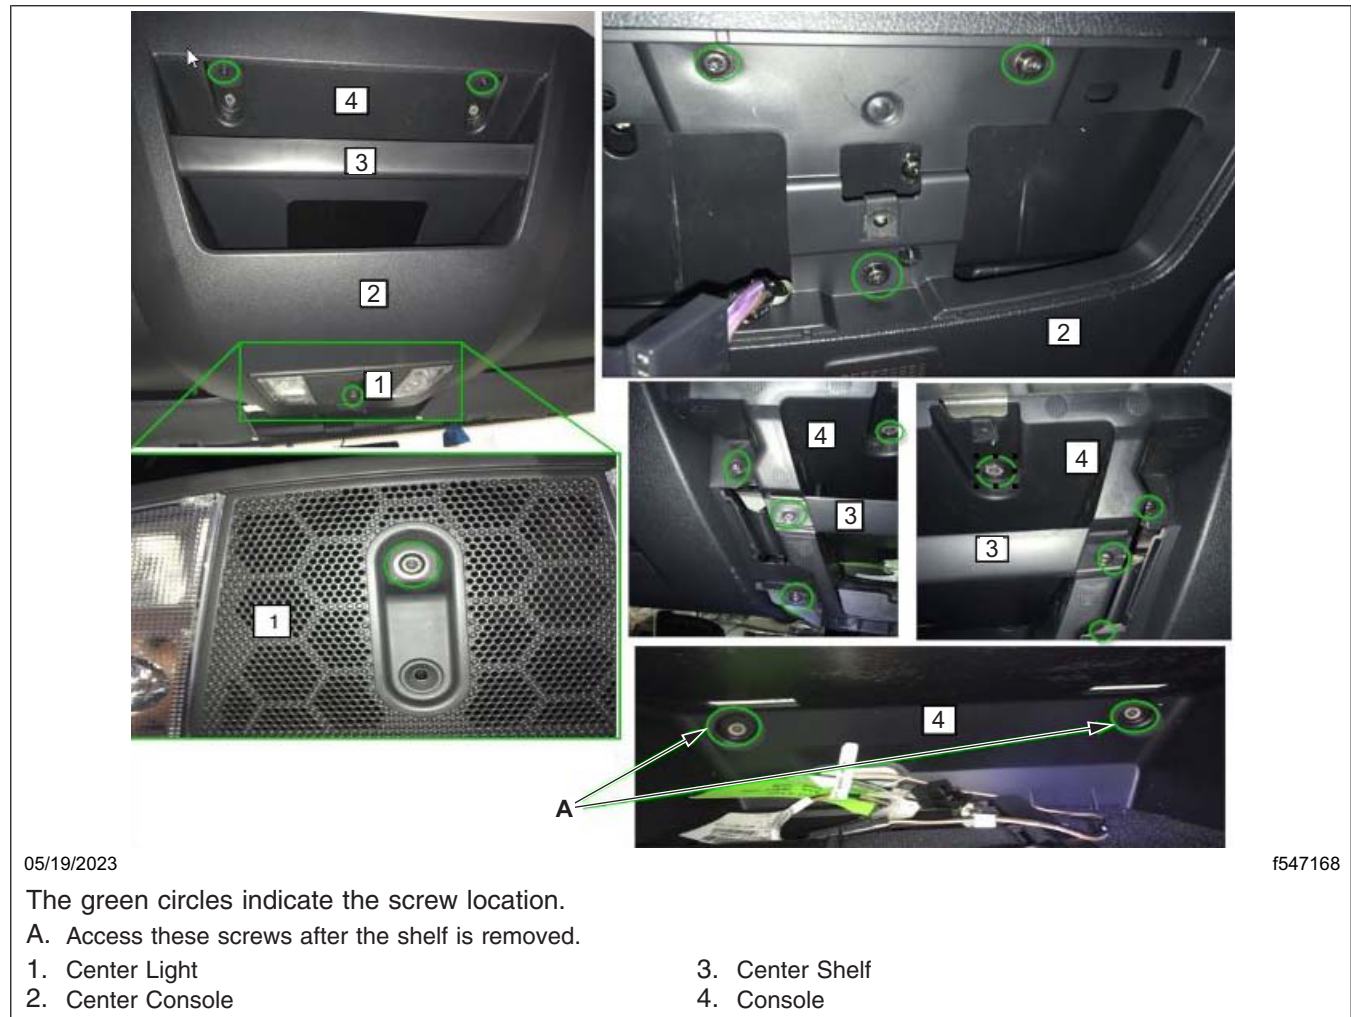
Fig. 14, Center Overhead Console Part Location

4. Remove the eighteen T25 screws in the order shown in **Fig. 14**. See **Fig. 15** for reference of the parts removed.

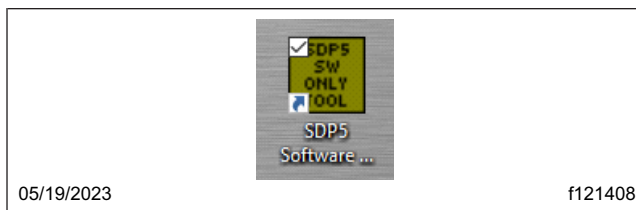
**Fig. 20, SDP5 Software Only Update Tool DTNA V3_0
Shortcut Icon**

8. Double-click the 'SDP5 Software Only Update Tool DTNA V3_0' shortcut icon on the desktop to run the software update program. See [Fig. 20](#).

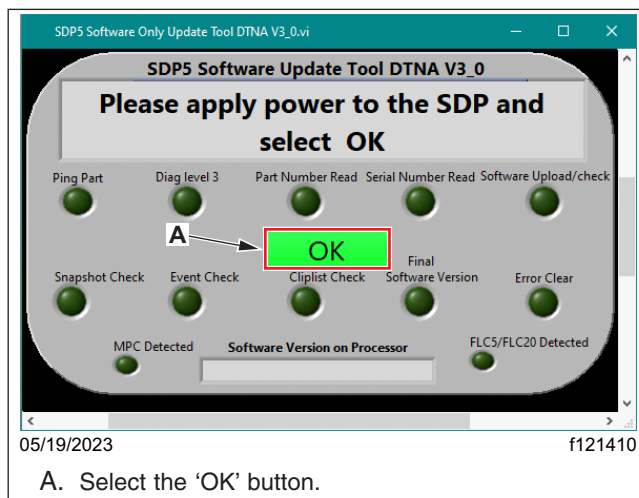
Fig. 22, Beginning to Communicate with the SDP5

10. Select the 'OK' button to begin communication with the SDP5. See [Fig. 22](#).

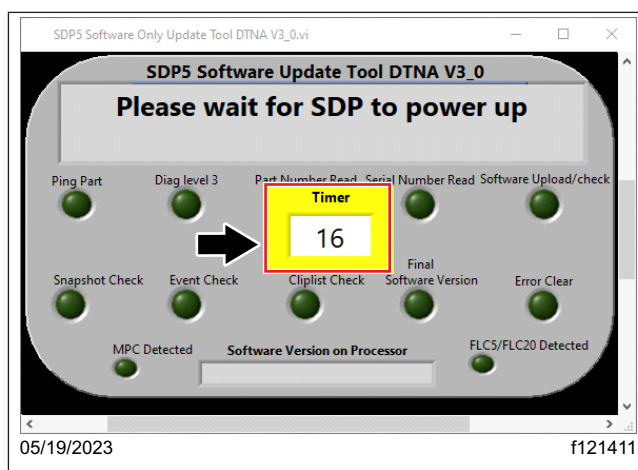
Fig. 23, Time Left for the Connection to Establish

11. A timer is displayed on the screen while communication with SDP5 is being established. See [Fig. 23](#).

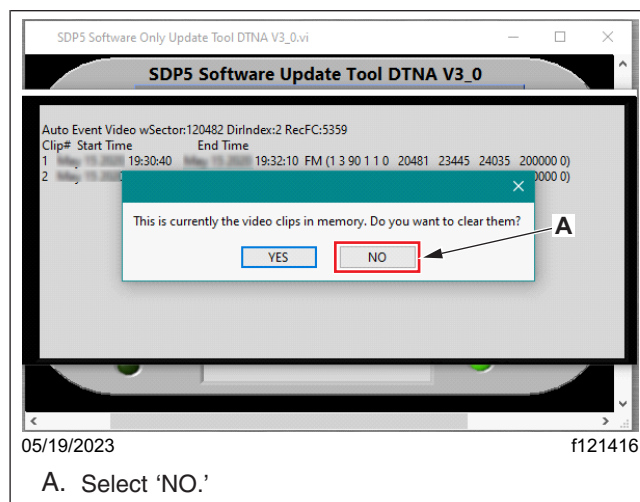
Fig. 29, Clearing the Memory

15. Some vehicles may have previously-recorded clips in the memory, and a pop-up saying 'This is currently the video clips in memory. Do you want to clear them?' appears. Select 'NO.' See [Fig. 29](#).
