October 2023
SF639A
REVISED NOTICE

Subject: Bendix SDP5 Software Update

Models Affected: Specific model year 2022 Freightliner Cascadia; and Western Star 49X vehicles manufactured January 4, 2021, through May 16, 2021.

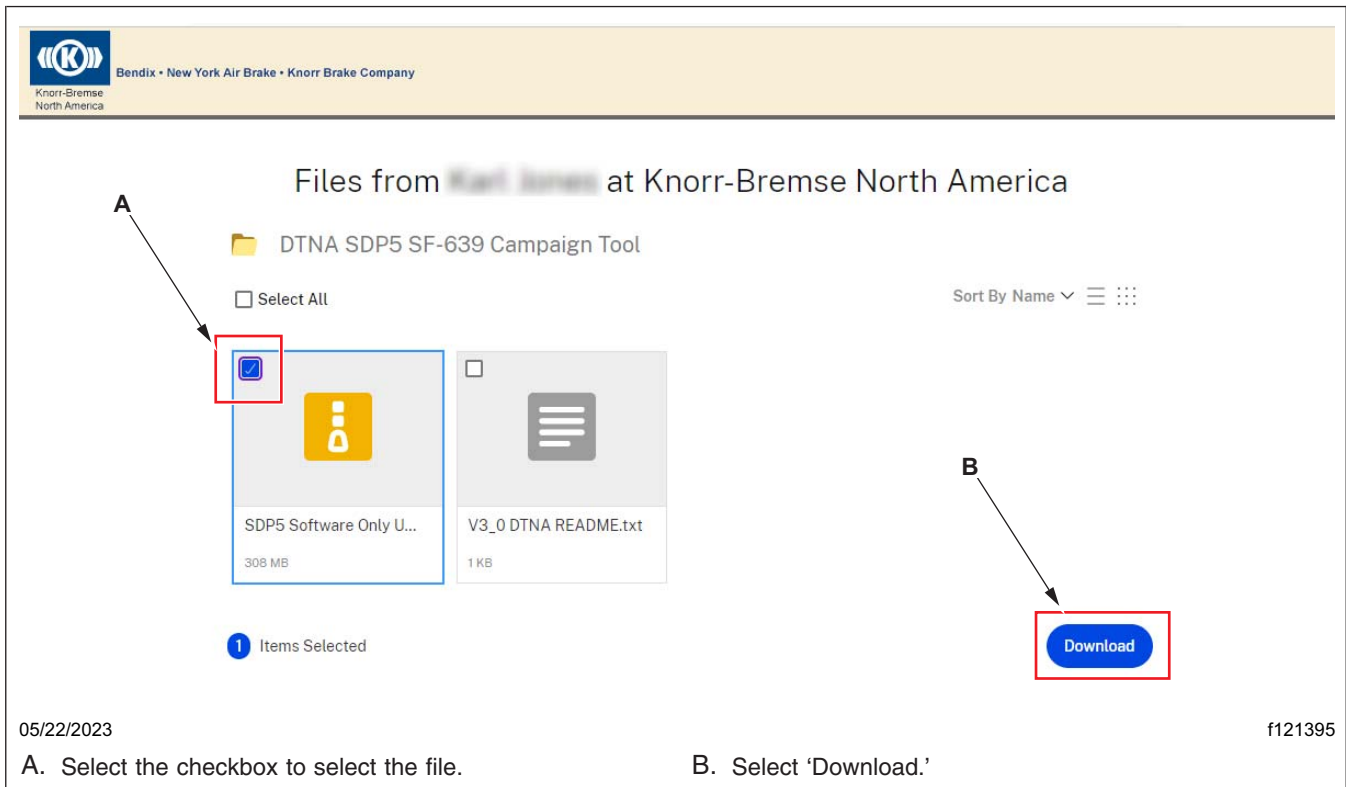
Fig. 2, Starting Download

4. Select the checkbox corresponding to the 'SDP5 Software Only U...' zip file, indicated by the larger file size than the other file. Select 'Download.' See [Fig. 2](#).

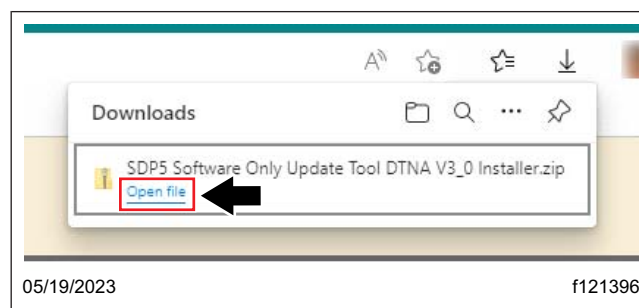
Fig. 3, Opening the Downloaded File

5. A 'Downloads' box will appear in the upper-right corner of the browser window. Once the download is complete, select 'Open file' to see the contents of the downloaded zip file within the file explorer. See [Fig. 3](#).

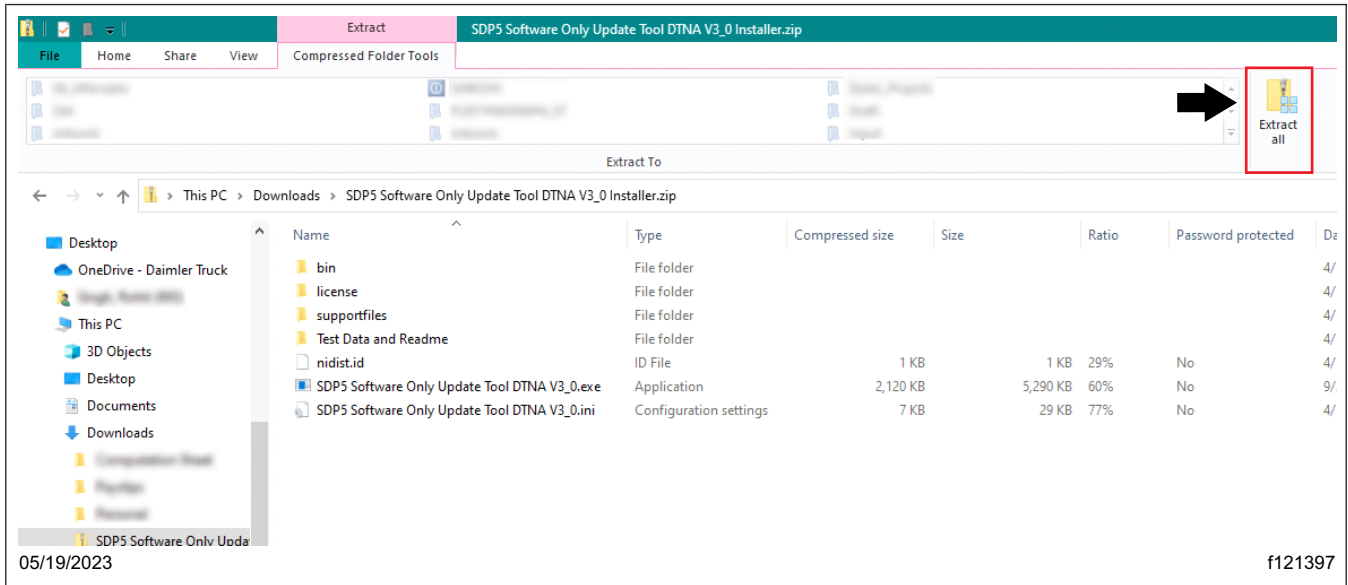
Fig. 4, Selecting Extract All

6. Select 'Extract all' in the top-right of the window to extract all the contents from the zip file. See [Fig. 4](#).

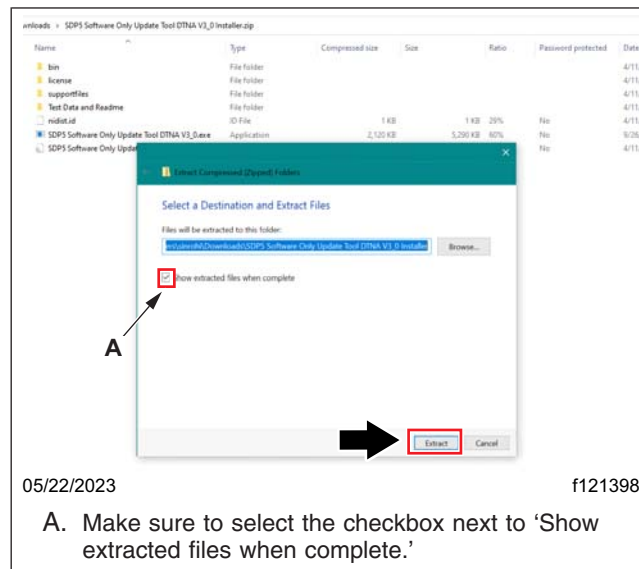
Fig. 5, Extract Compressed (Zipped) Folders Window

7. The 'Extract Compressed (Zipped) Folders' appears. Make sure the checkbox next to 'Show extracted files when complete' is selected, then select 'Extract.' See Fig. 5.

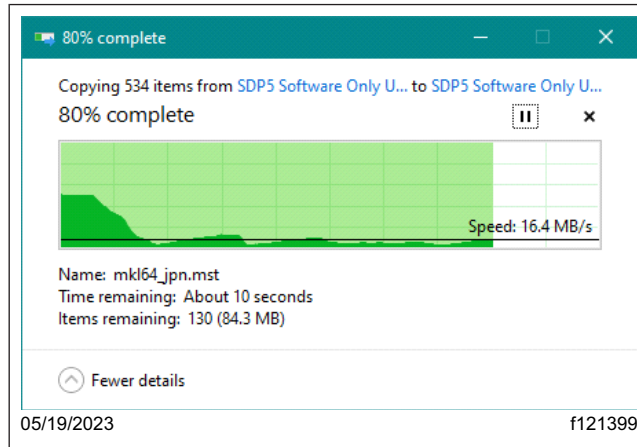
Fig. 6, Extracting the Files

8. The files are extracted to the destination folder. See Fig. 6.

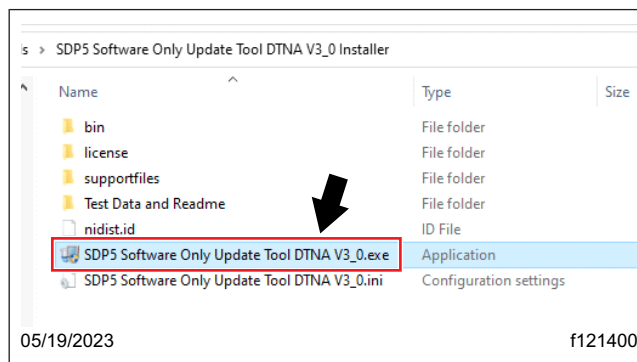
Fig. 7, Selecting and Running the Setup File

- The extracted contents are shown in a new window. Double-click to run the 'SDP5 Software Only Update Tool DTNA V3.0.exe' application file. See [Fig. 7](#).

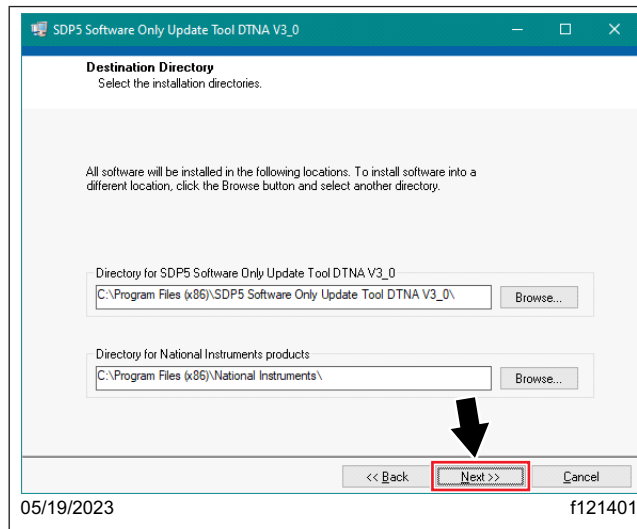
Fig. 8, Selecting Next

- The software installation window pops-up. Select 'Next.' See [Fig. 8](#).

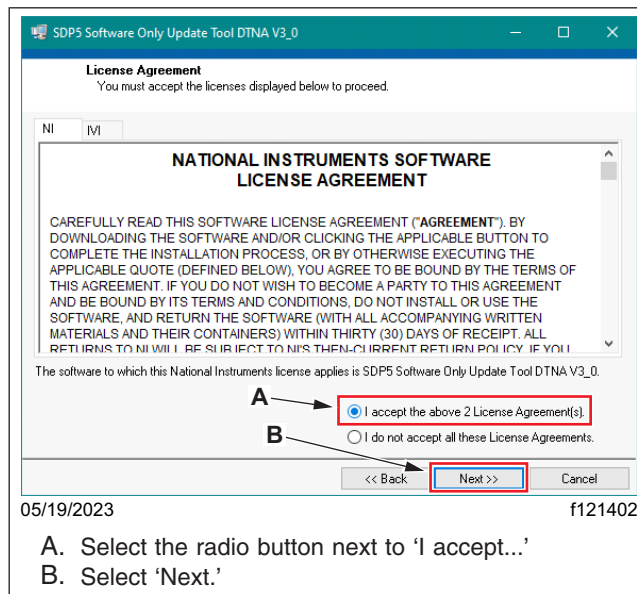
Fig. 9, Accepting the License Agreements

11. Select the radio button next to 'I accept the above 2 License Agreement(s).' Select 'Next.' See [Fig. 9](#).

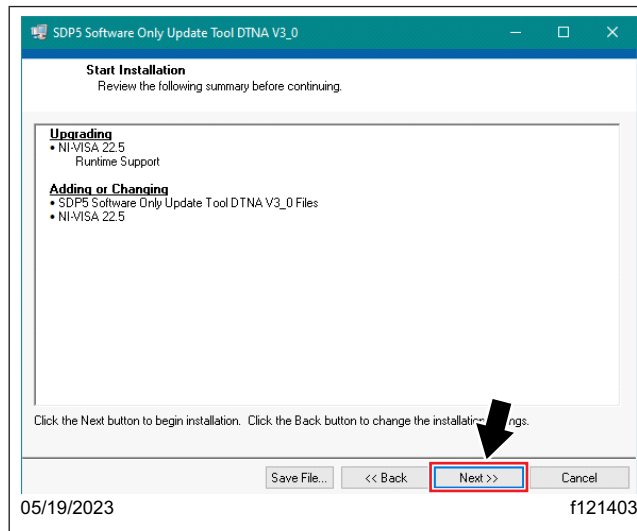
Fig. 10, Beginning the Installation Process

12. Select 'Next' to begin the installation. See [Fig. 10](#).

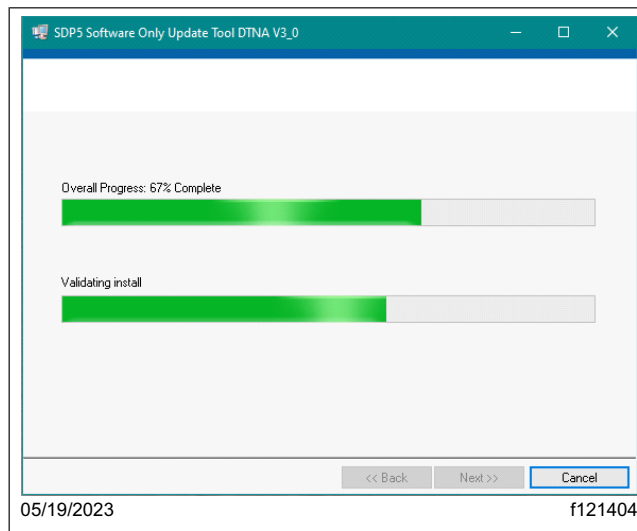
Fig. 11, Software Installation in Progress

13. The software installation begins. See [Fig. 11](#).

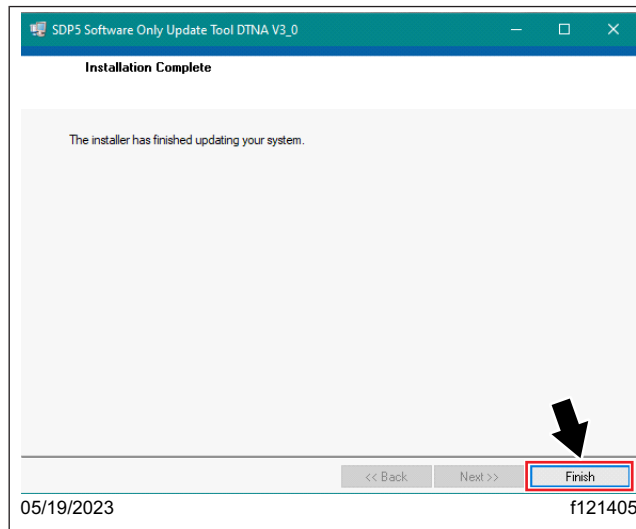
Fig. 12, Installation Completed

14. Once the installation is complete, select 'Finish.' See [Fig. 12](#).

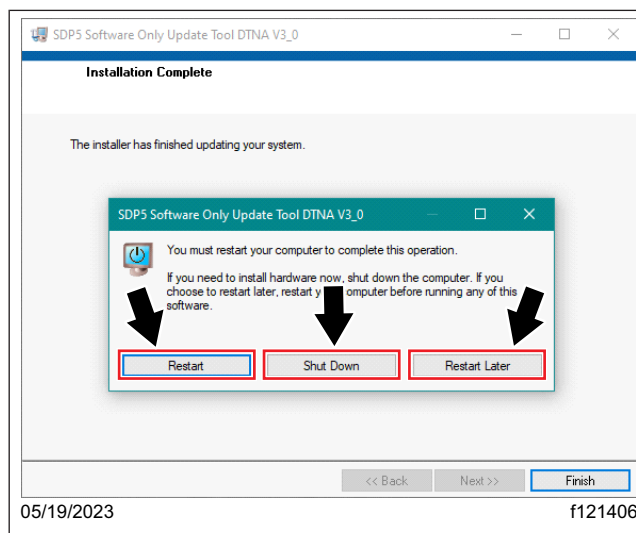
Fig. 13, Restarting the Computer

15. Select 'Restart' or 'Shut Down' to complete the installation process. See [Fig. 13](#).

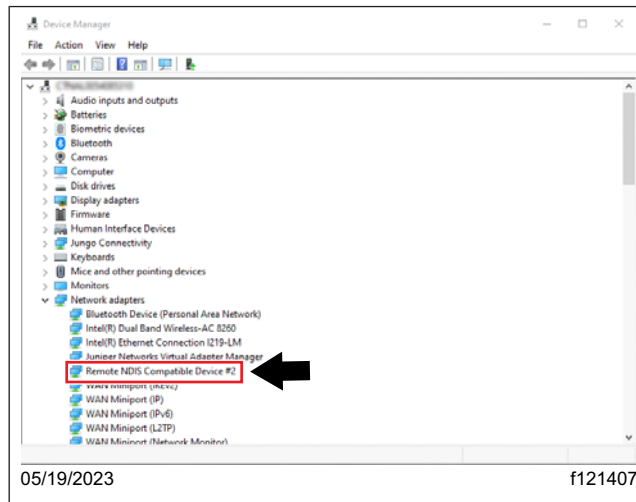
Fig. 19, Laptop Device Manager

7. Connect the hard-wired connection between the SDP5 module and the laptop. Open the laptop device manager, and verify that the 'Remote NDIS Compatible Device #2' is present under the 'Network adapters' dropdown. See [Fig. 19](#).

7.1 If 'Remote NDIS Compatible Device #2' is not listed under 'Network adapters' even after waiting for approximately 5 minutes:

7.2 Check again for 'Remote NDIS Compatible Device #2' under 'Network Adapters.'

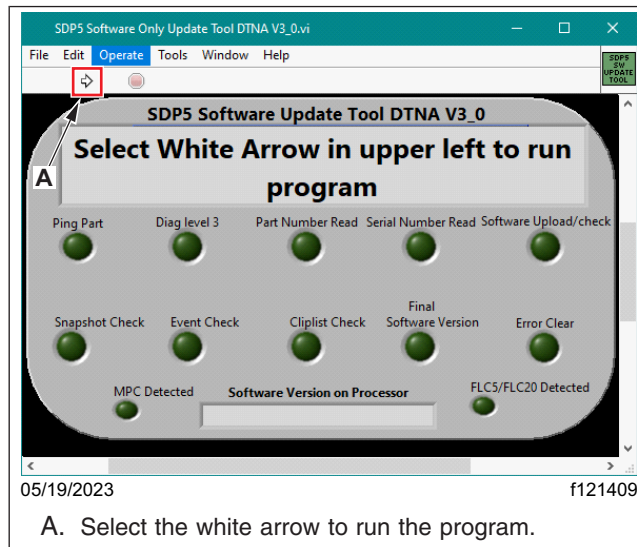
Fig. 21, Running the Program

- close the SDP5 Software Only Update Tool,
 - correct the disruption,
 - disconnect the USB cable between the SDP5 module and the laptop,
 - connect the USB cable between SDP5 module and the laptop again,
 - run the SDP5 Software Only Update Tool again.
9. The 'SDP5 Software Only Update Tool DTNA V3_0.vi' window appears. Select the white arrow in the upper-left corner to run the program. See [Fig. 21](#).

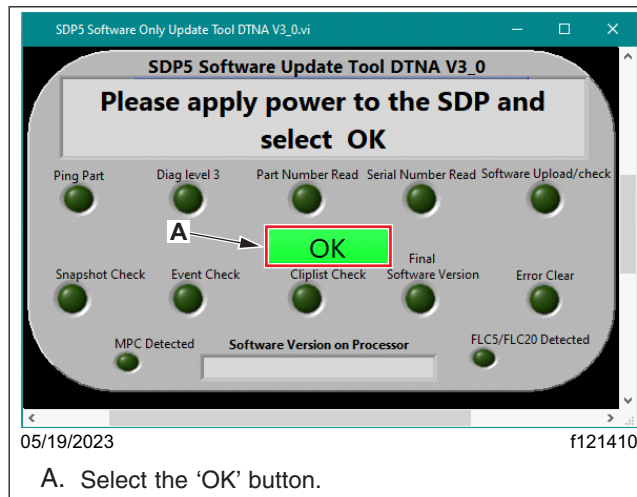
Fig. 22, Beginning to Communicate with the SDP5

10. Select the 'OK' button to begin communication with the SDP5. See [Fig. 22](#).

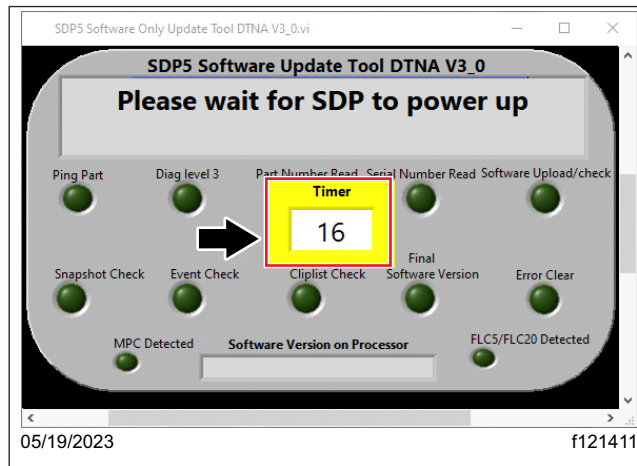
Fig. 23, Time Left for the Connection to Establish

11. A timer is displayed on the screen while communication with SDP5 is being established. See [Fig. 23](#).

NOTE: The software update process is automatic, and requires no user interaction. If for any reason the timer shown in Fig. 23 expires and the window shown in Fig. 24 does not open, usually within five minutes, try using a different computer to perform the campaign.

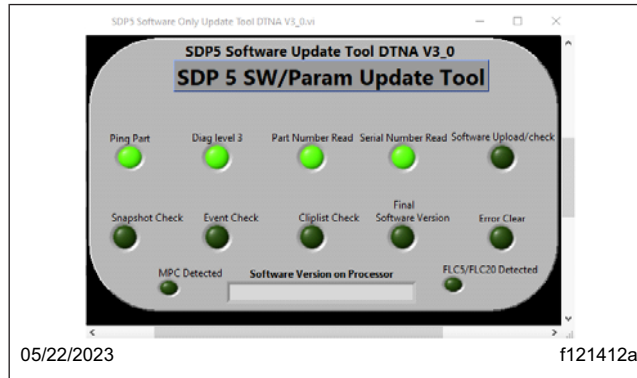
Fig. 25, Green Status Lights Illuminating on Completion of Each Step

The green status lights within the 'SDP 5 SW/Param Update Tool' window illuminate as each step is completed. Some green status lights may not illuminate on all vehicles. See Fig. 25.

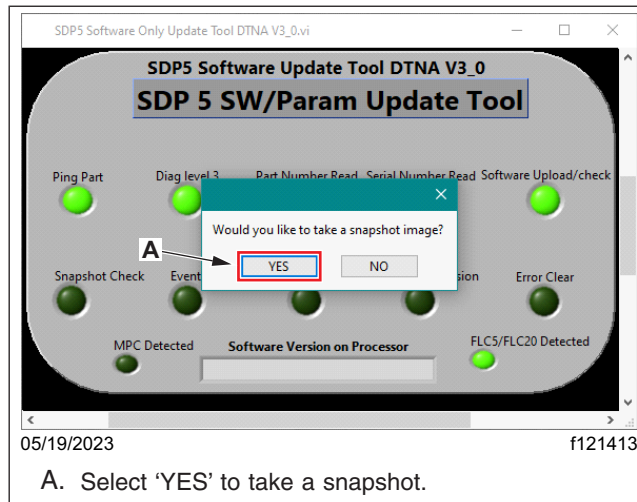
Fig. 26, Taking a Snapshot with the FLC5 Camera

- Once the software update is complete, a pop-up window saying 'Would you like to take a snapshot image?' appears. See [Fig. 26](#).

YES → Select 'YES.' A photo, which matches the view from the windshield of the vehicle looking forward, as shown in [Fig. 27](#), is displayed in the pop-up window. Capture a screenshot of the photo, and retain with the repair order. If desired, another photo can be taken by selecting 'YES' otherwise, select 'NO.'

A. Select 'YES' to take a snapshot.

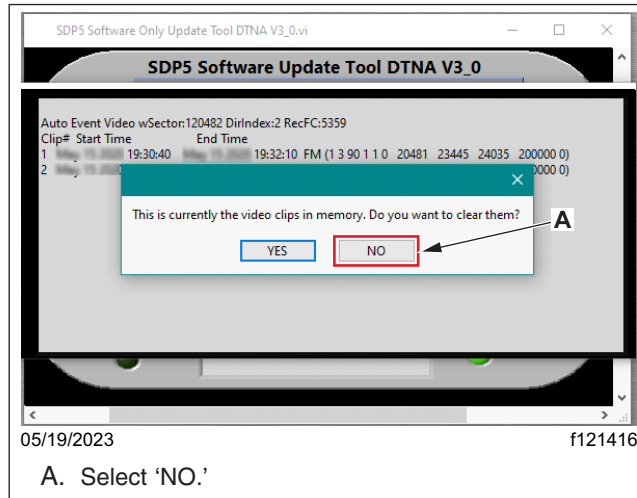
Fig. 29, Clearing the Memory

15. Some vehicles may have previously-recorded clips in the memory, and a pop-up saying 'This is currently the video clips in memory. Do you want to clear them?' appears. Select 'NO.' See **Fig. 29**.

A. Select 'NO.'

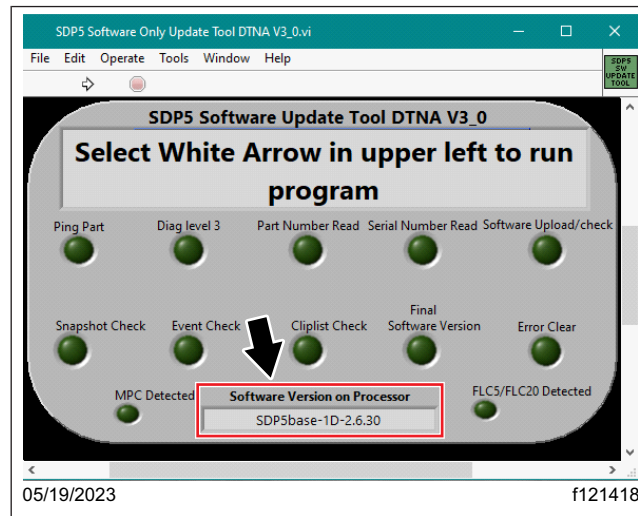
Fig. 31, Updated Software Version

17. The 'Software Version on Processor' panel now displays 'SDP5base-1D-2.6.30.' See [Fig. 31](#).
